Boston University

National Emerging Infectious Disease Laboratory

Building Automation System Network Performance Review

July 21, 2016

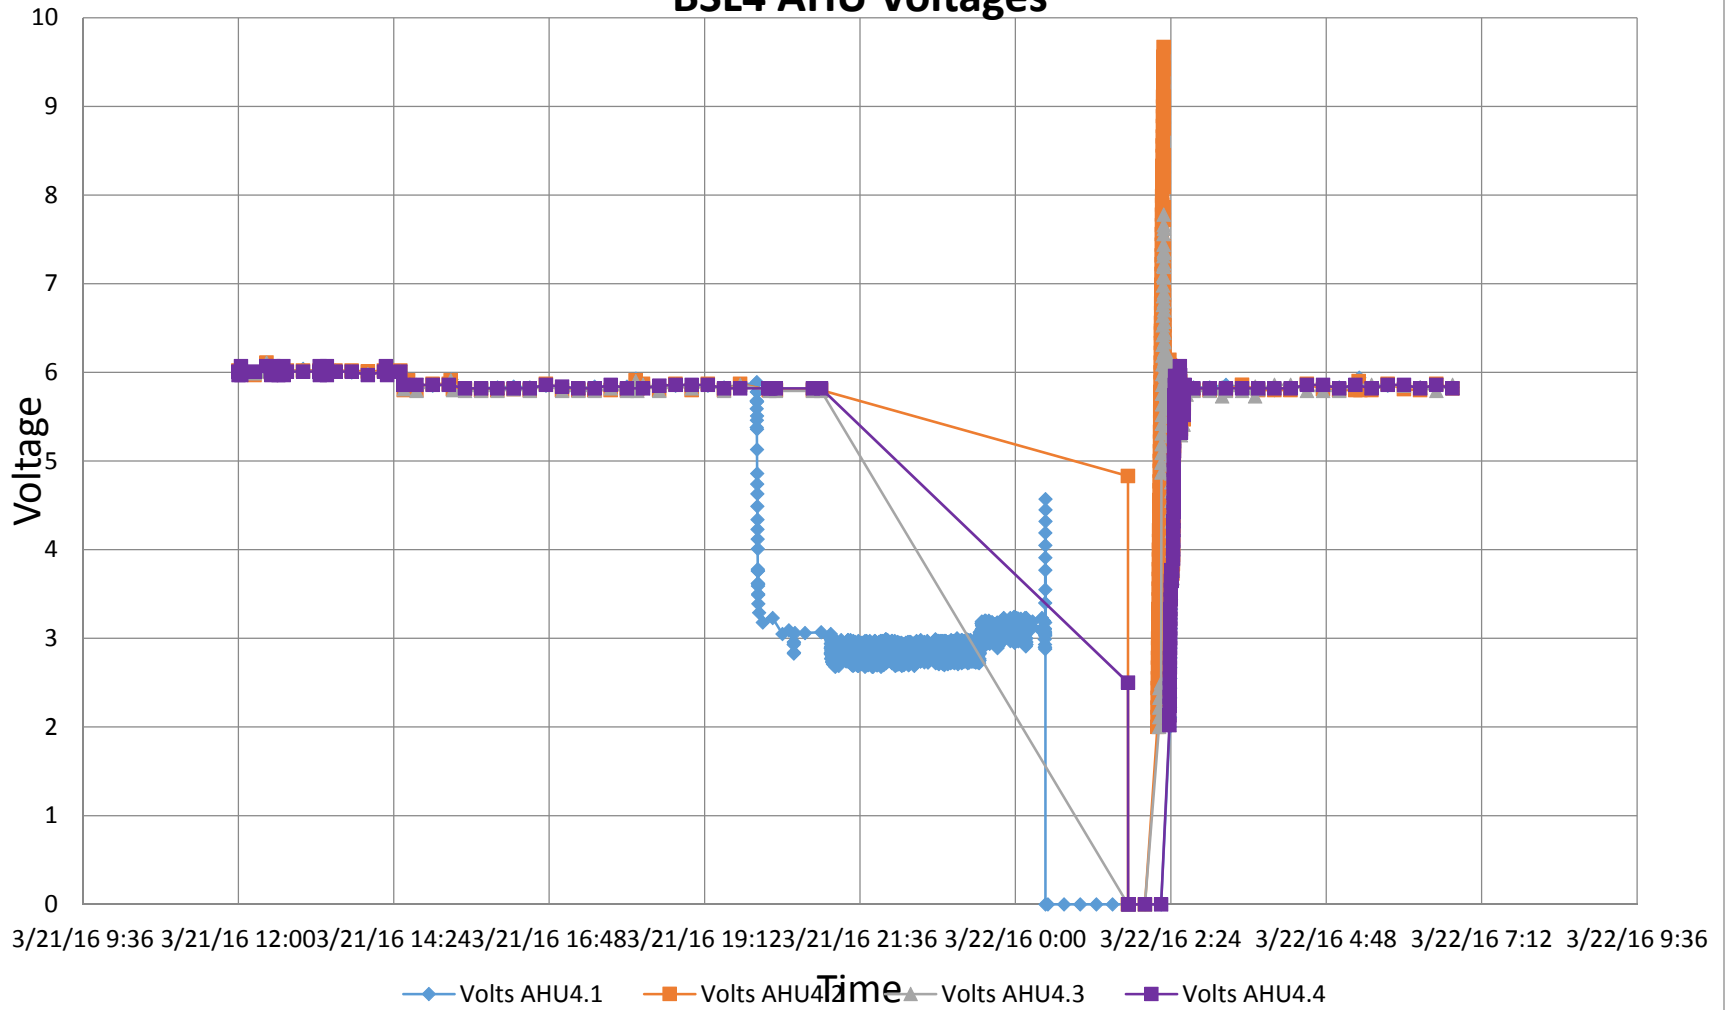
BSL4 AHU Voltages

The last time the units were operating under normal conditions was 19:45, and this was before the Notification Errors were indicated on the network switches. The network switches indicated Notification Errors at 19:59, and this was just before the status was reading “off.” These events line up in the timeline.

Time Stamp	BSL4 AHU-1	BSL4 AHU-2	BSL4 AHU-3	BSL4 AHU-4
Mon 19:45	operating normally	operating normally	operating normally	operating normally
Mon 20:00	showing normal voltage (5.88 v)	No data showing	No data showing	No data showing
Mon 20:11	Showing normal voltage readings	Showing some voltage readings		Showing some voltage readings
Mon 20:13; and 20:15 thru 20:18	Failed execution status (not executing commands)	Failed execution status (not executing commands)	Failed execution status (not executing commands)	Failed execution status (not executing commands)
Mon 20:52 to Tues 01:30	Showing some voltage readings	Failed execution status (not executing commands)	Failed execution status (not executing commands)	Failed execution status (not executing commands)
Tues 01:45	0 voltage reading	0 voltage reading	0 voltage reading	0 voltage reading
Tues 02:23	Unit is coming back on-line	Unit is coming back on-line	Unit is coming back on-line	Unit is coming back on-line

Tues 02:30	Unit operating normally at pre-failure voltage	Unit operating normally at pre-failure voltage	Unit operating normally at pre-failure voltage	Unit operating normally at pre-failure voltage

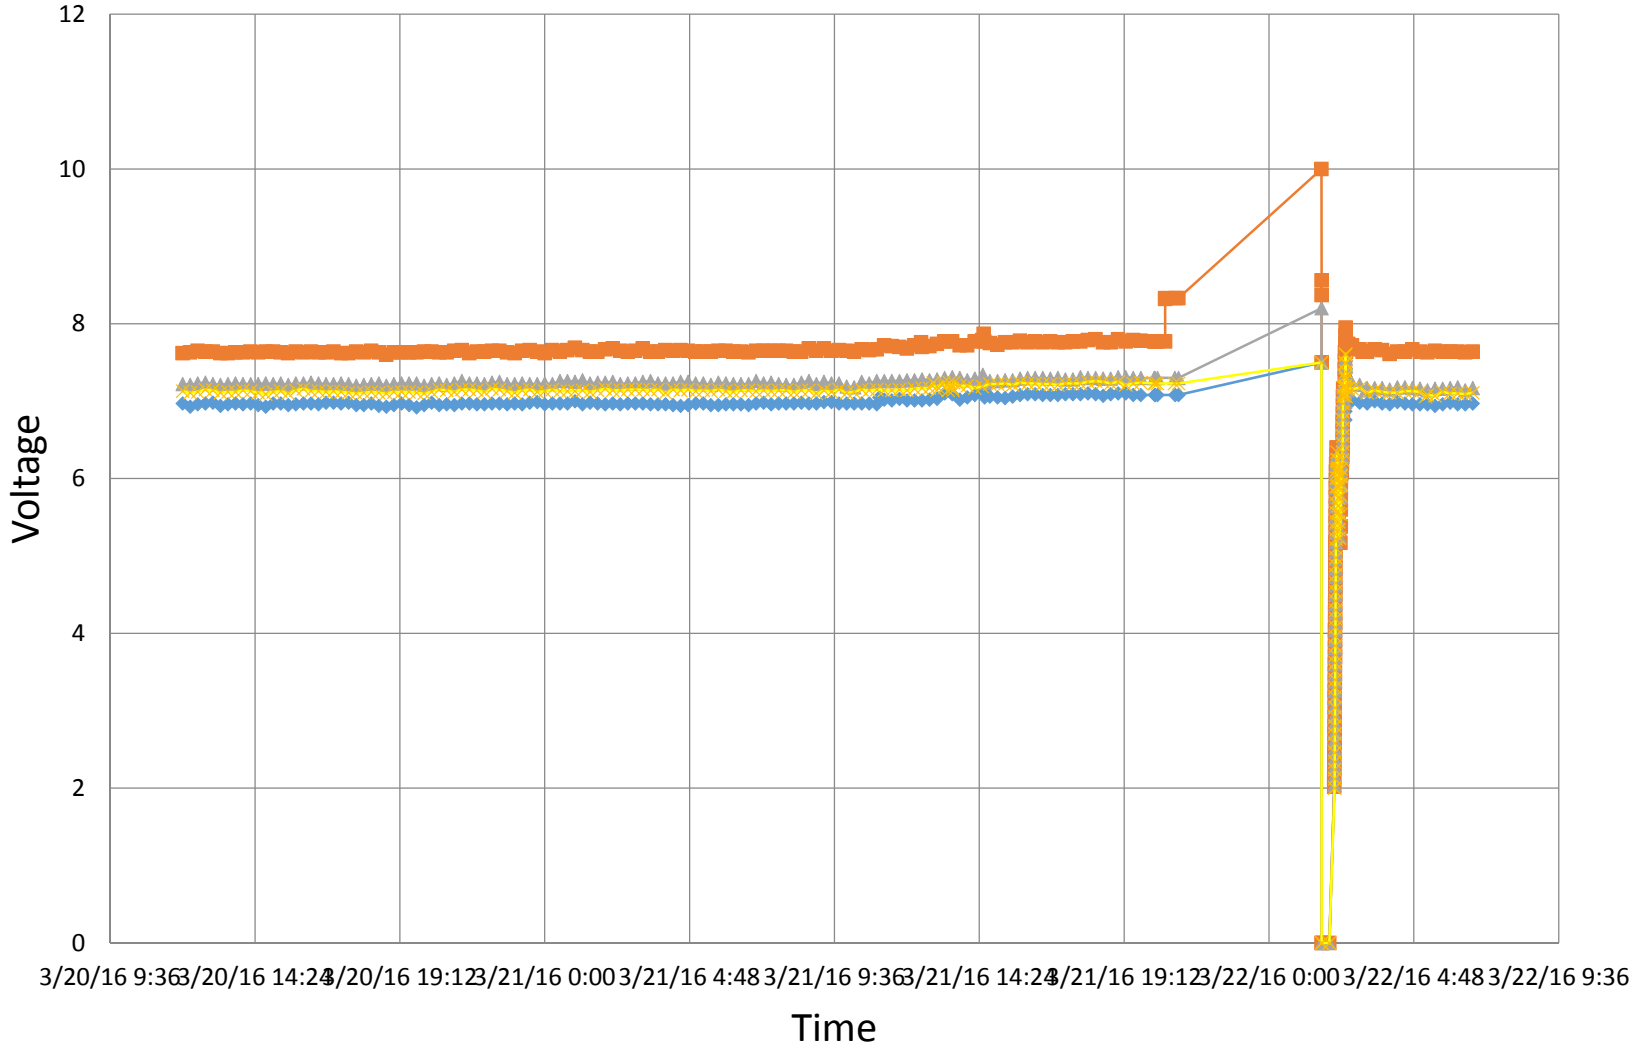
BSL4 EF Voltages

Time Stamp	BSL 4 Exhaust Fans
Mon 20:20	All 4 fans operating normally
Mon 20:15	No data recorded
Mon 20:18	All 4 fans show failed execution status

Mon 20:18 thru 20:52	No data recorded
Mon 20:52	Voltage indicated to all 4 fans; but failure status is also shown for all 4 fans
Mon 21:00	Voltage indicated to all 4 fans; but failure status is also shown for all 4 fans
Mon 21:00 thru Tues 1:44	No data recorded
Tues 1:45	All fans indicate “on”, but only two fans show voltage
Tues 2:00	All fans indicate normal and are approaching normal operating voltage
Tues 2:30	All fans operating normally at 8 volts

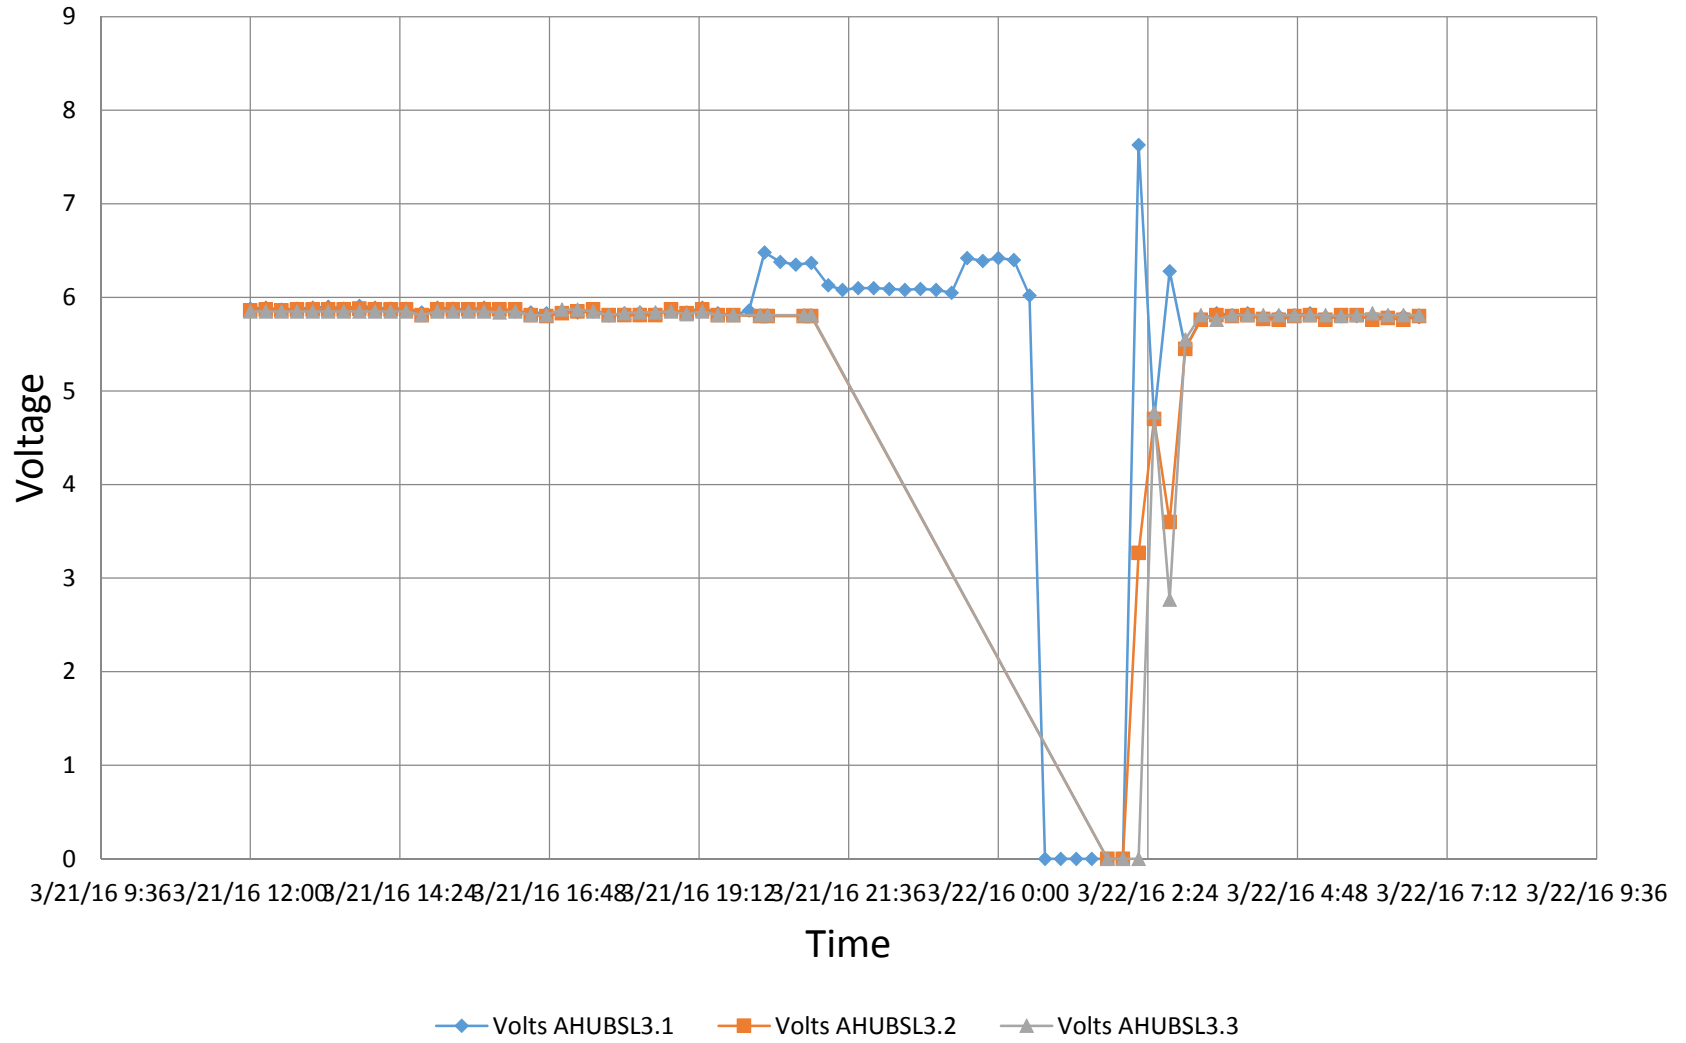
Voltages BSL3 AHUs

Time Stamp	BSL3 AHU-1	BSL3 AHU-2	BSL3 AHU-3
Mon 19:45	operating normally	operating normally	operating normally
Mon 20:00	showing normal voltage (5.86 v)	No data showing	No data showing
Mon 20:10	Showing voltage readings	Showing voltage readings	Showing voltage readings
Mon 20:15	Showing voltage readings	No voltage showing	No voltage showing
Mon 20:18	No data registered	Failed execution status (not executing commands)	Failed execution status (not executing commands)
Mon 20:30		No data registering	No data registering
Mon 20:45		No data registering	No data registering
Mon 20:52	No data registering	Failed execution status (not executing commands)	Failed execution status (not executing commands)
Mon 21:00		Failed execution status (not executing commands)	Failed execution status (not executing commands)
Mon 21:16 thru Tues 0:30	Showing voltage readings	No voltage showing	No voltage showing
Tues 0:45 thru Tues 1:45	No voltage showing	No data registering	No data registering

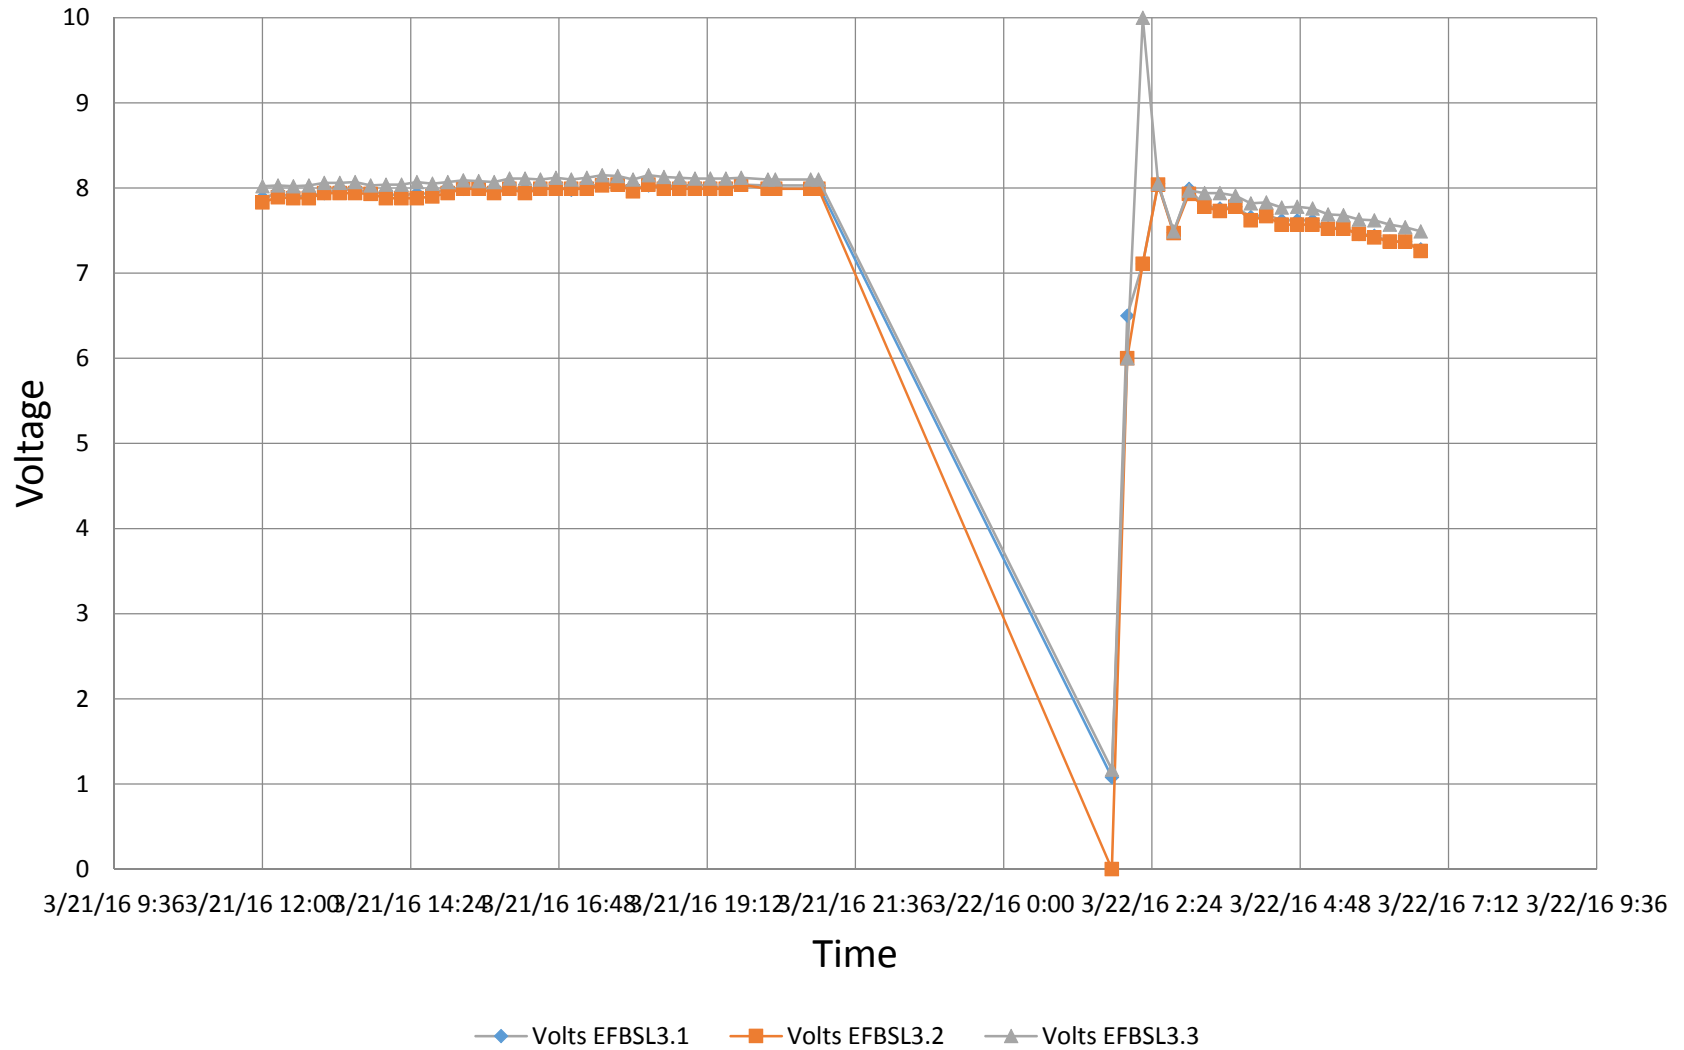
Voltages BSL3 EFs

The exhaust fans were also trended at 15 minute intervals and were last trended operating normally up until 20:10. The last time the units were operating under normal conditions was 19:45, and this was before the Notification Errors were indicated on the network switches. The BAS switches indicated Notification Errors at 19:59, and this was just before the status was reading “Failed” and these events line up in the timeline.

Time Stamp	BSL 3 Exhaust Fans
Mon 20:10	Operating normally
Mon 20:15	No data recorded
Mon 20:18	All 3 fans show failed execution status
Mon 20:18 thru 20:52	No data recorded
Mon 20:52	Voltage indicated to all 3 fans; but failure status is also shown
Mon 21:00	Voltage indicated to all 3 fans; but failure status is also shown
Mon 21:00 thru Tues 1:45	No data recorded
Tues 1:45	All fans indicate “on”, but only two fans show voltage
Tues 2:00	All fans indicate normal and are approaching normal operating voltage
Tues 2:30	All fans operating normally at 8 volts

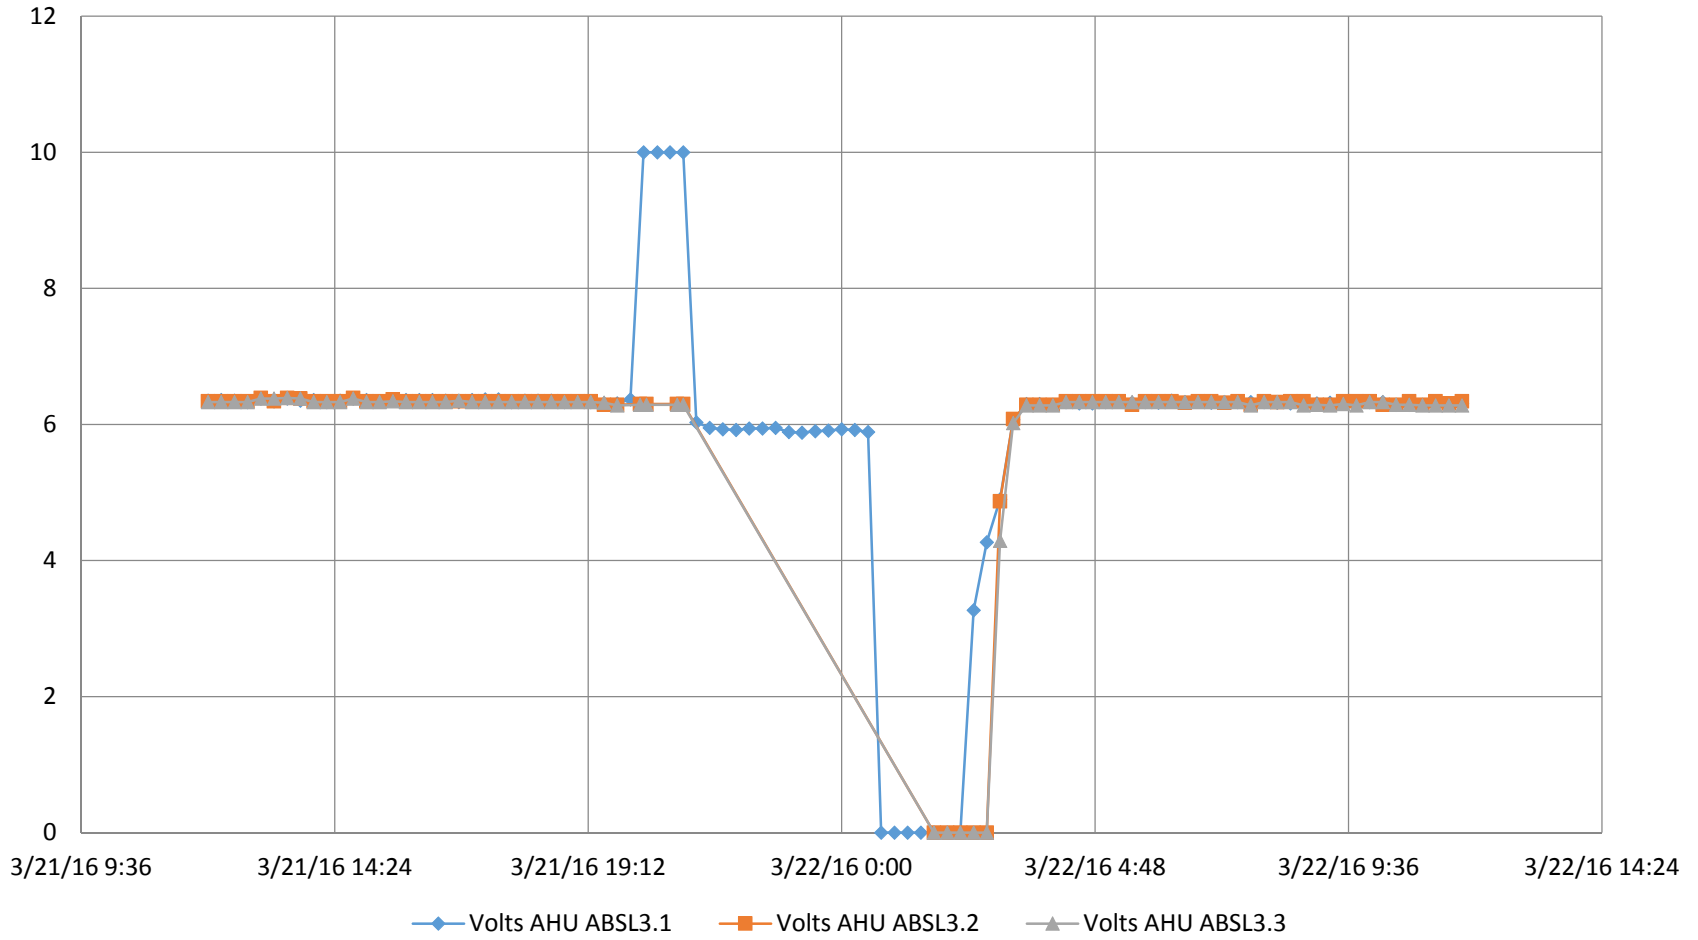
Voltages ABSL3 AHUs

Time Stamp	ABSL3 AHU-1	ABSL3 AHU-2	ABSL3 AHU-3
Mon 19:45	operating normally	operating normally	operating normally
Mon 20:00	showing normal voltage (6.37 v)	No data showing	No data showing
Mon 20:10	Showing voltage readings	Showing voltage readings	Showing voltage readings
Mon 20:15	Showing voltage readings	No voltage showing	No voltage showing
Mon 20:18	No data registered	Failed execution status (not executing commands)	Failed execution status (not executing commands)
Mon 20:30		No data registering	No data registering
Mon 20:45		No data registering	No data registering
Mon 20:52	No data registering	Indicated "off"	Indicated "off"
Mon 21:00		Indicated "off"	Indicated "off"
Mon 21:16 thru Tues 0:30	Showing voltage readings	No voltage showing	No voltage showing
Tues 1:45 thru Tues 2:15	No voltage showing	No data registering	No data registering
Tues 2:30 thru 2:45	Data registering, an slight voltage showing	Data registering, but showing 0 voltage	Data registering, but showing 0 voltage

The last time the units were operating under normal conditions was 19:45, and this was before the Notification Errors were indicated on the network switches. The network switches indicated Notification Errors at 19:59, this was just before the Status was reading off. These events line up in the timeline.

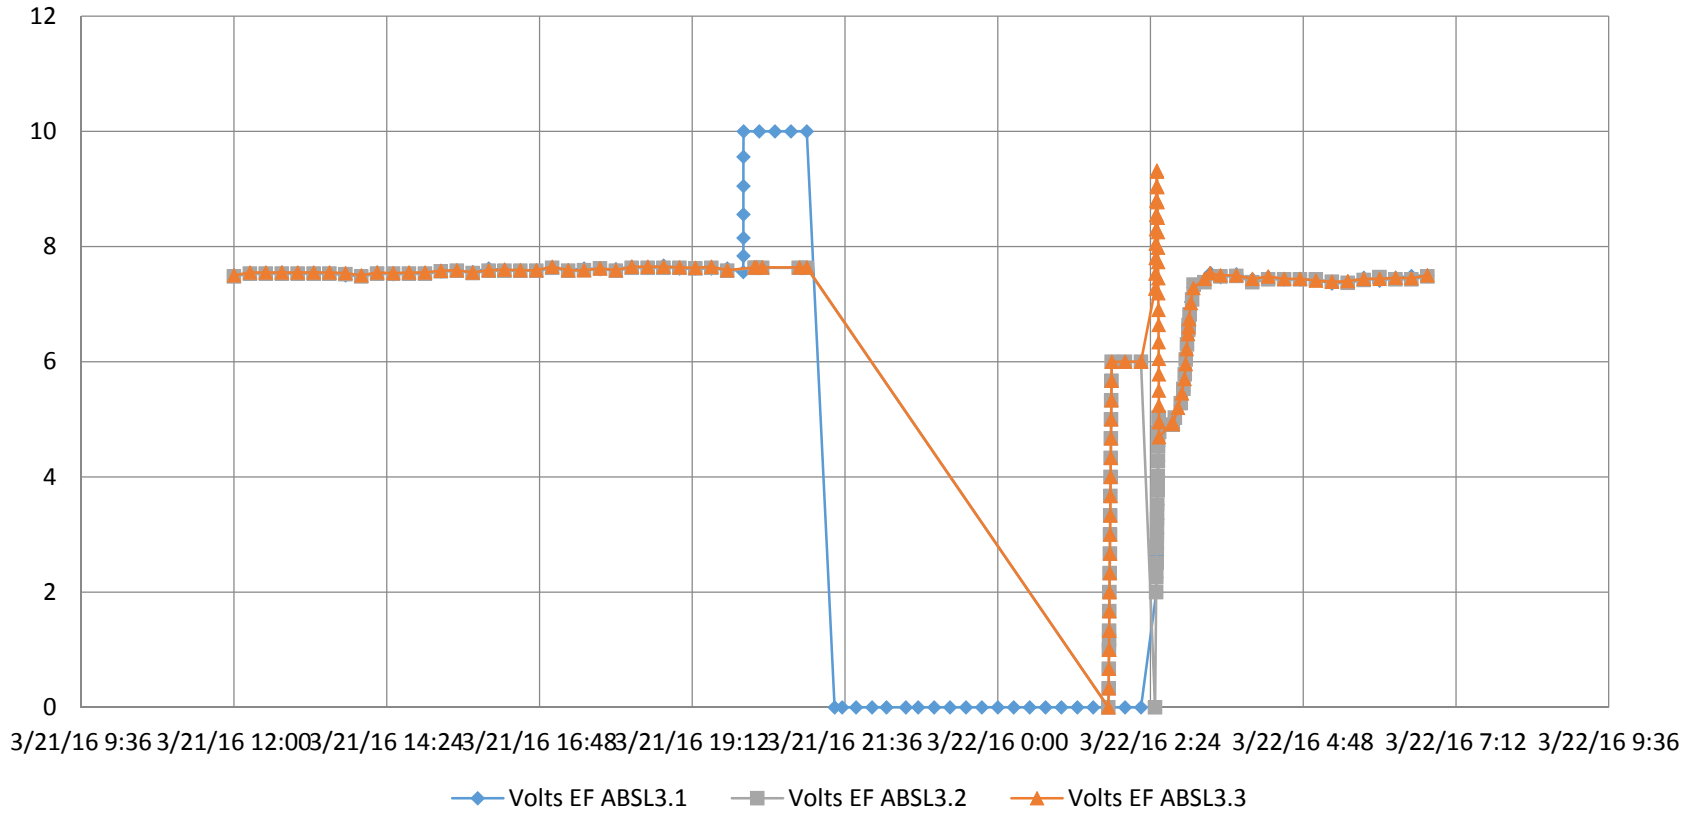
Voltages ABSL3 EFs

Time Stamp	ABSL 3 Exhaust Fans
Mon 19:45	All fans operating normally
Mon 20:00	7 data points recorded for ABSL3 EF-1; no data recorded on the other two fans
Mon 20:12	All 3 fans show failed execution status
Mon 20:18	All 3 fans show failed execution status
Mon 20:52	Voltage indicated to all 3 fans; but failure status is also shown
Mon 21:00	Voltage indicated to all 3 fans; but failure status is also shown
Mon 21:26 thru Tues 1:45	No data recorded
Tues 1:45	All fans indicate “normal”, but only two fans show voltage
Tues 2:00	All fans indicate normal and are approaching normal operating voltage
Tues 2:30	All fans operating normally at 8 volts

20:01) were registered and believed to be when the last operational exhaust fan failed. No Stage 2 lockouts registered.

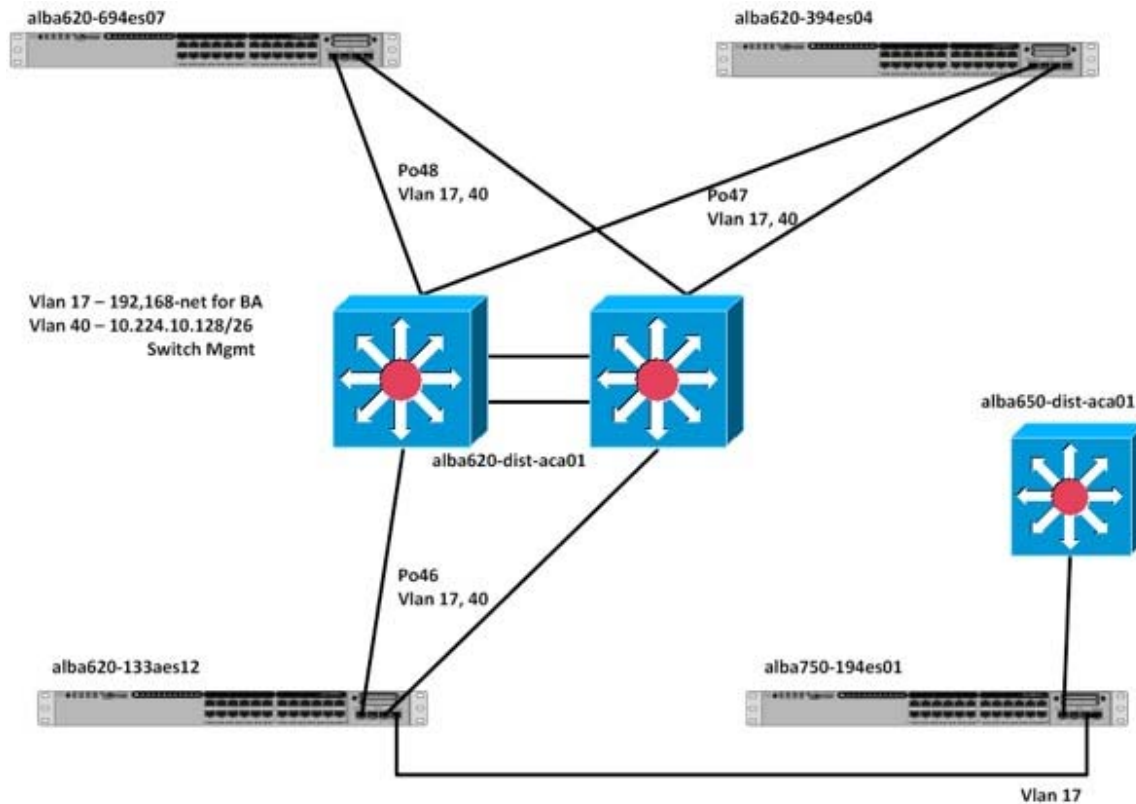
This network configuration introduced two distribution routers (as shown in the two blue squares in the center) which were connected to the three switches on the BAS network. The switches were no longer connected to each other but had two connections each to the two central distribution routers (one to each router). A fourth switch was added to allow monitoring of the network from the power

plant for off-hour support. That switch is shown on the bottom right and is connected to the BU network. Security is maintained across this network using logical VLANs. The fourth switch has access to the switches themselves for monitoring and direction but does not have access to the BAS network.

This redundant network was (and is) still designed as a flat network. The redundancy eliminates the single point of failure scenario but does not segment the network. The network is still seen as a single big loop with everything connected to everything else. The distribution routers are not configured to route network traffic and are simply serving as a pass through.

In the scenario that occurred on March 21, 2016 the redundancy worked as it was designed. Every time the SFP module “flapped” off, the network failed over to the other link and continued normally. When the SFP module flapped back on, network traffic resumed normally. Both routers performed normally throughout the entire event and evidenced no failures of any kind. They simply passed network traffic back and forth. Very shortly after 19:59 on the 21st, the SFP module entered into an unanticipated error state a precipitated a broadcast storm. There was no failure of the network itself or the routers. They simply became overwhelmed with network traffic.

It is our opinion that redundancy did not contribute to the broadcast storm. In conversations with professionals from Cisco they shared their opinion that based on the IS&T account of the events and the support case notes from the troubleshooting performed during this incident it did not appear the network topology (design) had any kind of adverse effect on the network during this incident. A broadcast storm was possible in the old network configuration as it was in the new. It has been suggested that the SFP module failure in the old network would have caused it to fail more quickly. It is true that had the SFP module failed in a normal manner then the network would have failed in the old design. But the SFP module did not have a normal or anticipated failure. The SFP module didn’t just stop working. It precipitated a flood of broadcast traffic that neither network topology was designed to handle and is not routinely tested for in normal business practice.

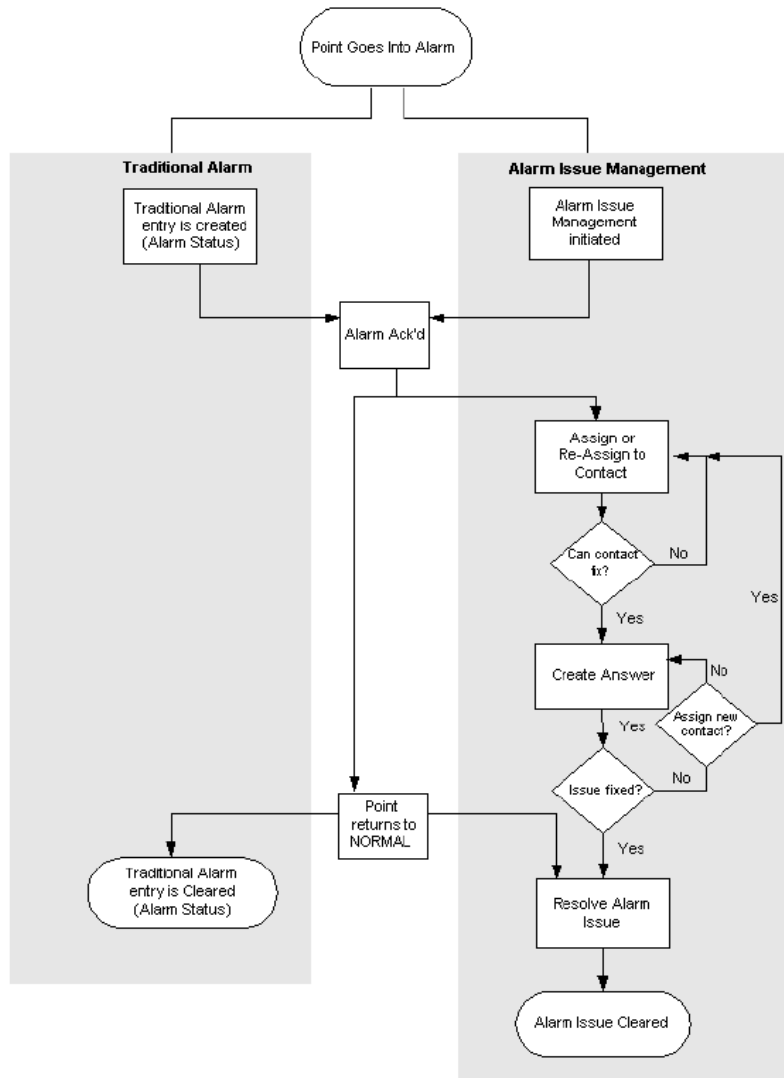
Figure 4. Traditional vs. Alarm Issue Management Lifecycle Illustration.

BU NEIDL currently has the Alarm Issue Management Option for Insight, but it is not being used to its fullest potential. AIM allows you to manage the life cycle of an alarm issue through all stages, from initiation to resolution. By configuring a point for Alarm Issue Management, an ordered procedure is imposed for each point in alarm: Acknowledge, Assign (to a contact), Answer, Resolve, and Clear. Each step is logged through the Alarm Issue Management application, which provides you with the full history of that alarm issue. AIM is a best practice technology module that many of our Siemens life science customers use to ensure systems alarms are handled according to procedure.

- a. **Resolution:** Implement full features of AIM and assign points of contact for process flow.
