# ARCHAEOLOGICAL INVESTIGATIONS IN THE HOLMUL REGION, PETEN RESULTS OF THE FOURTH SEASON, 2003

*Edited by*  
*Francisco Estrada-Belli*

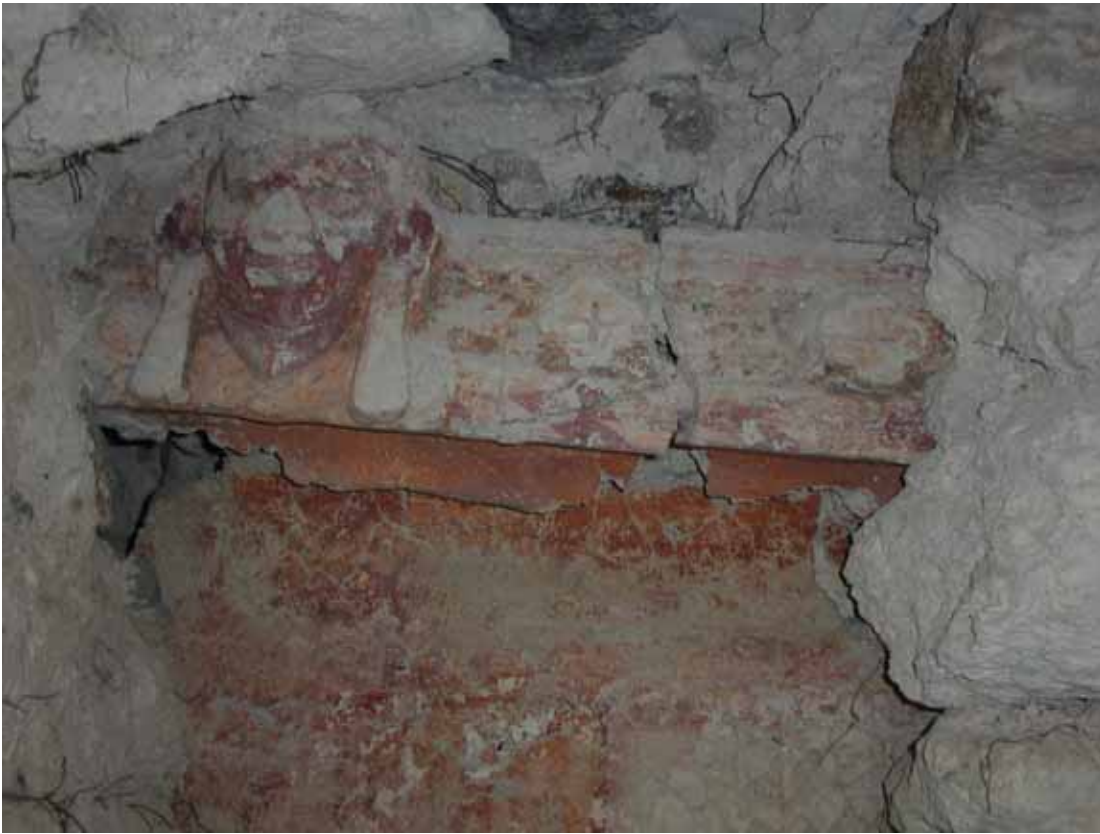
Figure 1. Stucco mask adorning the NW corner of Room 1. Paint is red and black. Traces of mural painting below the mask is also visible.

The outside (NW) corner of the mural room (Structure 1 sub 1), which is abutted by the E-W wall with the new bench, is decorated with a stucco frieze. This frieze included quatrefoils and a small stucco head painted in black and red. The rather devilish-looking head wears a bib and cloth in the ears and has inlaid teeth. According to Coggins (pers. comm.) it may be a representation of a captive with Highland Mexican connotations. This possible representation of a captive, as well as the Mural 5 scaffold sacrifice, may actually depict important components of Early Classic accession rituals.

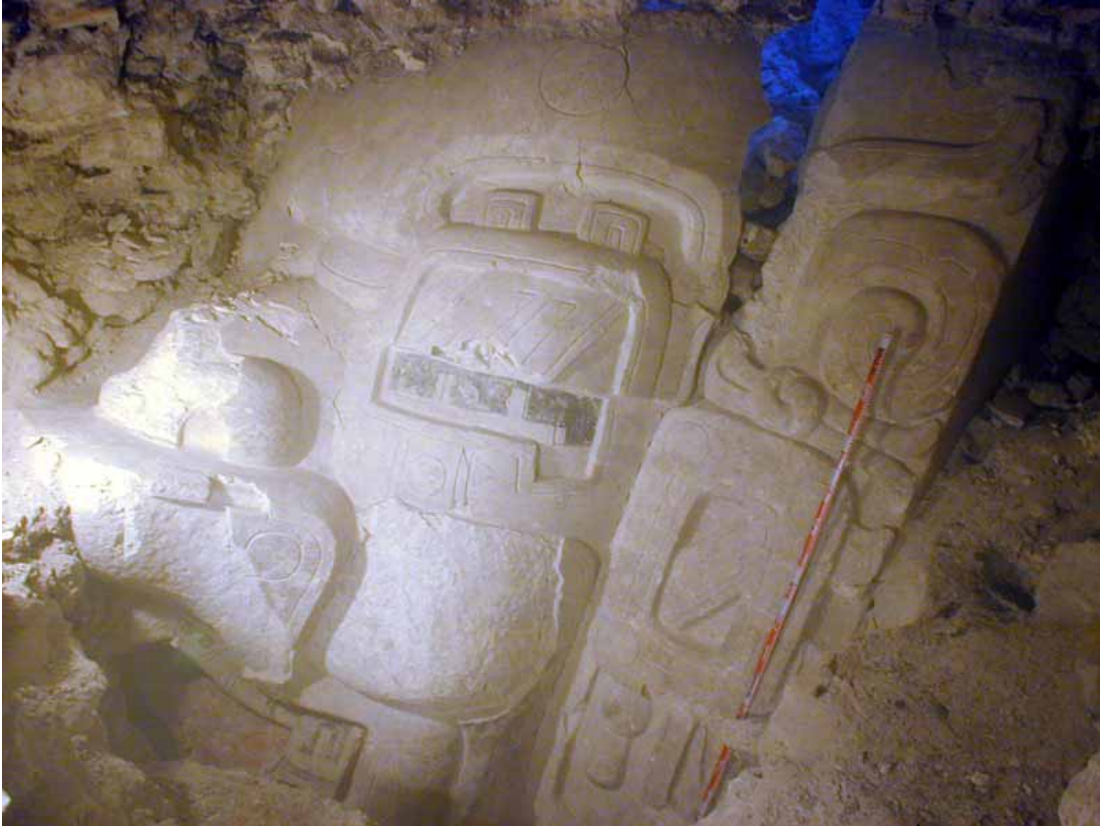
Figure 3. Stucco mask adorning the southern side of the upper terrace of Str.1 sub-2<sup>nd</sup> in Triadic Group 1 at Cival, Petén. Viewer looks northeast. Scale bar is 2 m.

Some of the most spectacular finds of the 2003 seasons were made at Cival. A tunnel in Str. 1 on top of Triadic Group 1 (the eastern structure) penetrated the later phase stairway of a Preclassic pyramid (dated stylistically to A.D. 100 in 2002). An almost perfectly preserved giant stucco mask (ca. 5m wide and 3 m high) was discovered on an earlier façade of this pyramid. The mask depicts a deity (perhaps G III), with an L-shaped eye and eyebrows with U-shape motifs, surmounted by merlons. The image has a squarish mouth with single fang, short nose, Kan-cross incised on the cheek, ear flare with four dots on a squared-circle and U-shape sign in the center. The flare is surmounted by a knot and a scroll with an unusual motif dangling from it.

Strong parallels with the Cerros lower terrace masks on Str. 5C-2<sup>nd</sup> support the identification of this anthropomorphic mask as a Sun God (Freidel and Schele 1988). It is located on the south side of the upper terrace of the pyramid. We believe that a lower terrace mask and a paring set on the opposing side of the stairway may well be preserved on this structure. Also, at the top of this pyramid is a largely preserved Late Preclassic masonry building only partially exposed by a looters' trench which may be explored in future excavations.

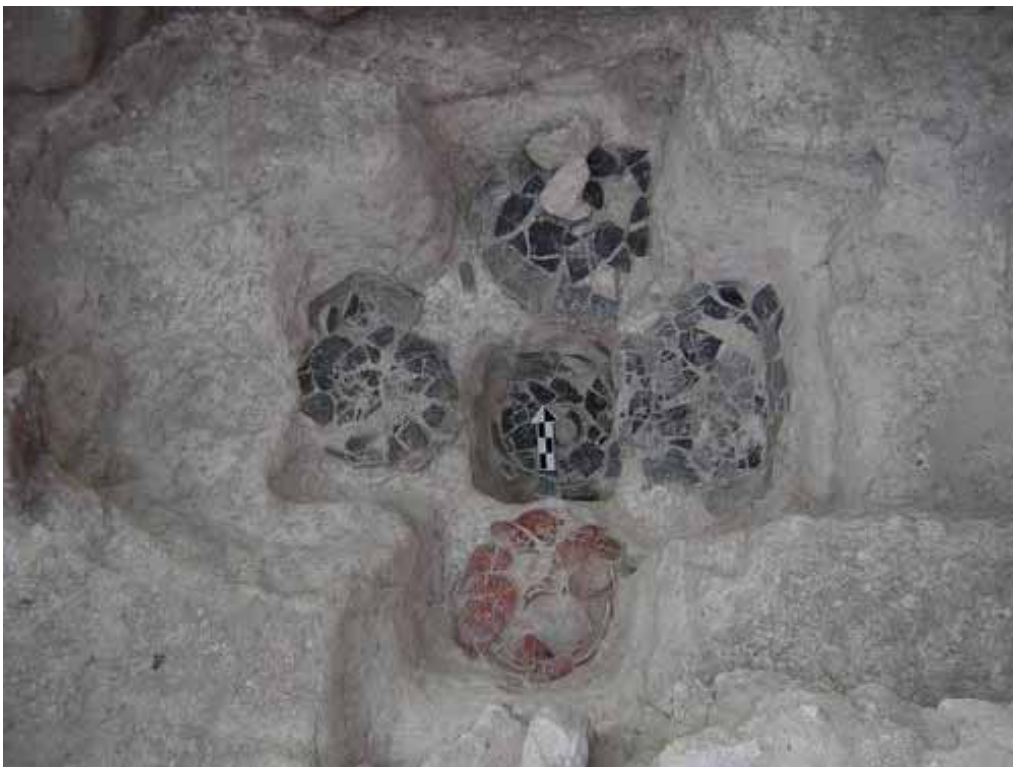
Figure 4a. Cru

ci form cache of five jars and underlying jades cut into bedrock on centerline of E-Group at Cival. Scale is 25 cm.

Further down into the stratigraphy of this centerline location a large cruciform cut into bedrock was detected. Four large jars were found smashed in each of the four arms of the cross and one in the center. The southern jar was red while all others were black. Under the central jar was a depression containing five upright plain jade celts (ca. 25 cm long) in cruciform patterns. The central and western celts were shaped out of blue jade while all others were of green jade. Surrounding the celts was a scatter of 115 pebbles of green and blue jade.

We identified the jars as Chunhinta black, Desprecio Incised and Joventud red types which date the whole cache to the Middle Preclassic Period. The content and shape of this cache closely approximates the early Middle Preclassic cache from Seibal and other jade caches from San Isidro Chiapas and La Venta (Lowe 1989). Structural and material similarities also link this cache to the Nohmul and Cerros Late Preclassic jade masks caches as well as the Pomona ear flare and associated figurines (four) as elaborated kan-cross or cruciform cosmograms (Justeson et al. 1986).

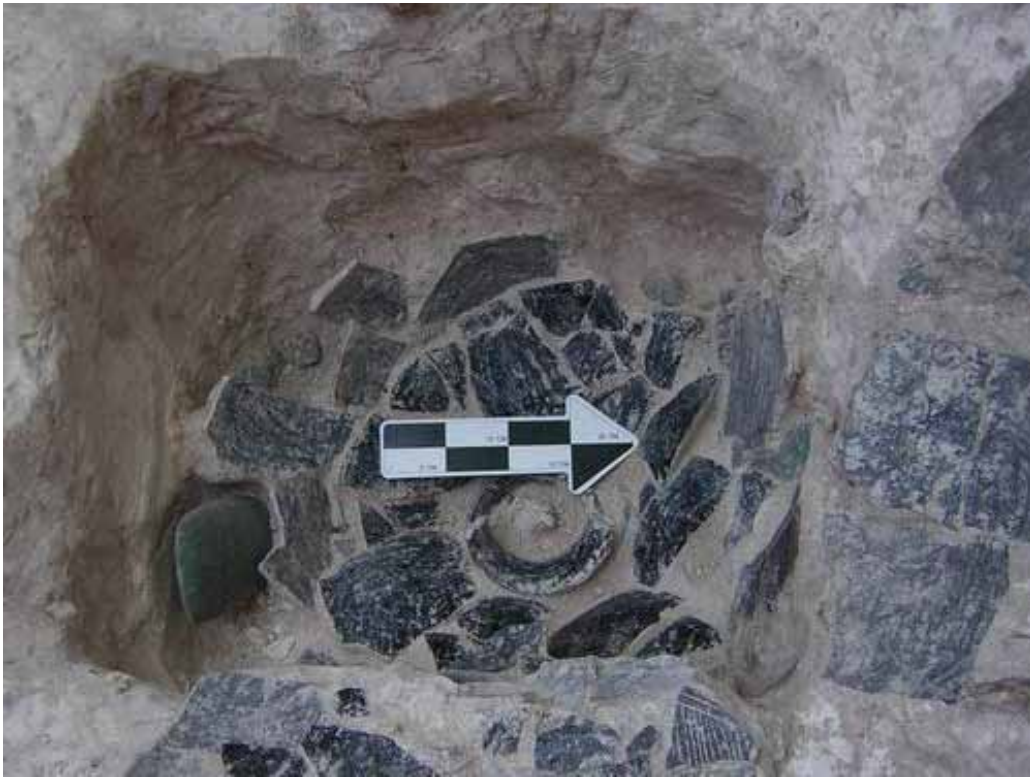
Figure 4b Detail of center of cruciform cache

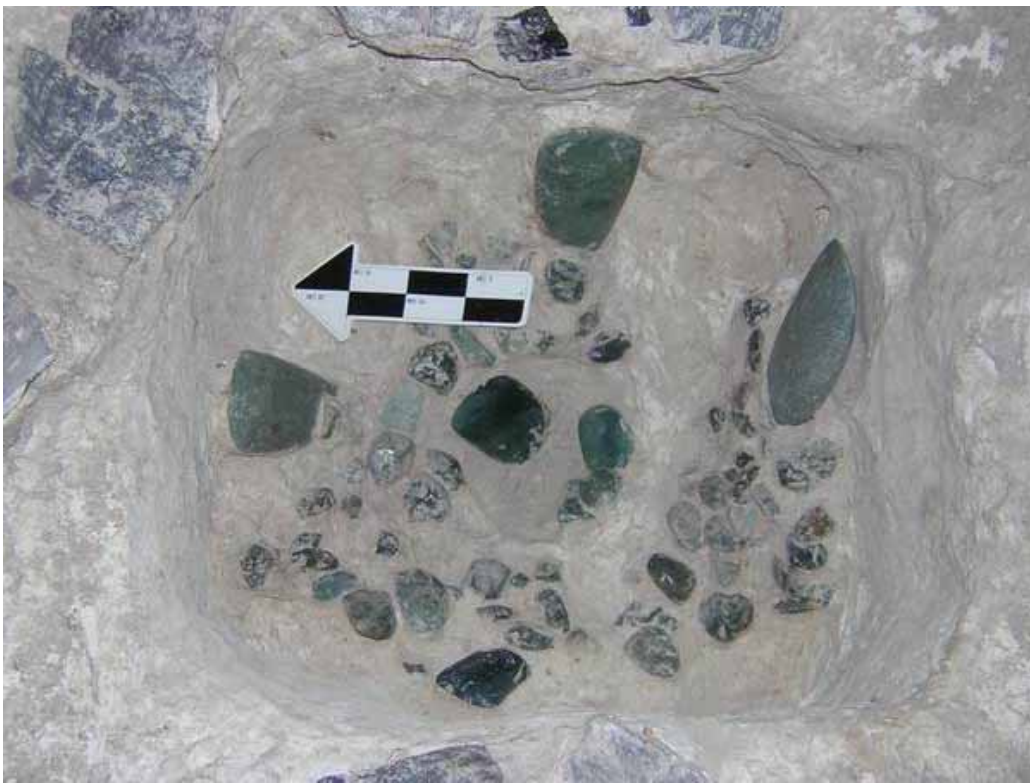
Figure 5. Central pit in cruciform cache with five upright jade celts and 115 pebbles. Scale is 25 cm.

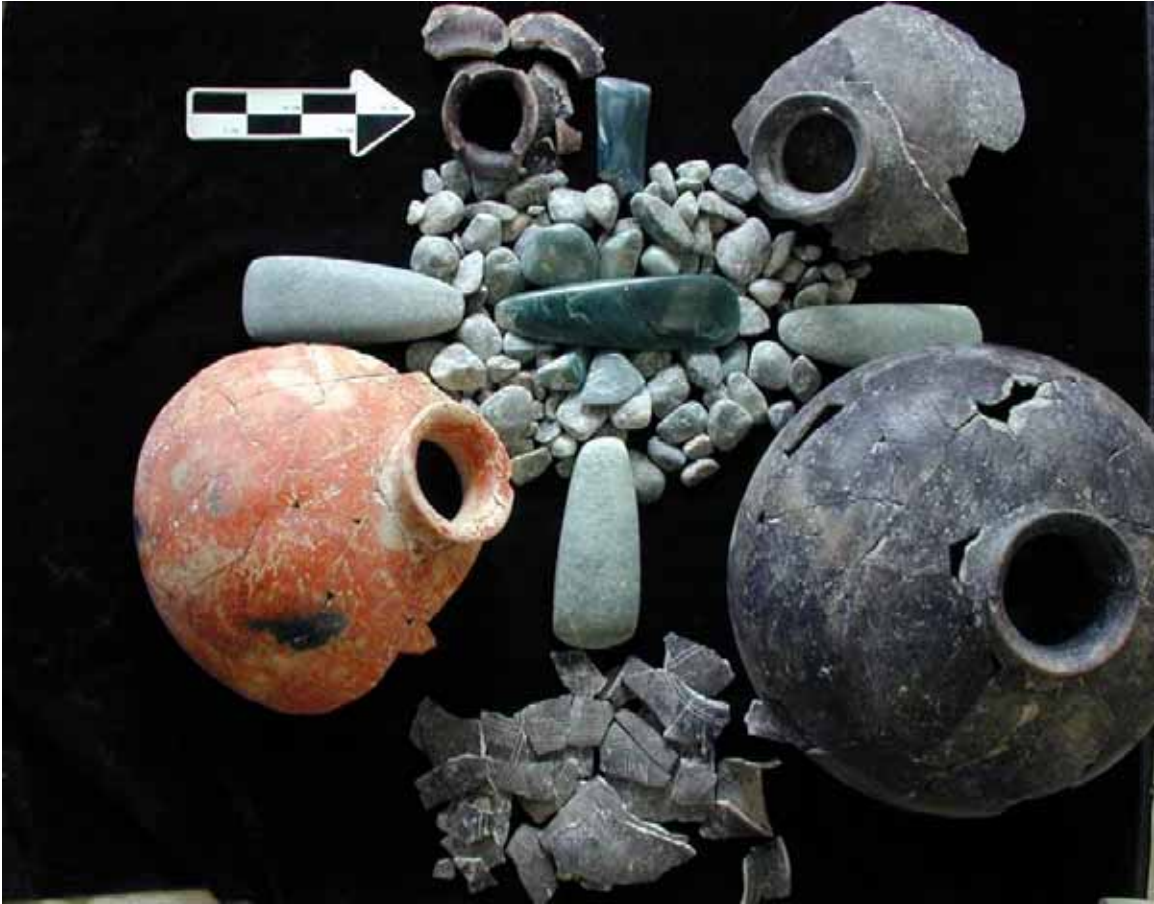
Figure 6. Cival Cruciform cache with partially reconstructed jars reassembled in the lab. Scale is 25 cm

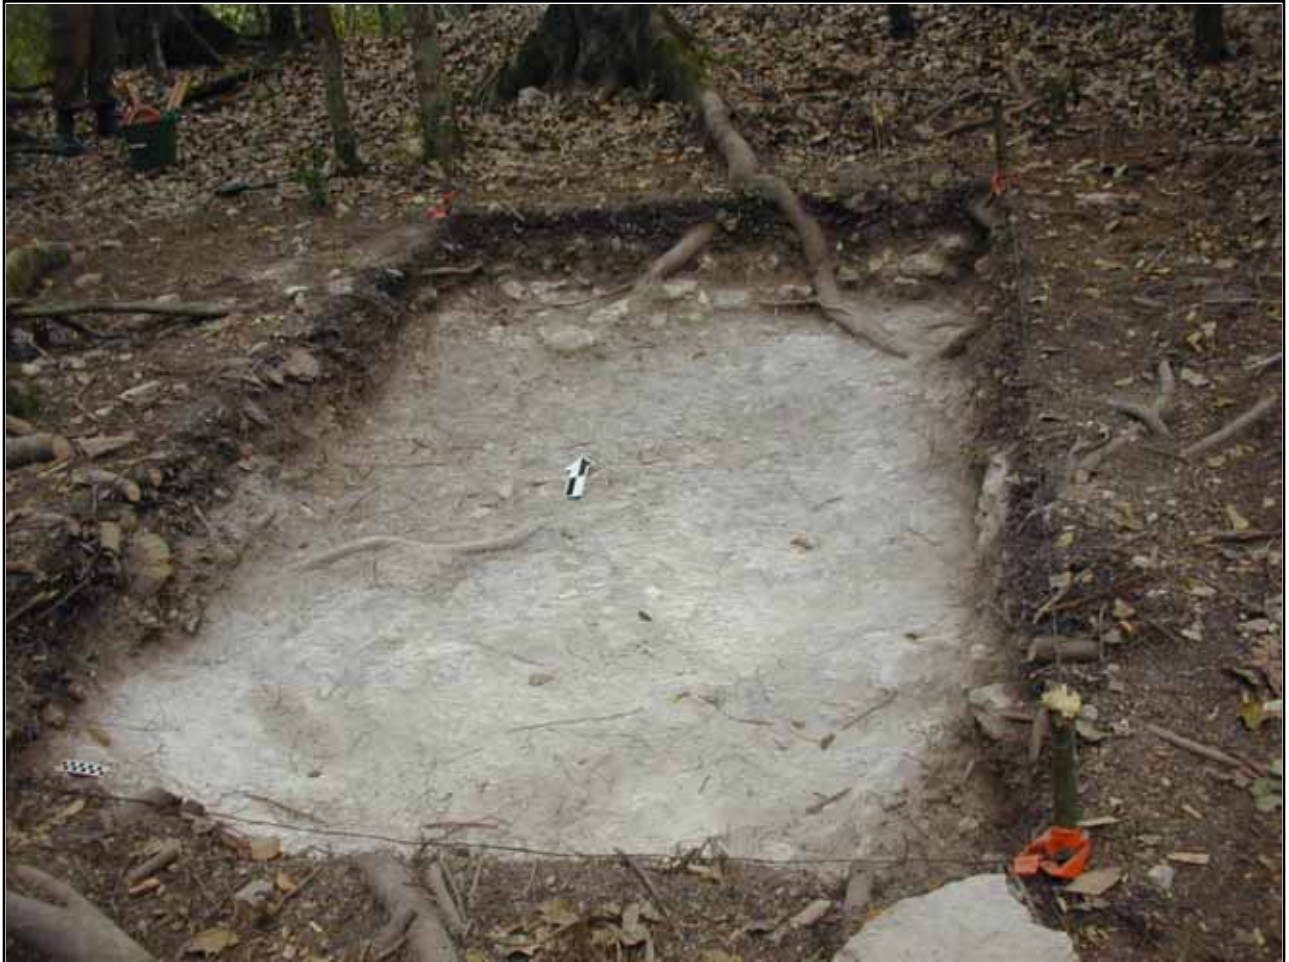
**Figure 4** Excavation ST17 with row of blocks comprising context ST17.07 in the southeast edge of the trench

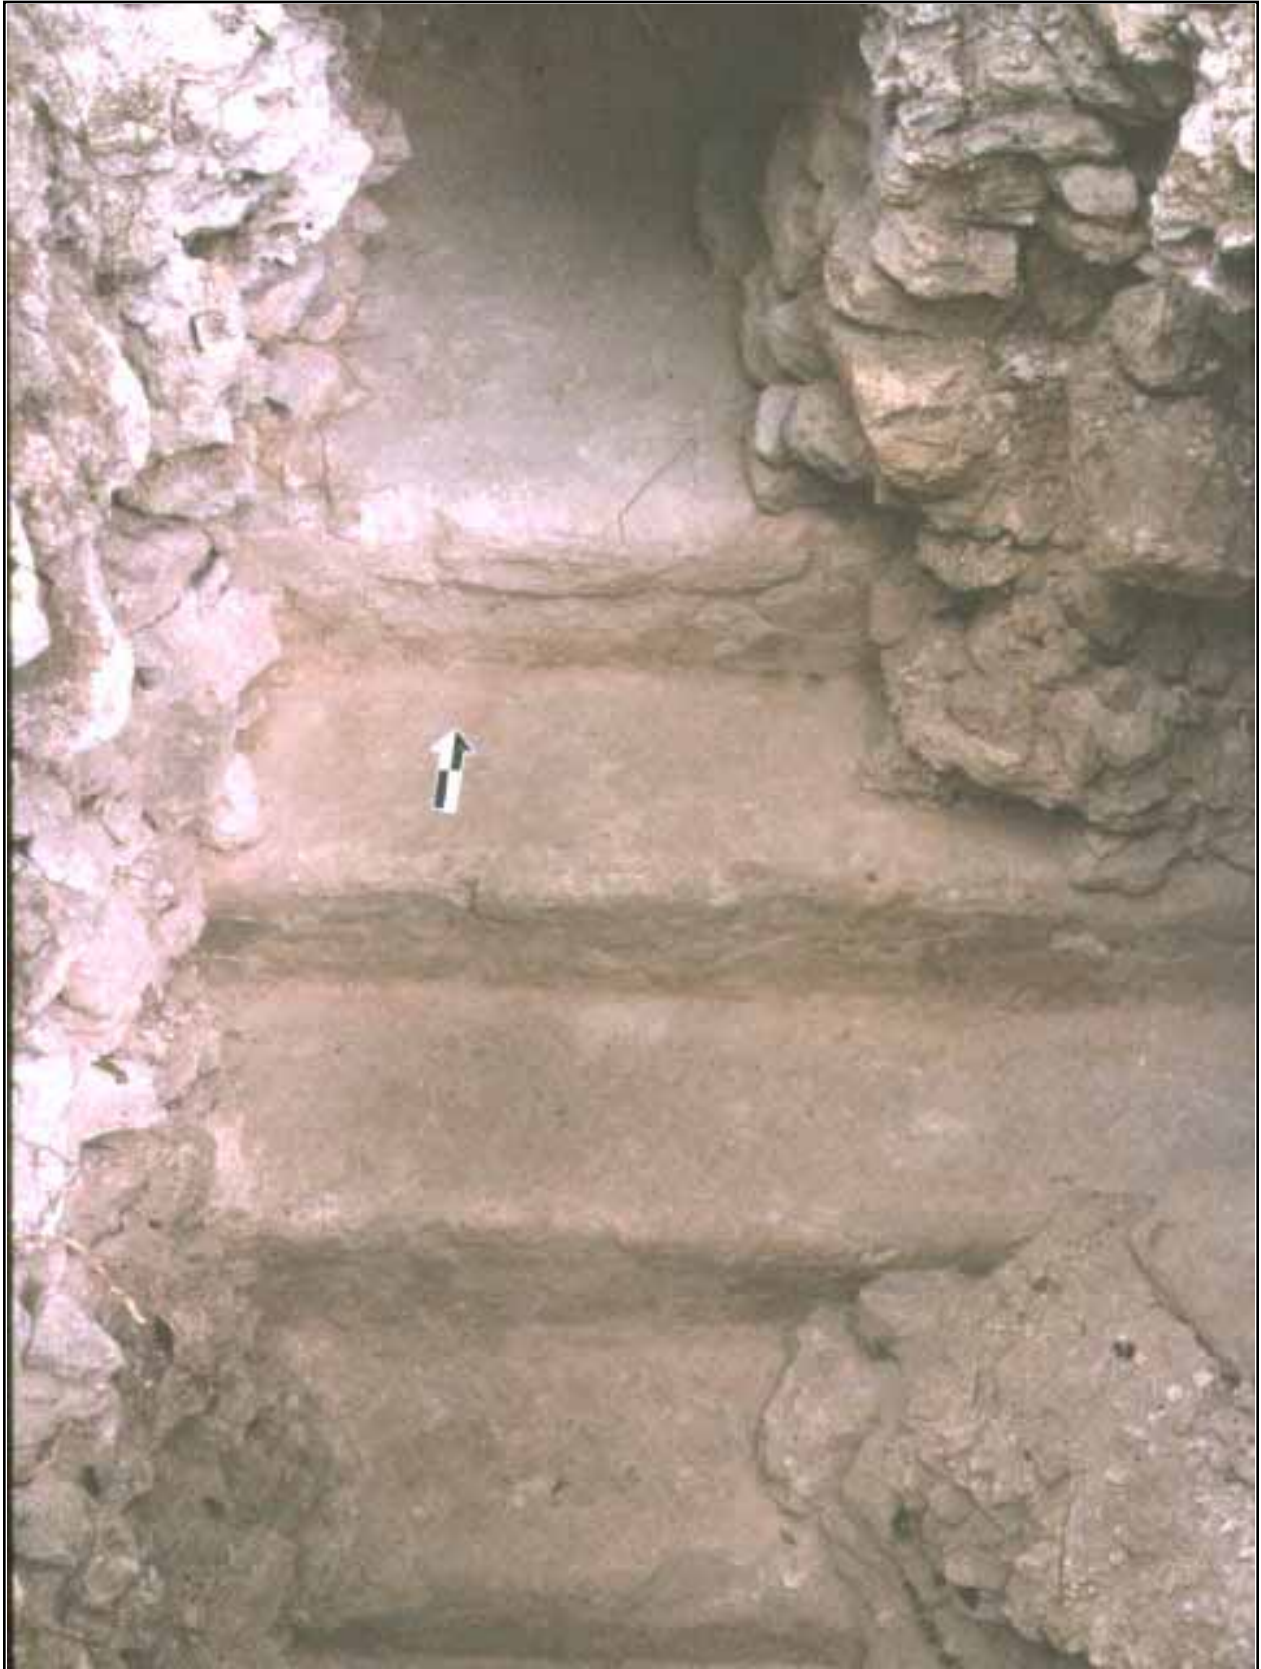
**Figure 6** Staircase uncovered in Excavation ST17

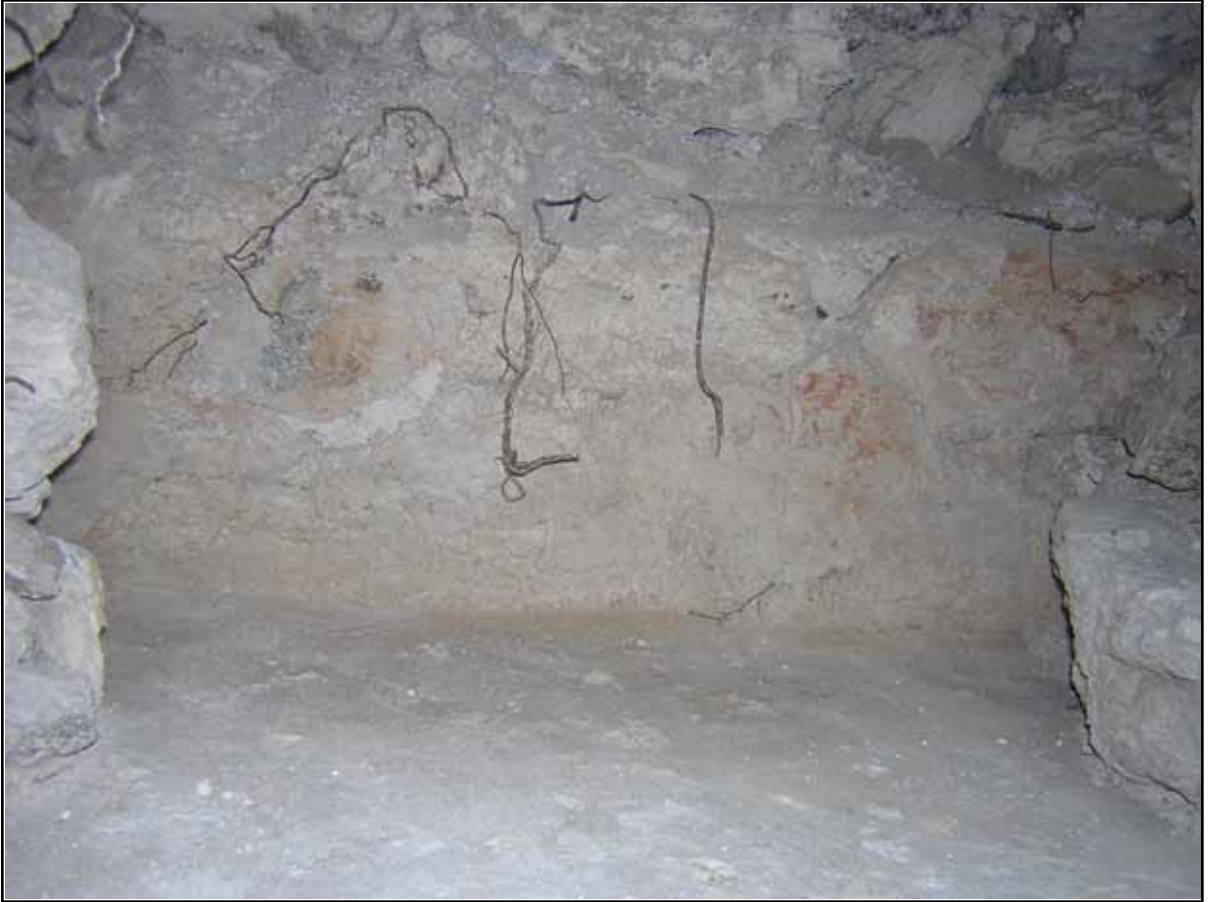
**Figure 7** Utmost stair of Staircase uncovered in Excavation ST17, with polychrome painted plaster and possible glyph.

At La Suficaya, work directed by Vanderbilt University graduate student Jenn Foley focused on the Str. 1 mural building. Two excavations were placed on the centerline of the mound, 3 meters west of the location of previously found murals. An interesting sequence of construction stages emerged from these excavations. We were able to identify at least 5 different sub-structure stages within the mound. The latest phase is of Late/Terminal Classic date and includes mostly perishable buildings, probably residences, built on top of a flat-topped mound. Two consecutive staircases leading up to a perishable building on the north end of the mound were found underneath the Late/Terminal Classic construction. The ground plan of the building at the summit of the staircases is largely lost due to the collapse of the edge of the mound into the plaza below. The earliest staircase of the two had eroded painted decoration on the steps, possibly hieroglyphic in content.

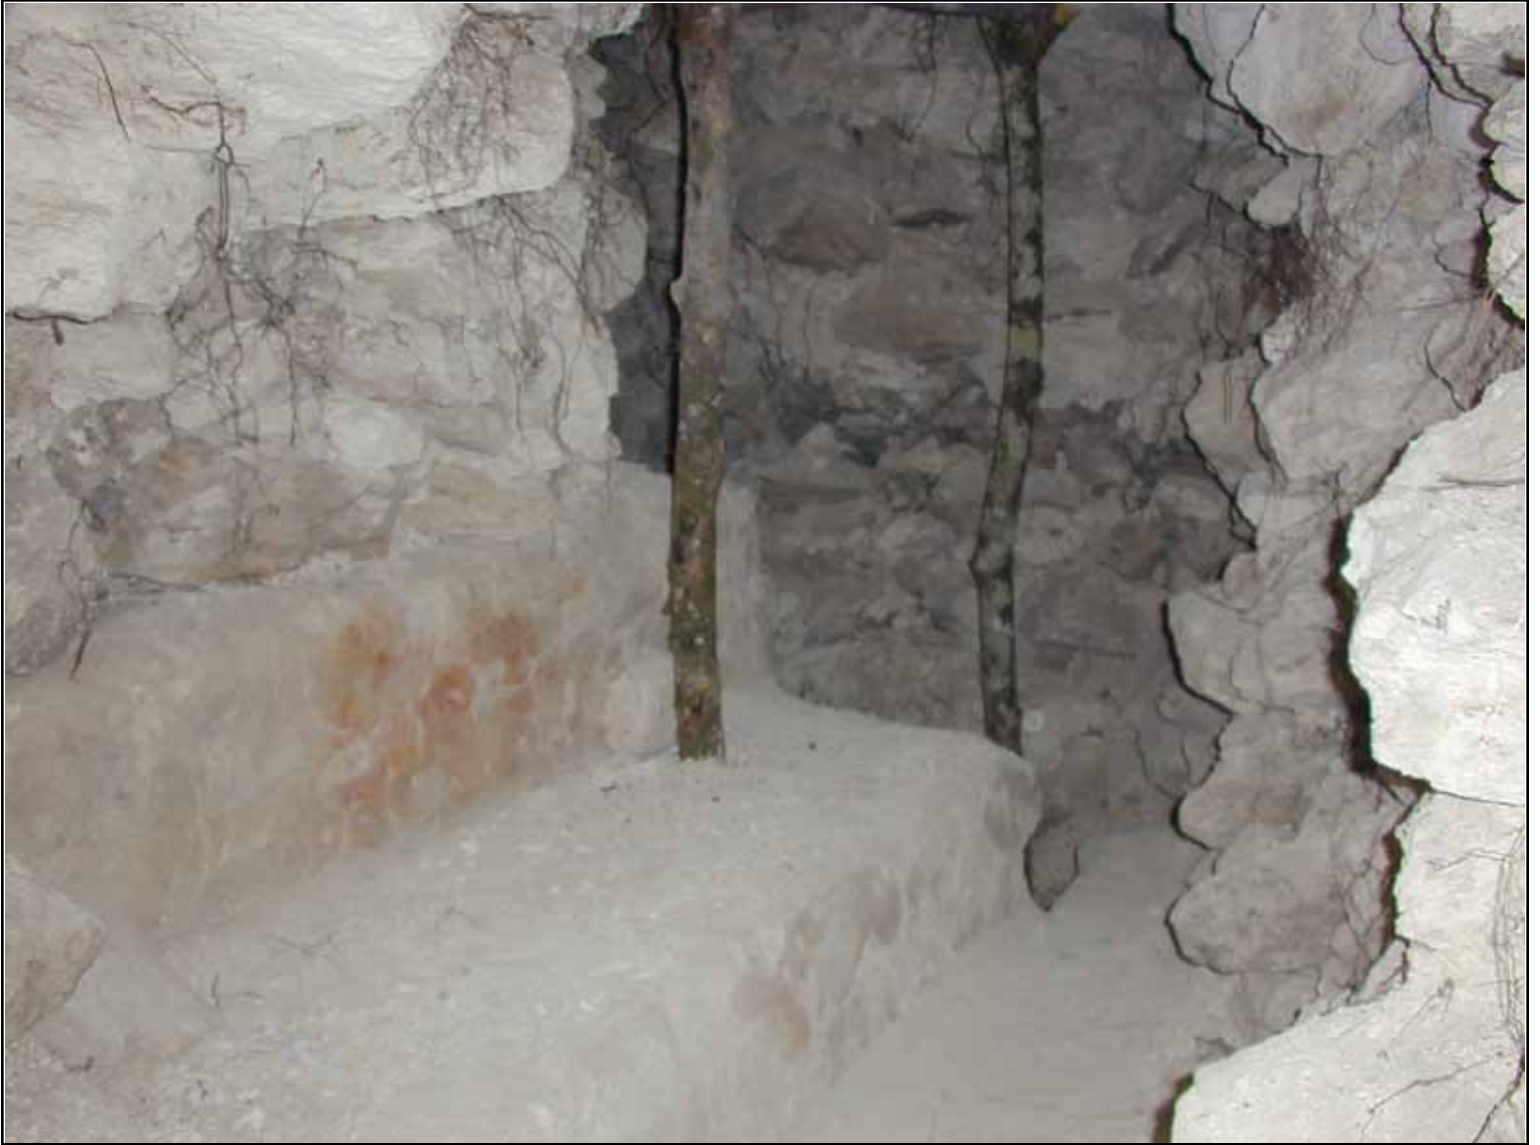
**Figure 8** Eastern end of stairs ST17.16 and ST17.17 and entrance to tunnel extension of Excavation ST17 in the eastern section wall

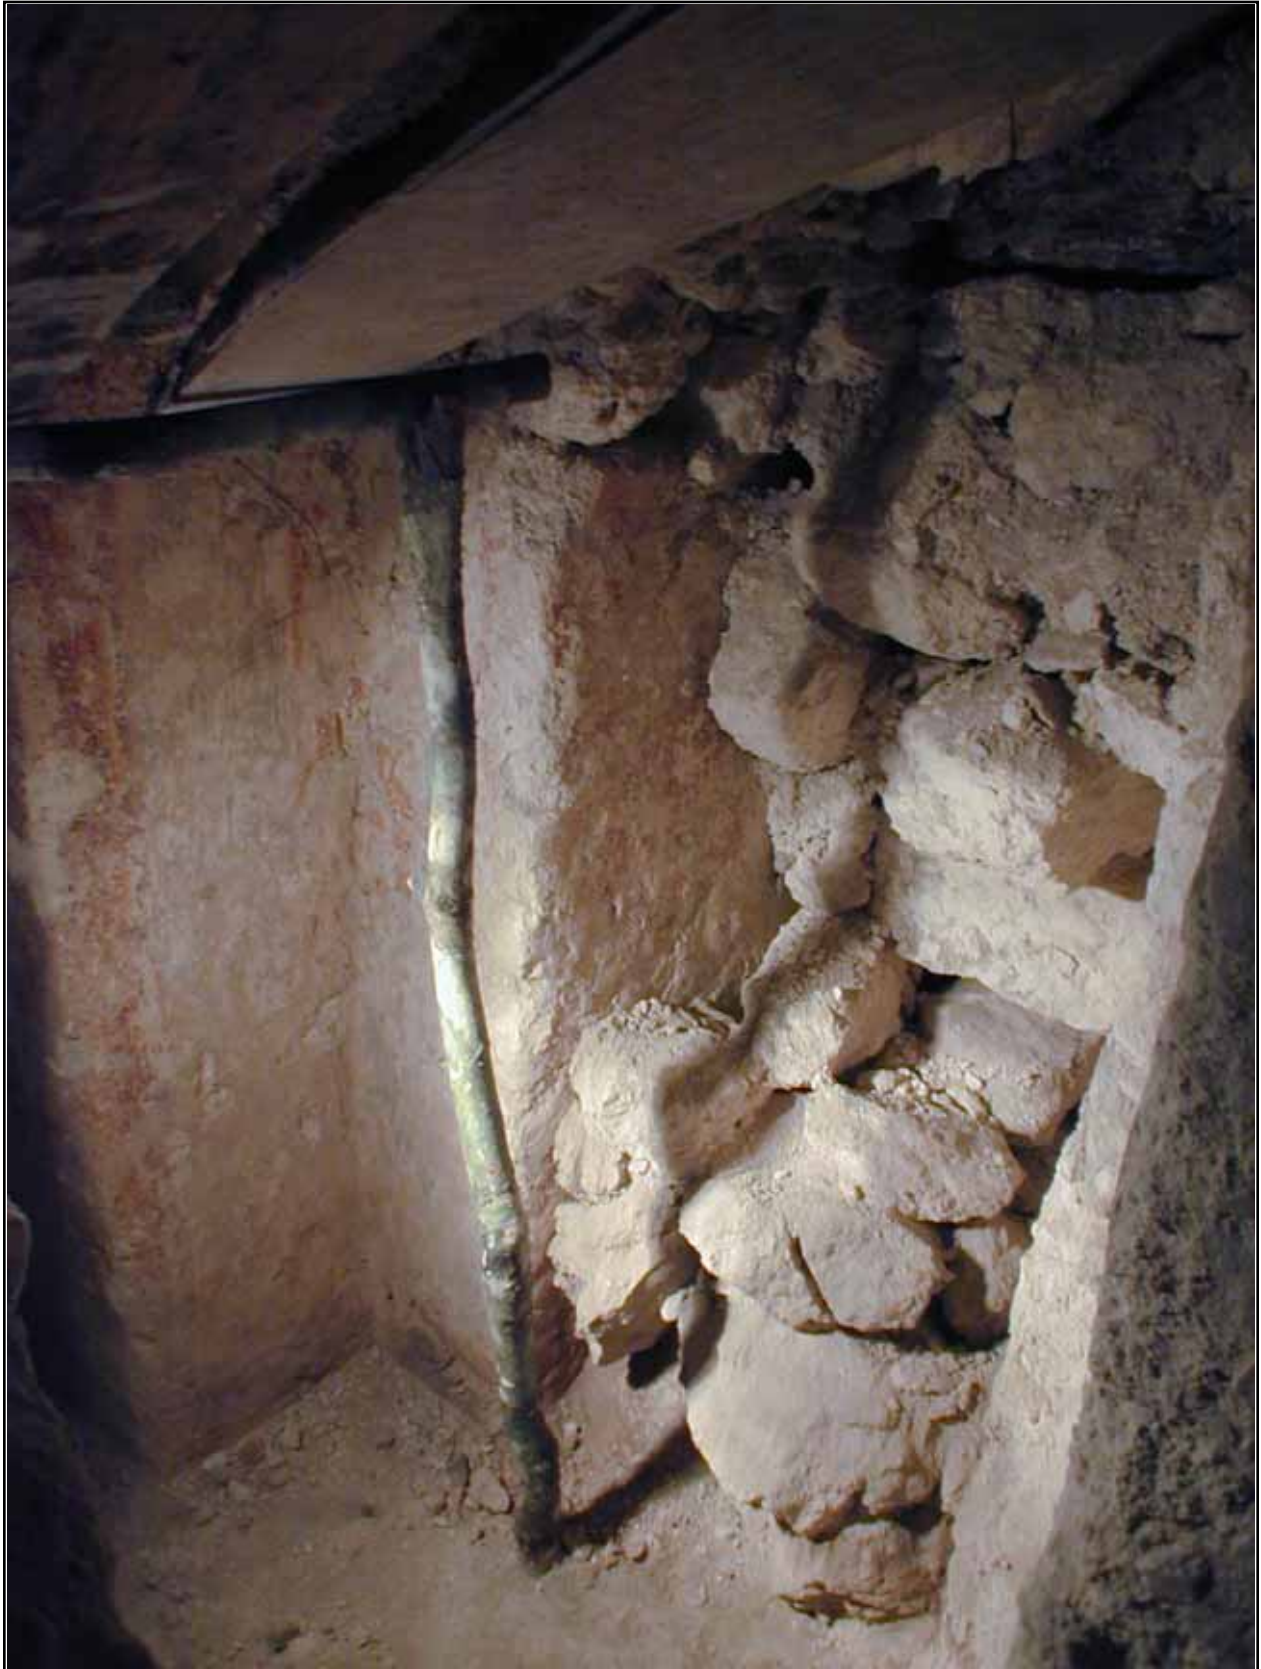
**Figure 10** Rubble-filled doorway to Structure 1 room 3

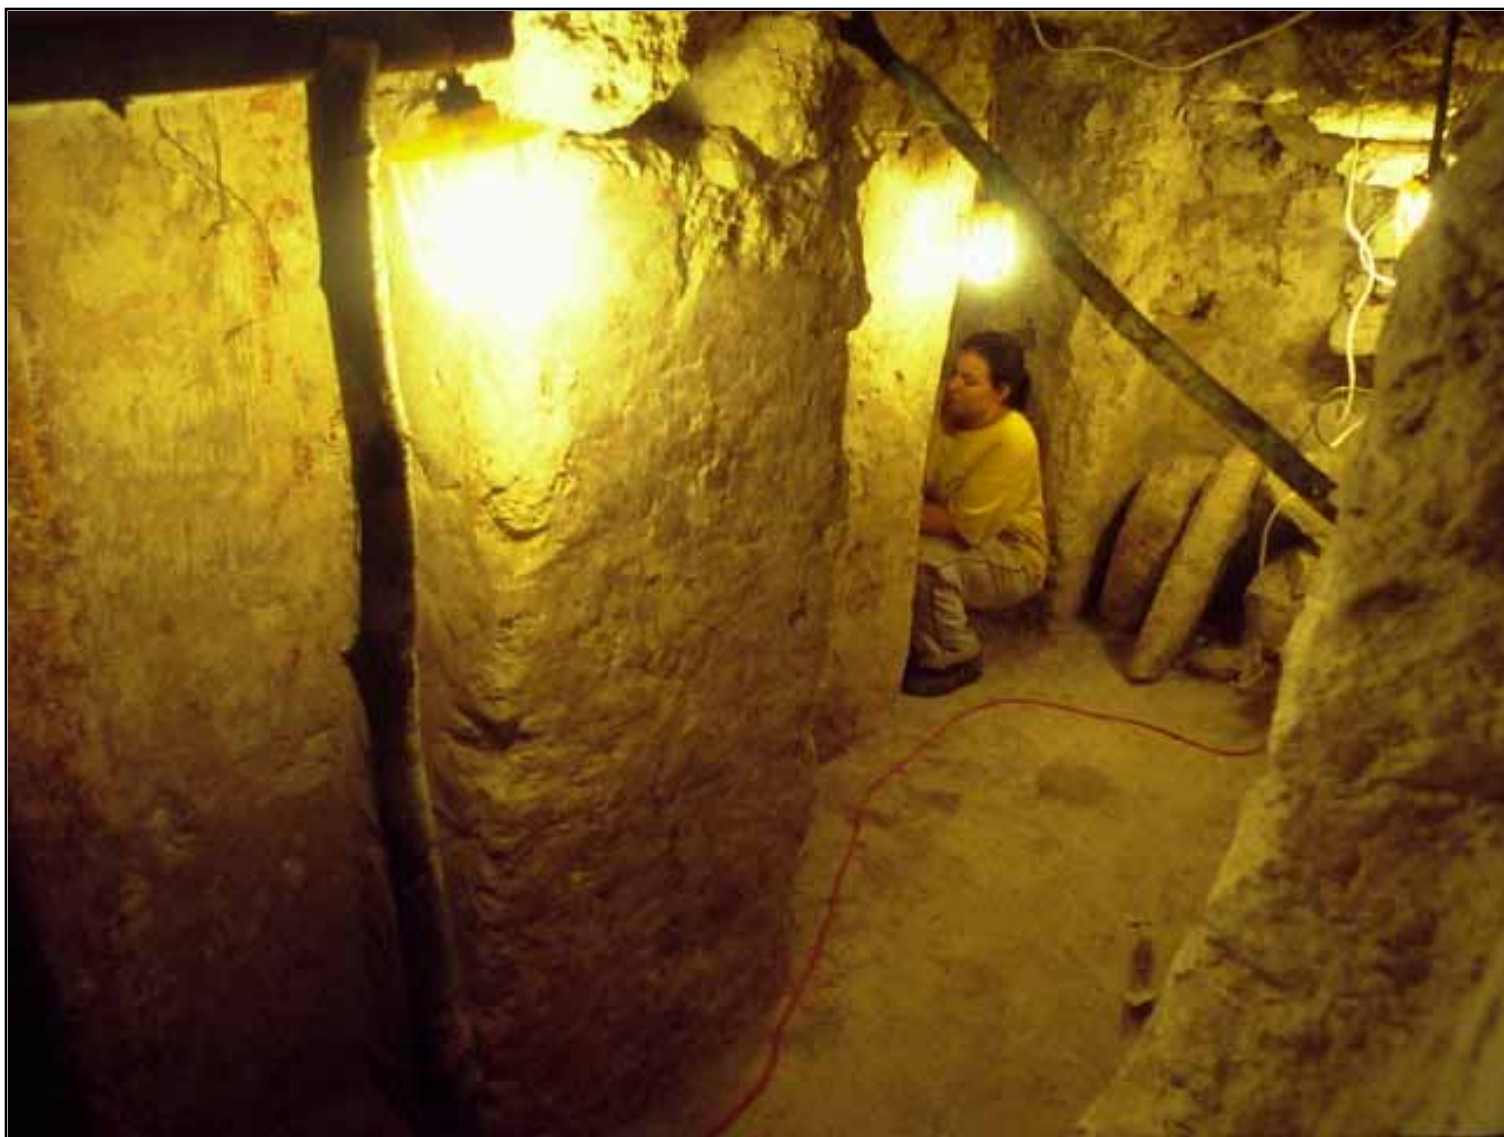
**Figure 11** Entrance to and interior of Structure 1 room 3, with doorway leading to Structure 1 sub 3

Further excavation within the tunnel revealed a doorway opening from Structure 1 sub 1 to the north where a later room (Structure 1 room 3) was built onto an open portico (as described above). From this room, a sealed doorway led to a second room to the west. The removal of the plaster and rubble that sealed the doorway revealed the outer walls (south and east) of a buried small structure with a cornice and plastered walls. In style and size, this building resembles Structure 5D sub 10-1<sup>st</sup> in the Northern Acropolis of Tikal (Coggins pers. comm.). This structure, the outer walls of which were elaborately painted also served as a funerary temple (Coe 1990). While La Suficaya Structure 1 sub 3 certainly resembles the Tikal structure in construction and layout, no paintings were evident on the outer walls of our building.

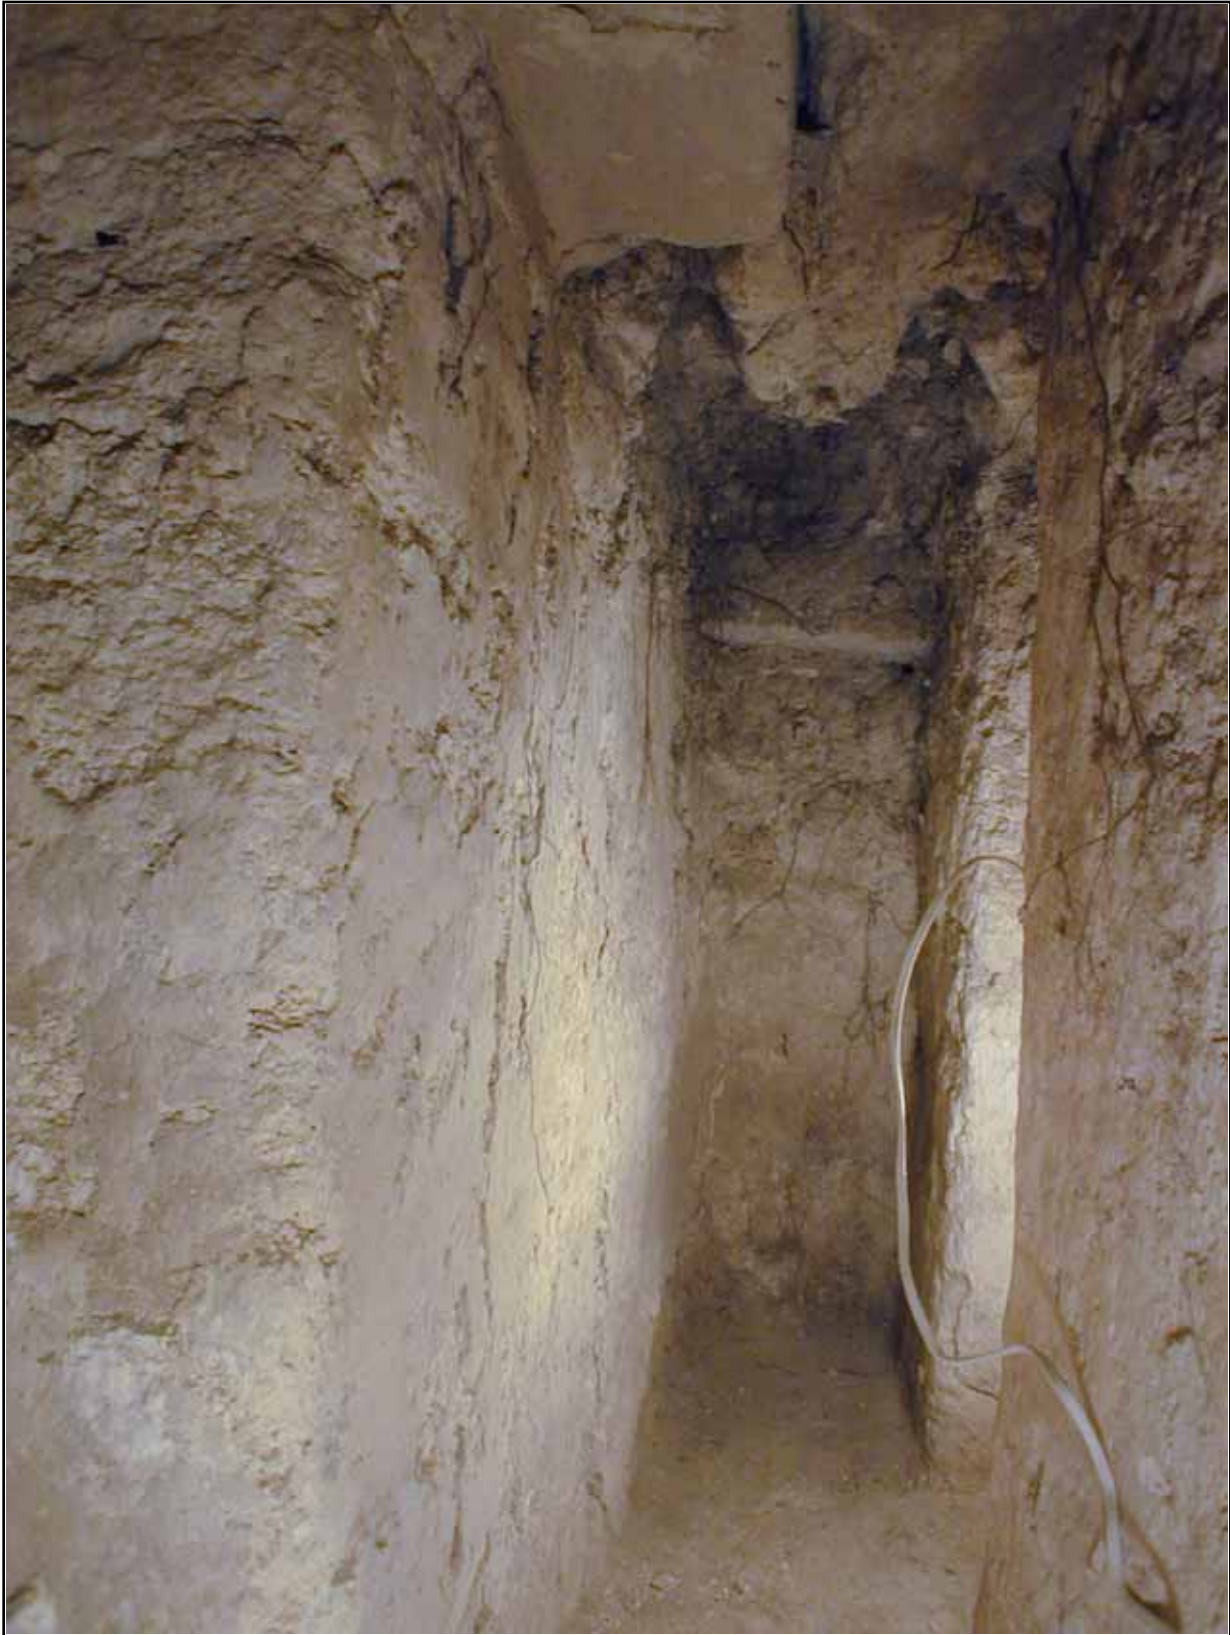
**Figure 12** Eastern wall of Structure 1 sub 3 with doorway leading to Structure 1 room 3 to the east

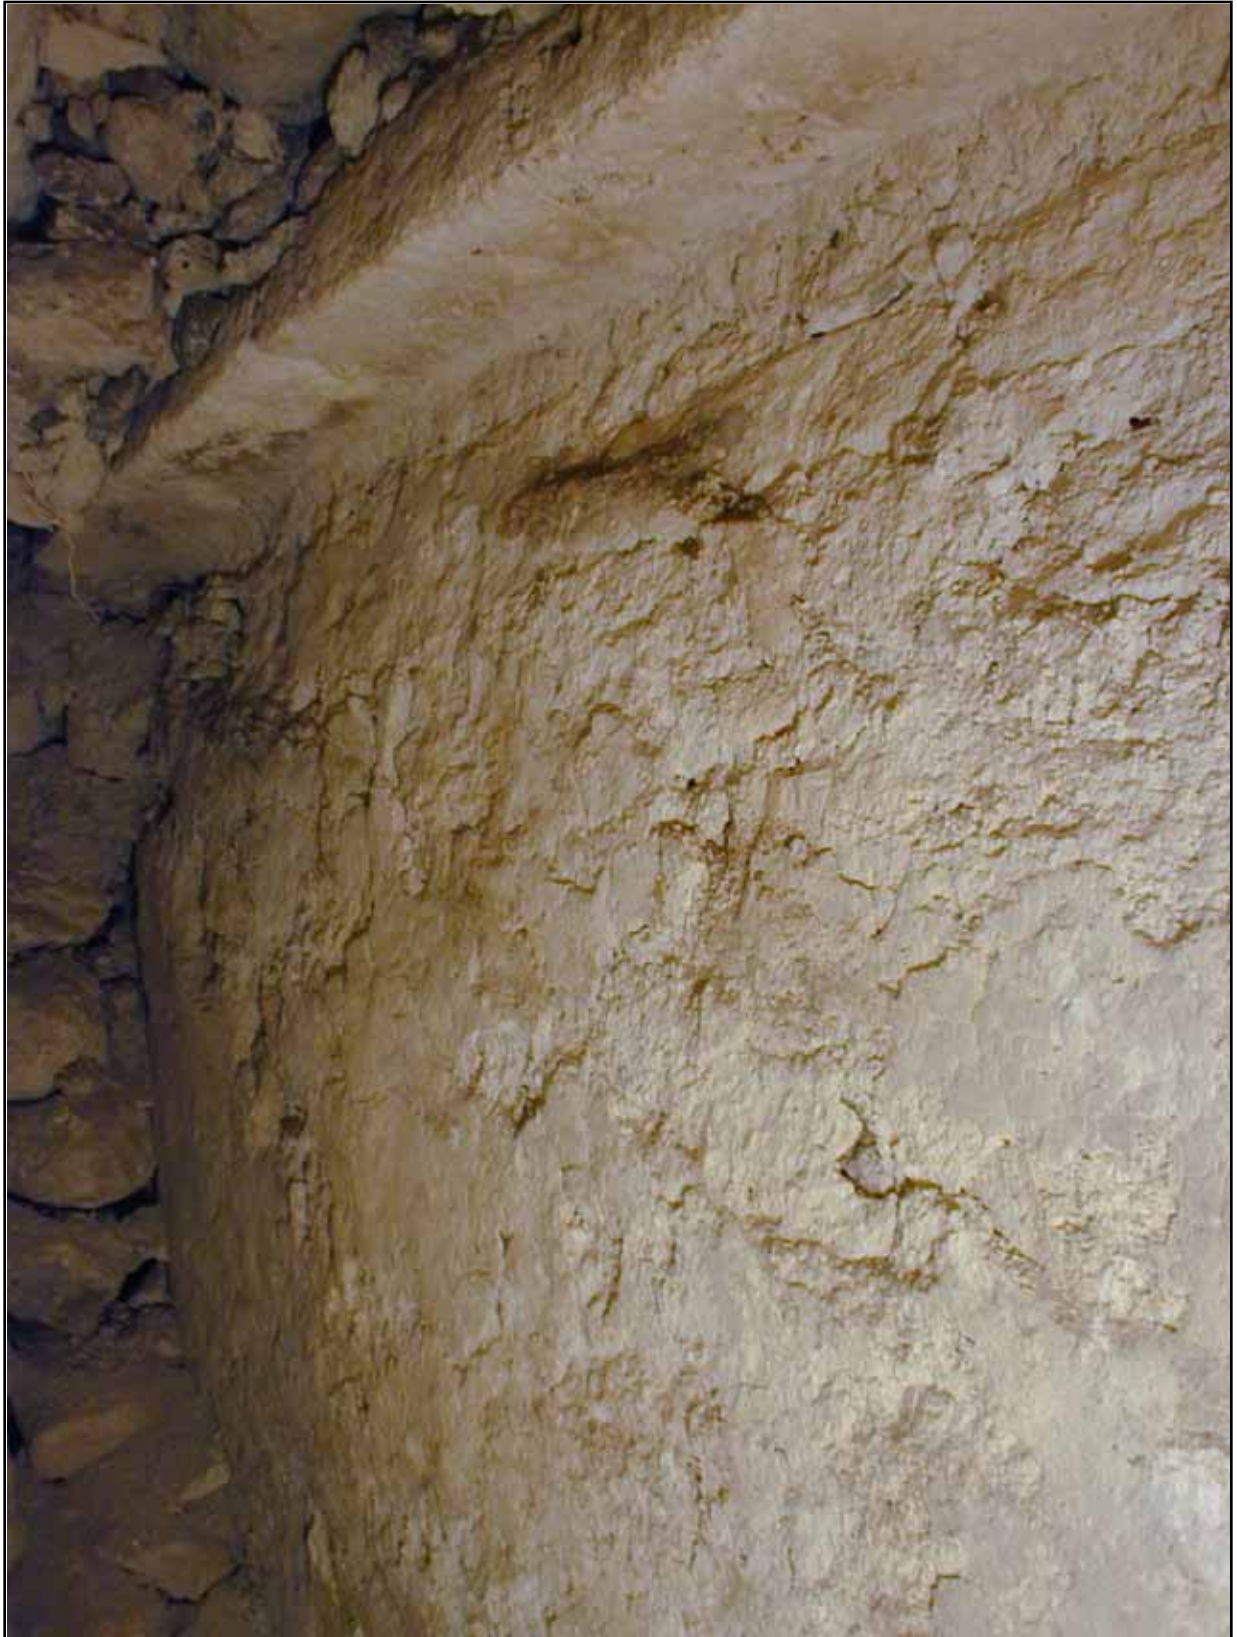
**Figure 13** Southern wall of Structure 1 sub 3 with cornice

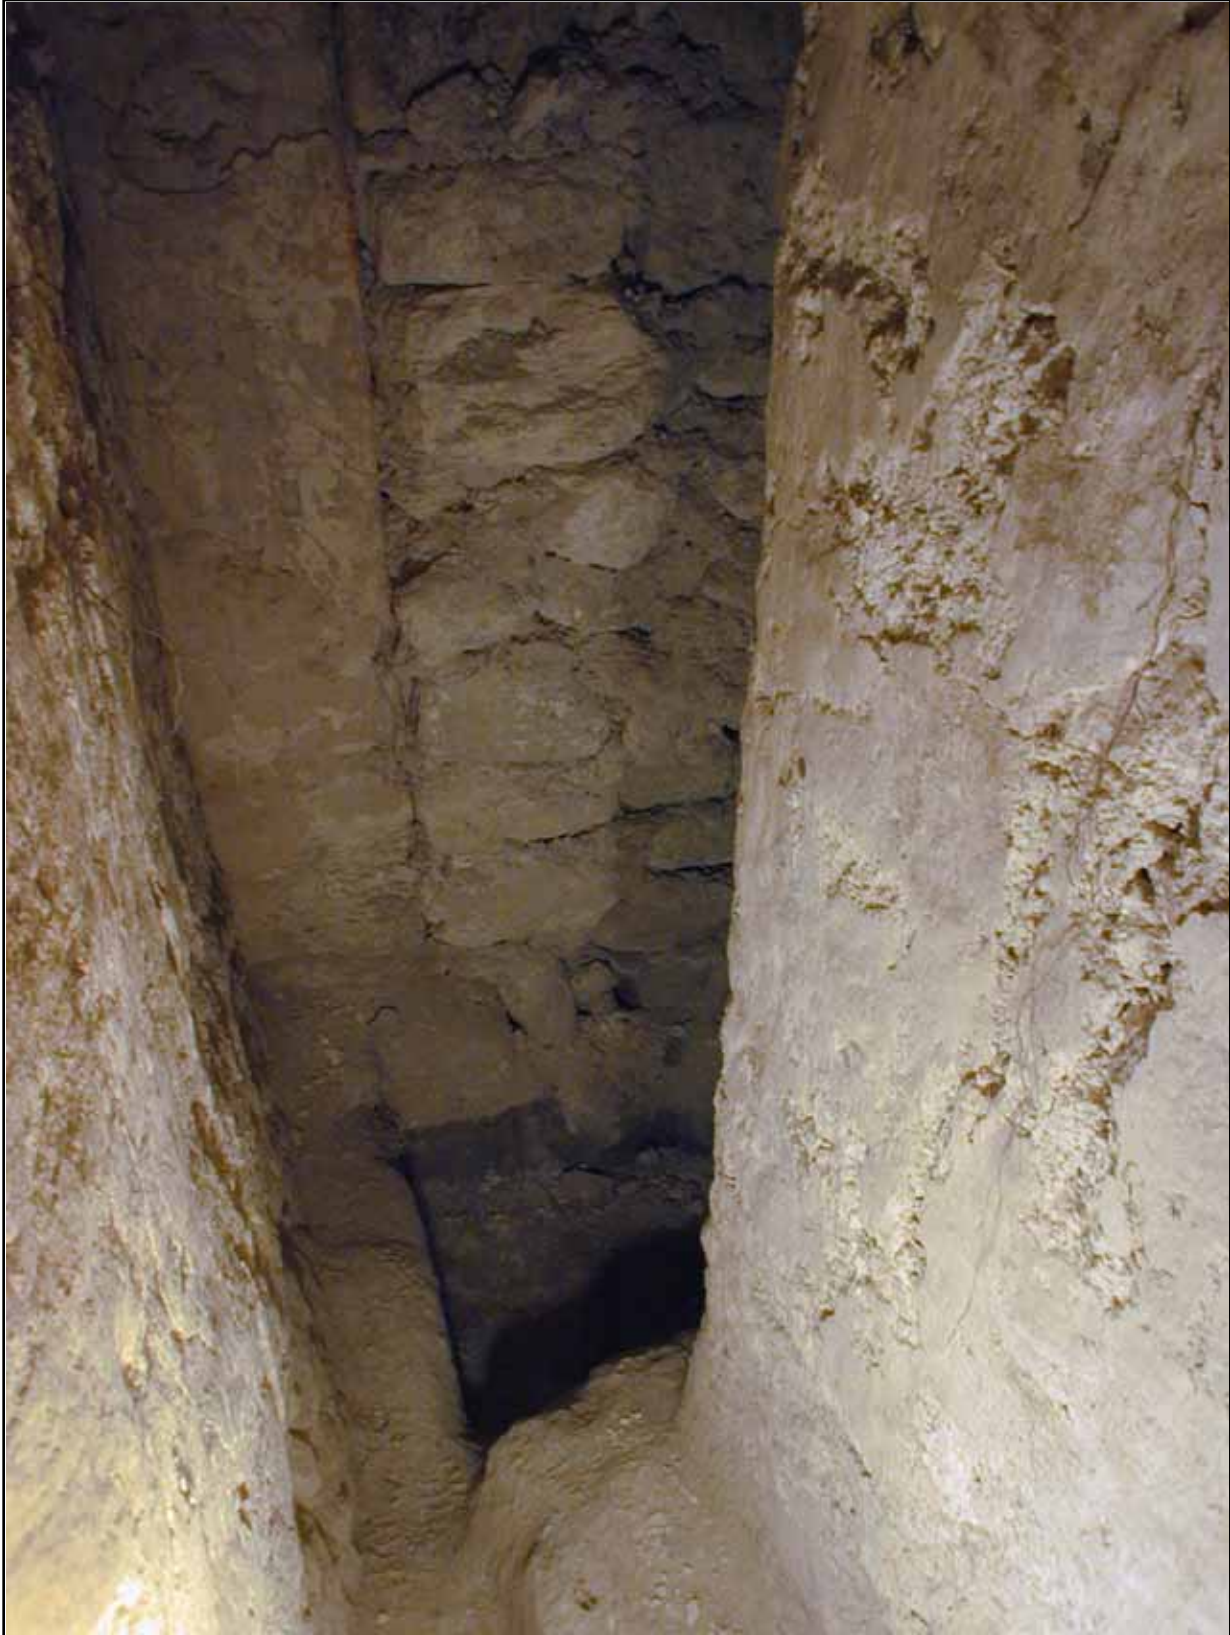
**Figure 14** Structure 1 sub 3 with plinth at the base of the wall in foreground. Cut ST17.44, wall ST20.25 and wall ST20.31 in background
