# ARCHAEOLOGICAL INVESTIGATIONS IN THE HOLMUL REGION, PETEN RESULTS OF THE FOURTH SEASON, 2003

*Edited by*  
*Francisco Estrada-Belli*

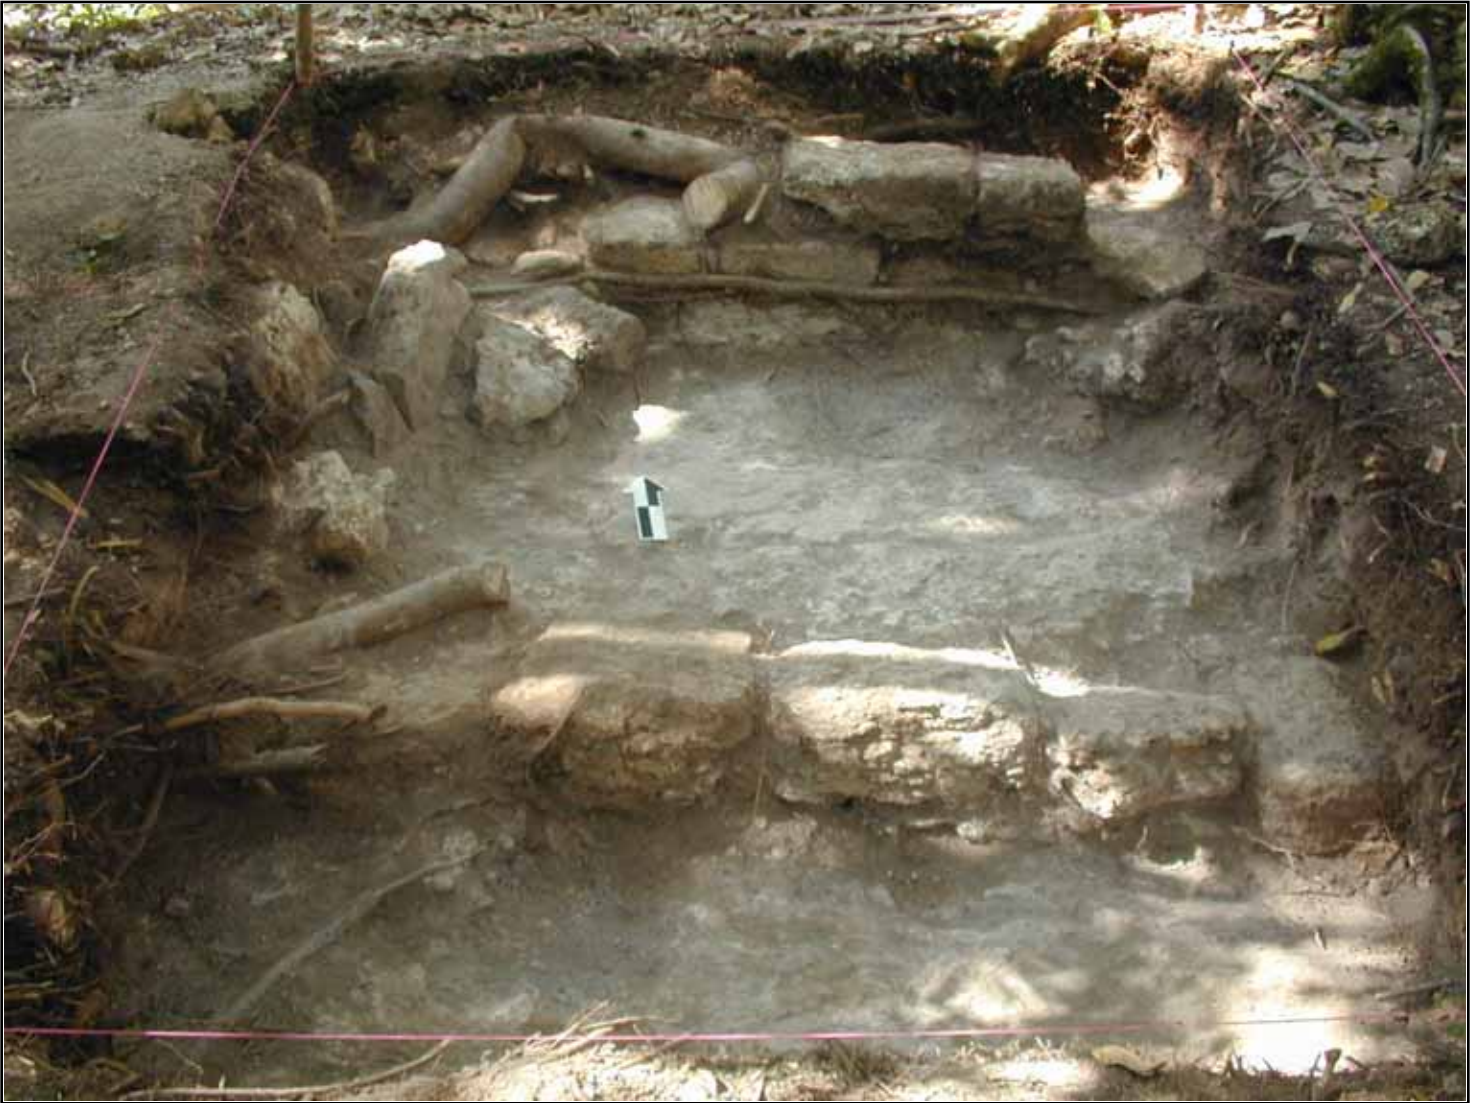
**Figure 18** Terrace uncovered in Excavation ST20

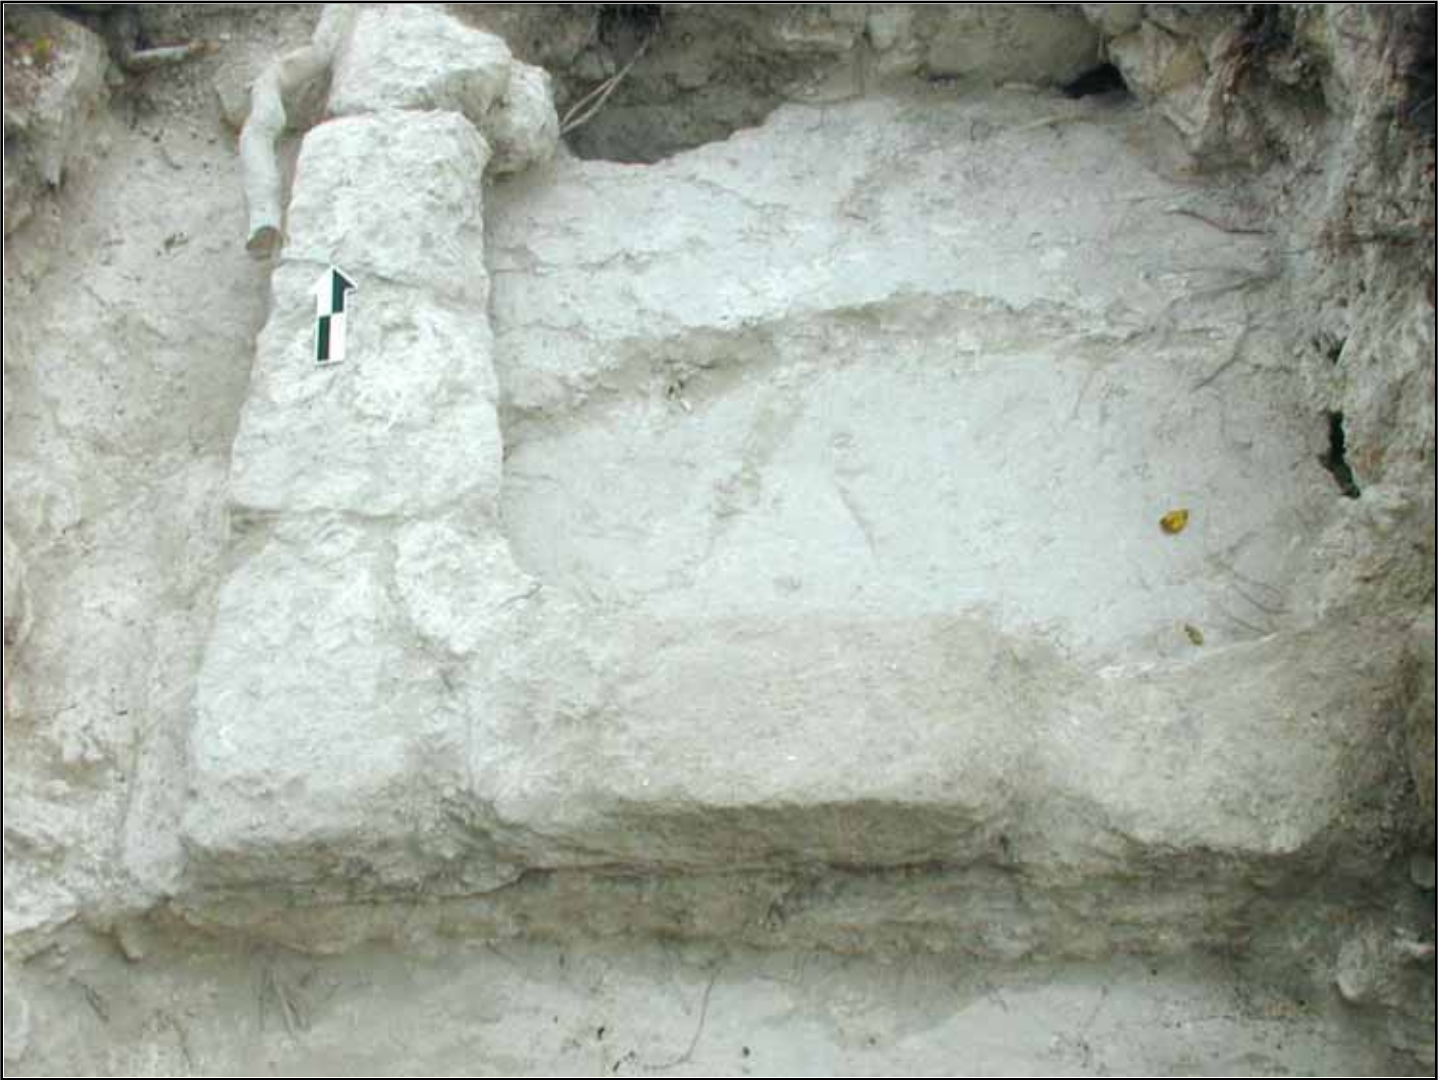
**Figure 19** L-shaped wall uncovered in Excavation ST20

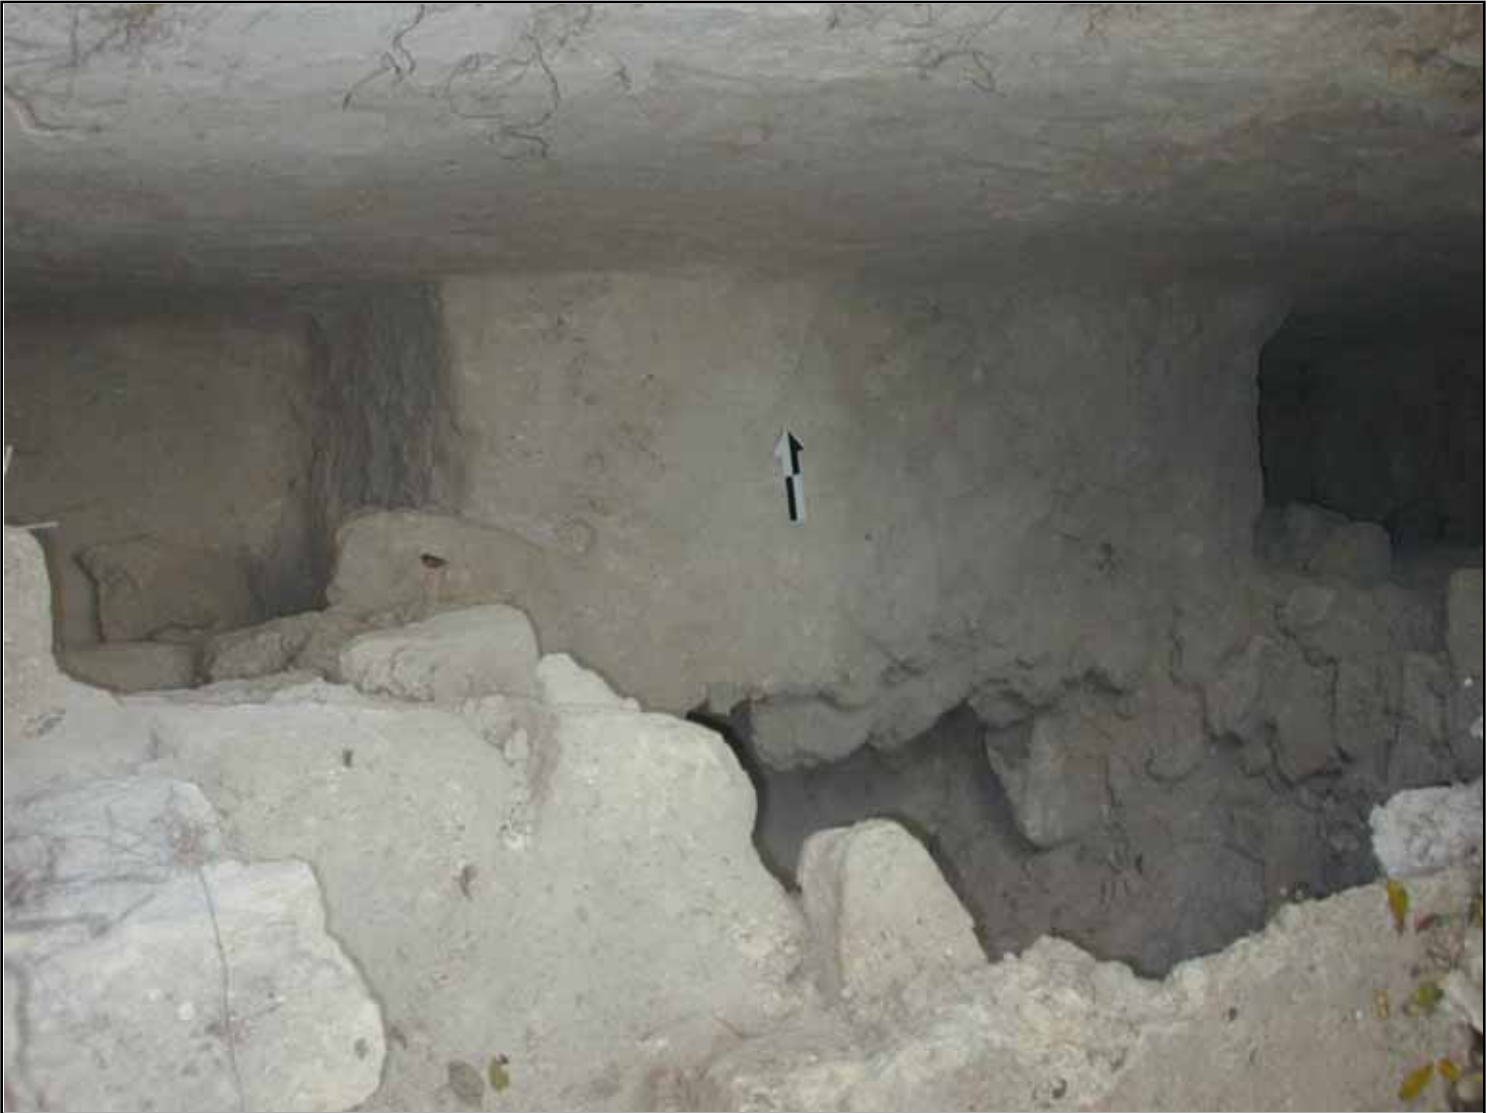
**Figure 20** Overhead view of Excavation ST20 with wall ST20.25, bench ST20.28 and floor ST20.30 visible

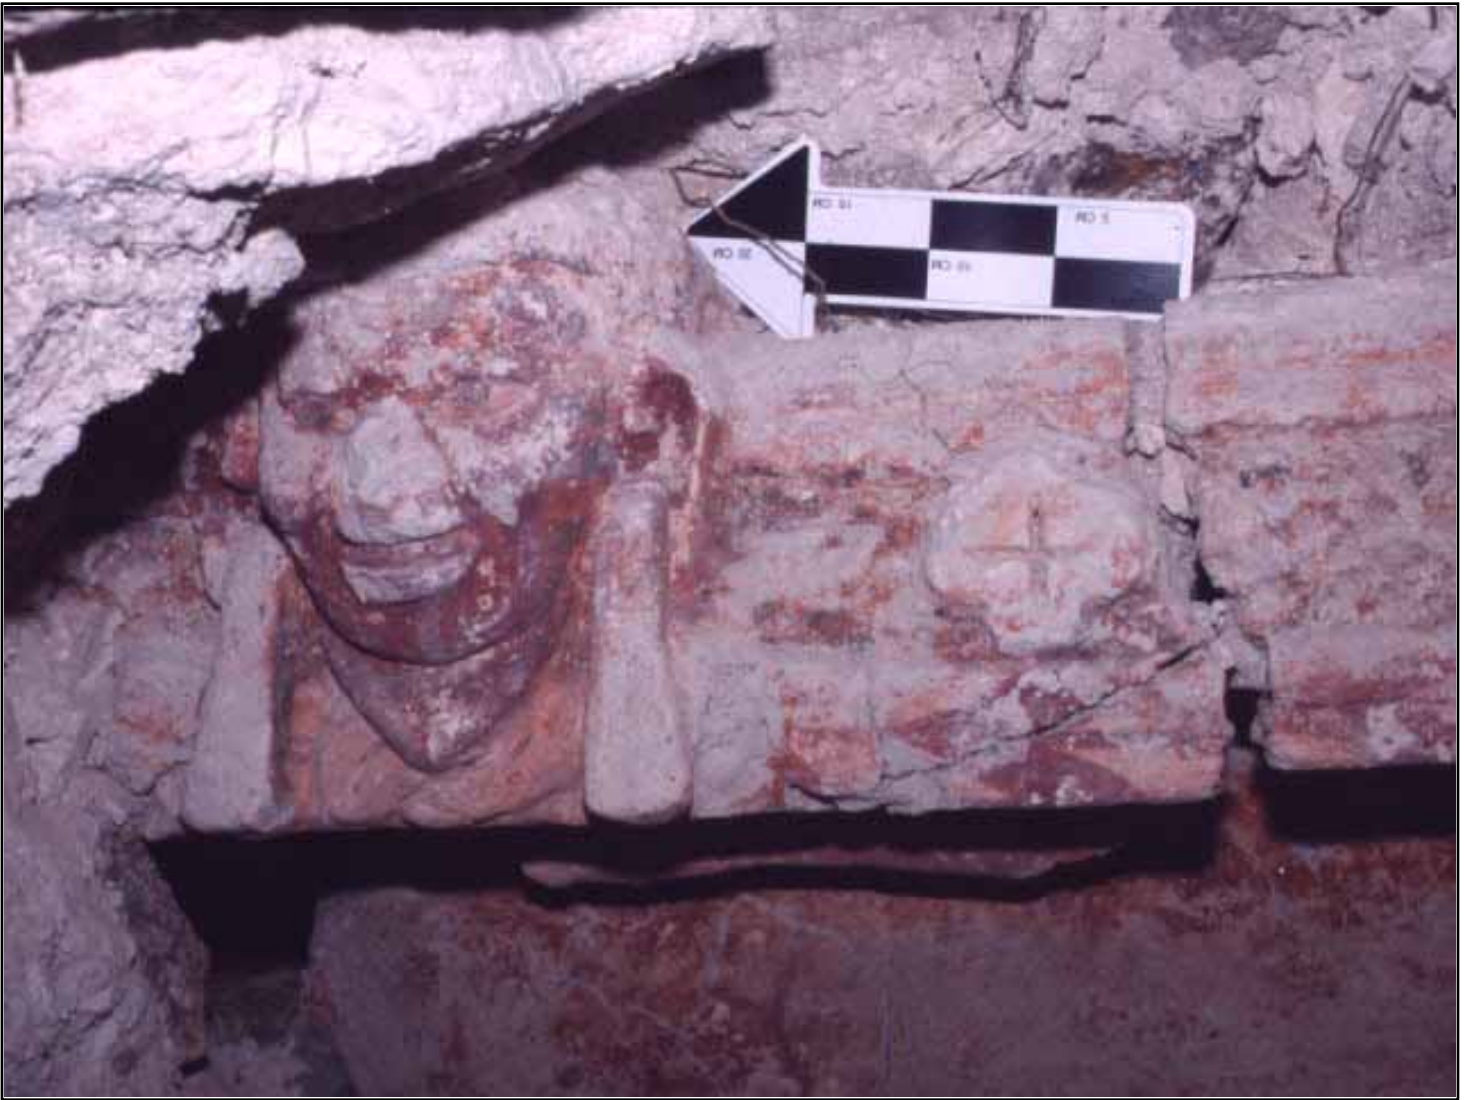
**Figure 21** Decorated frieze adorning outer face of western wall of Structure 1 sub 1

The outside (NW) corner of the mural room (Structure 1 sub 1), which is abutted by the E-W wall with the new bench, is decorated with a stucco frieze. This frieze included quatrefoils and a small stucco head painted in black and red. The rather devilish-looking head wears a bib and cloth in the ears and has inlaid teeth. According to Coggins (pers. comm.) it may be a representation of a captive with Highland Mexican connotations. This possible representation of a captive, as well as the Mural 5 scaffold sacrifice, may actually depict important components of Early Classic accession rituals.

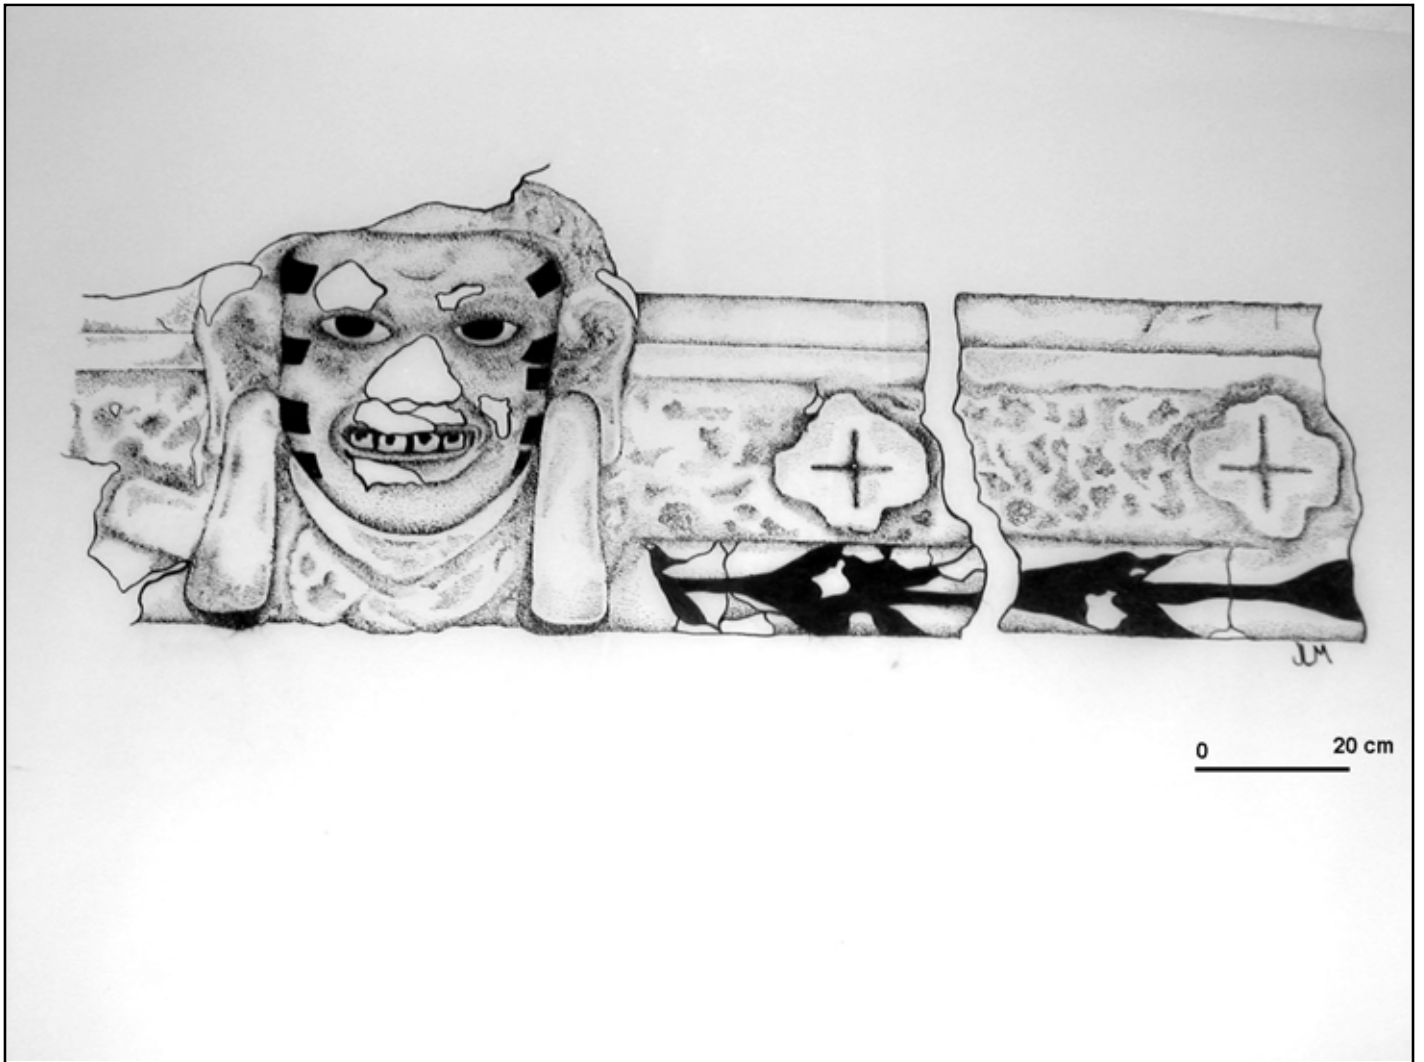
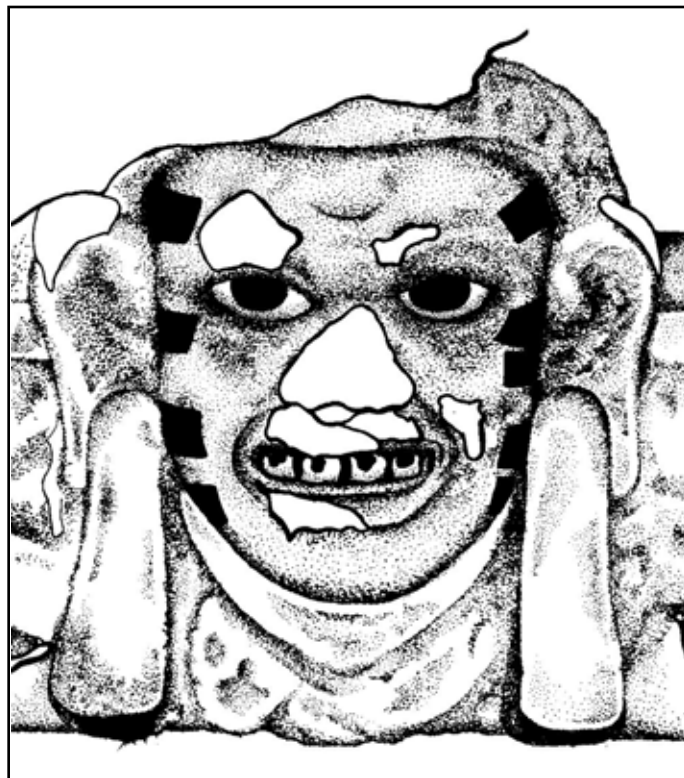
Figures 22 & 23 Detail of Structure 1 sub 1 frieze (Drawing by Jessica Mundt)

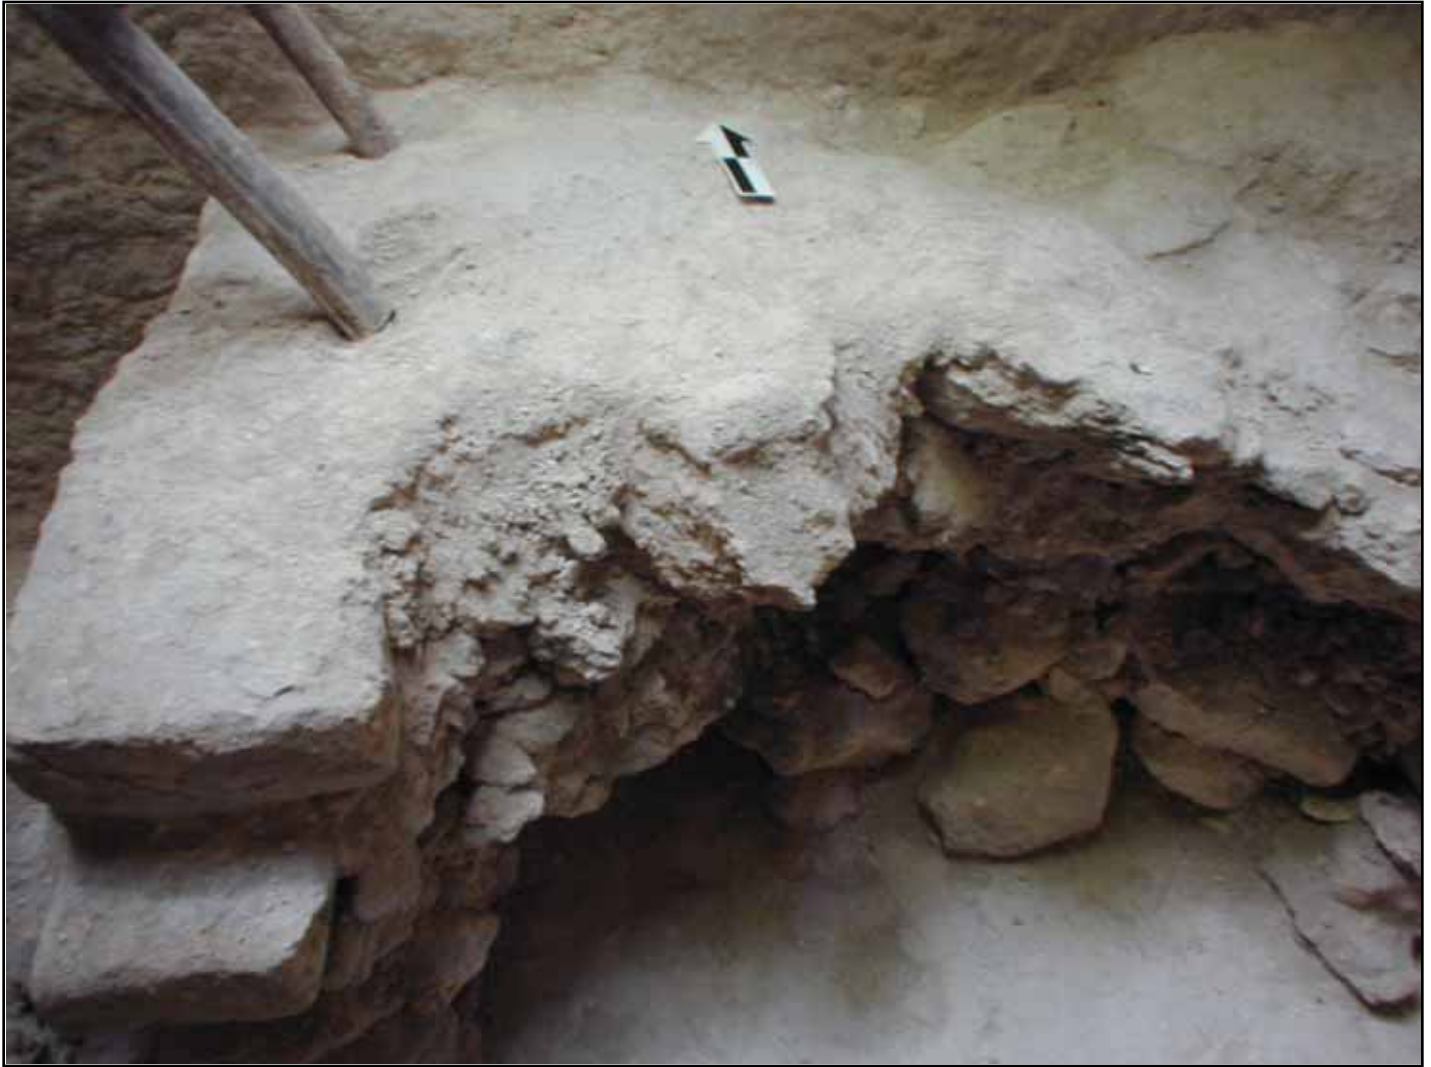
**Figure 24** Bench uncovered in Excavation ST20

The stairway covered an earlier construction on the outside of the mural room (Structure 1 sub 1, formerly Room 1). This consisted of a long E-W wall abutting the NW corner of the Room 1 building. A large masonry bench was constructed at the centerline of this wall (and the mound itself). The position and size of this bench suggests that it may have been a throne, even though it is not very elaborate. This centerline throne would have been accessed by walking past the portico with the Teotihuacán mural when it was in use. The excavation of the throne also reinforces our initial hypothesis that this structure functioned as a royal palace, at least for a short time in the Early Classic period (ca A.D. 200-550), and that the Structure 1 sub 1 mural depicts an accession ceremony presided by Teotihuacán warriors.

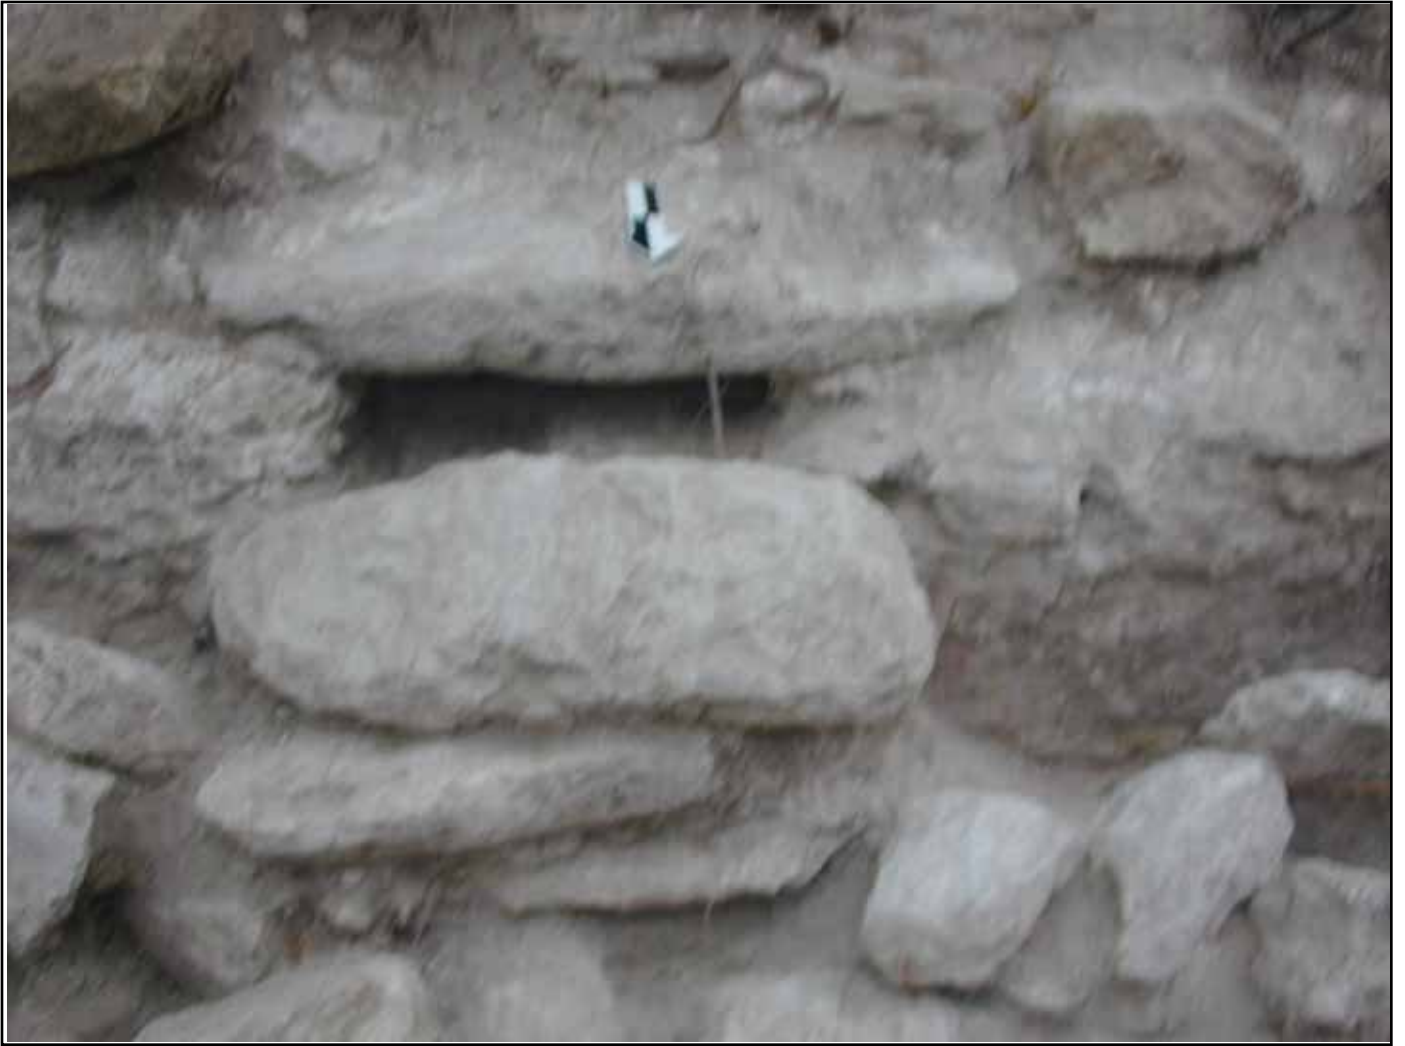
**Figure 27** Eye of mask uncovered in Excavation ST08E

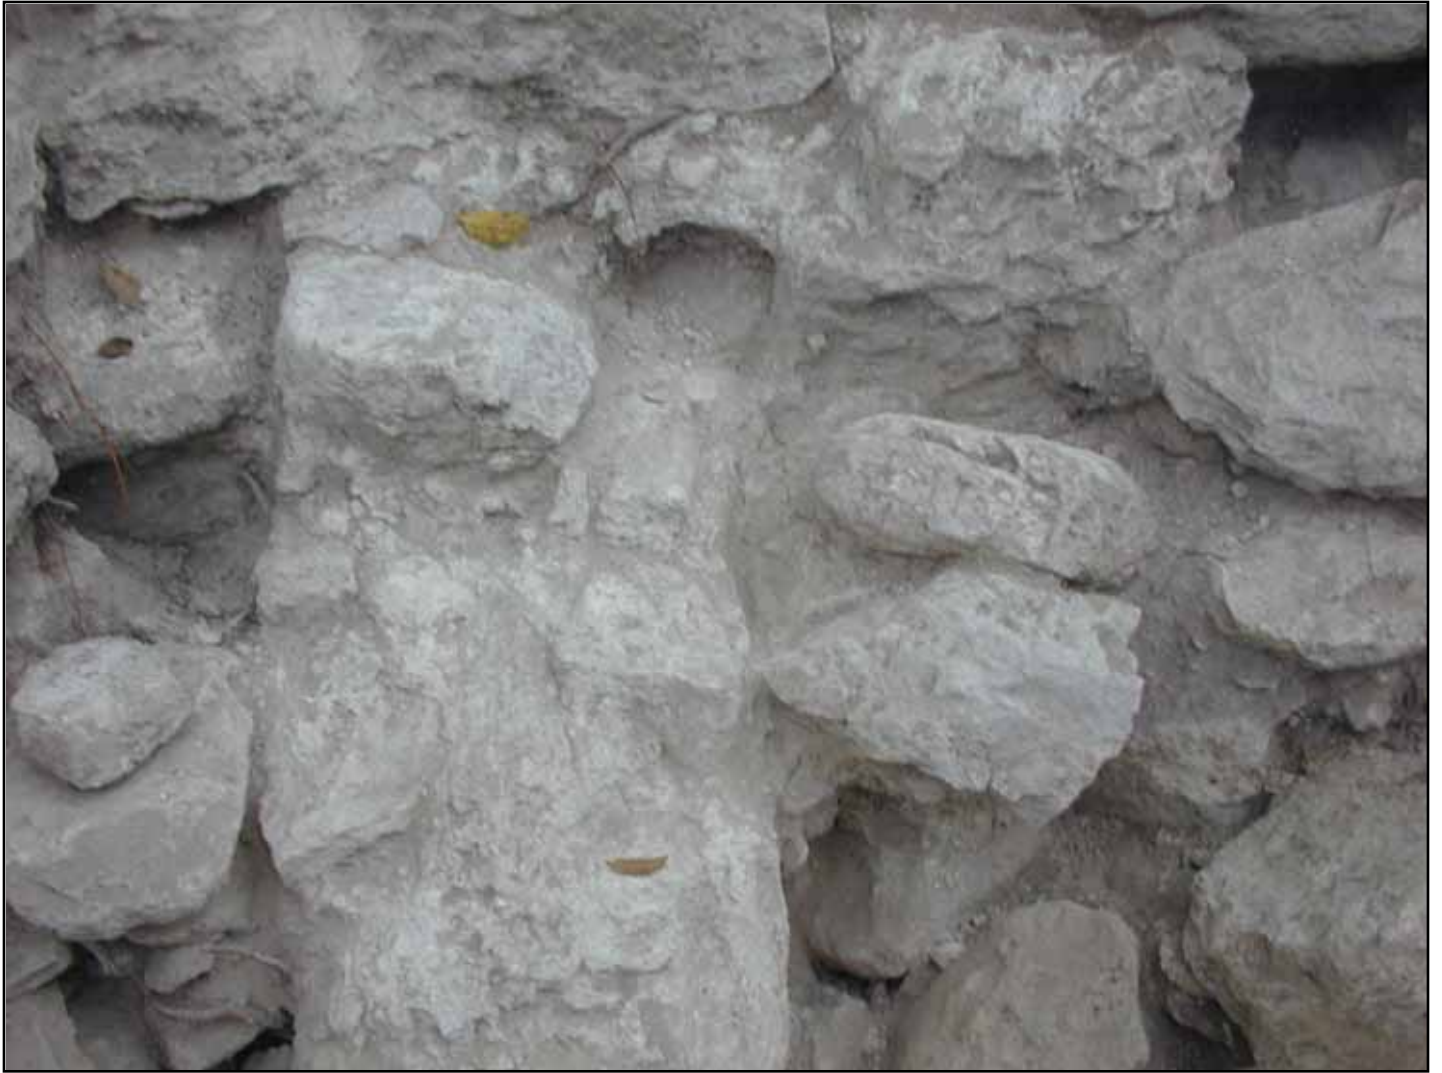
**Figure 28** Nose of mask uncovered in Excavation ST08E

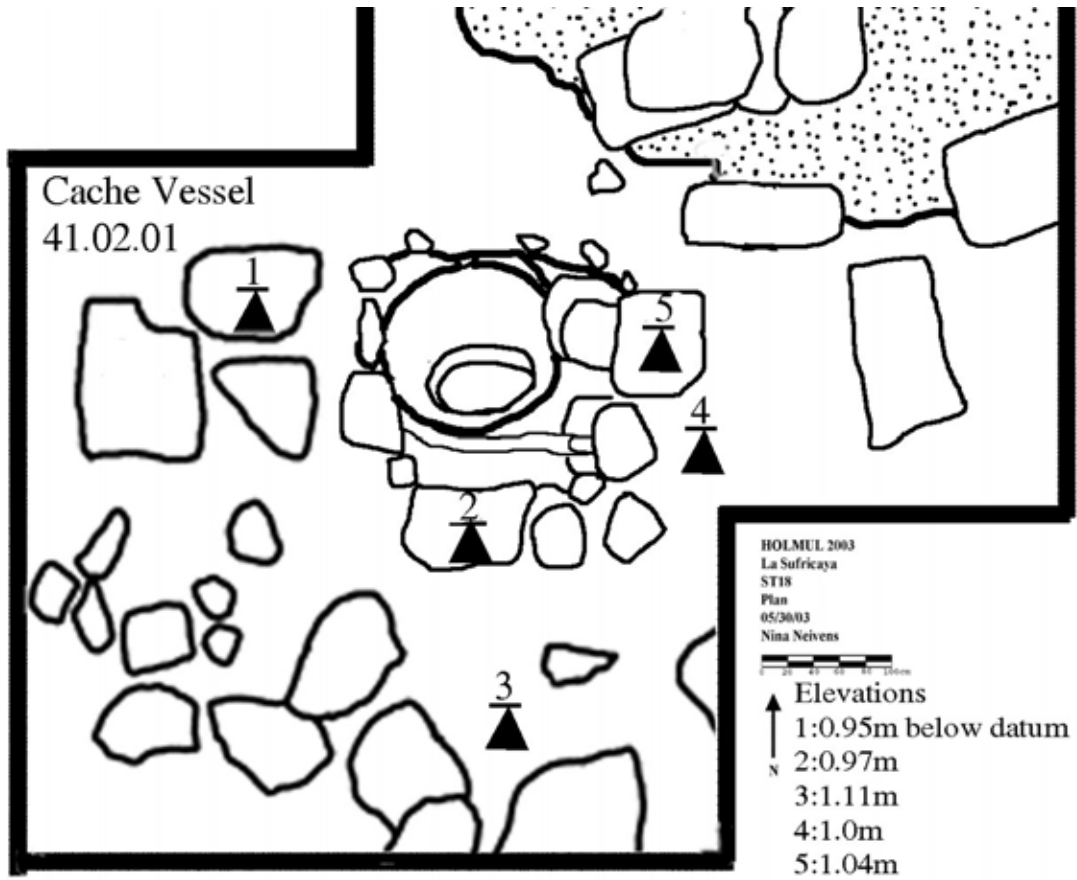
Figure 3. Detail of SW extension and cache #2.

On the southwest corner, two caches were made before (?-it had to be before unless it was cut through the fill) the mound was filled. The first cut, ST 18.40, was filled with ST 18.41 containing one complete ceramic vessel. Then ST 18.52 was cut directly above it, extending slightly to the south. This was lined with flat stones and filled with ST 18.39 containing another ceramic vessel of the same style. This was covered by a layer of stones, ST 18.38, and a layer of chert debitage, ST 18.37. The whole thing was then covered by a large flat stone. The area around the mound continued in use through the Late Classic and a layer of densely packed gray soil occurred around the building, ST 18.08, and finally the humus layer ST 18.32 and ST 18.36 covered the area.

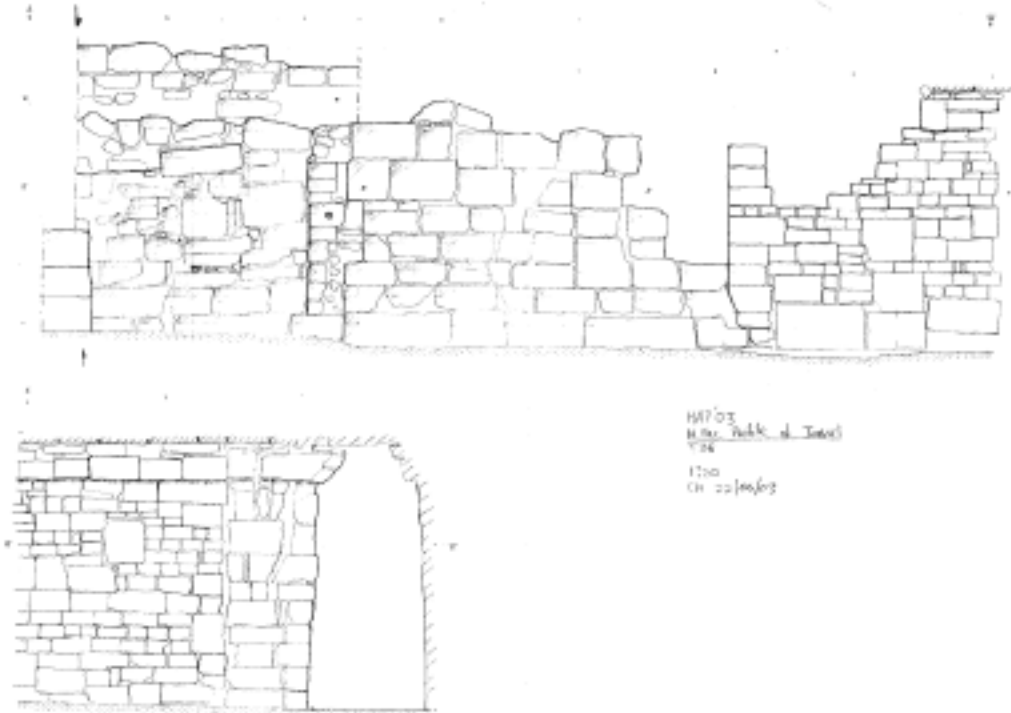
Figure 13. Profile of South wall of vaulted passage under Str. 43 (HT 36).

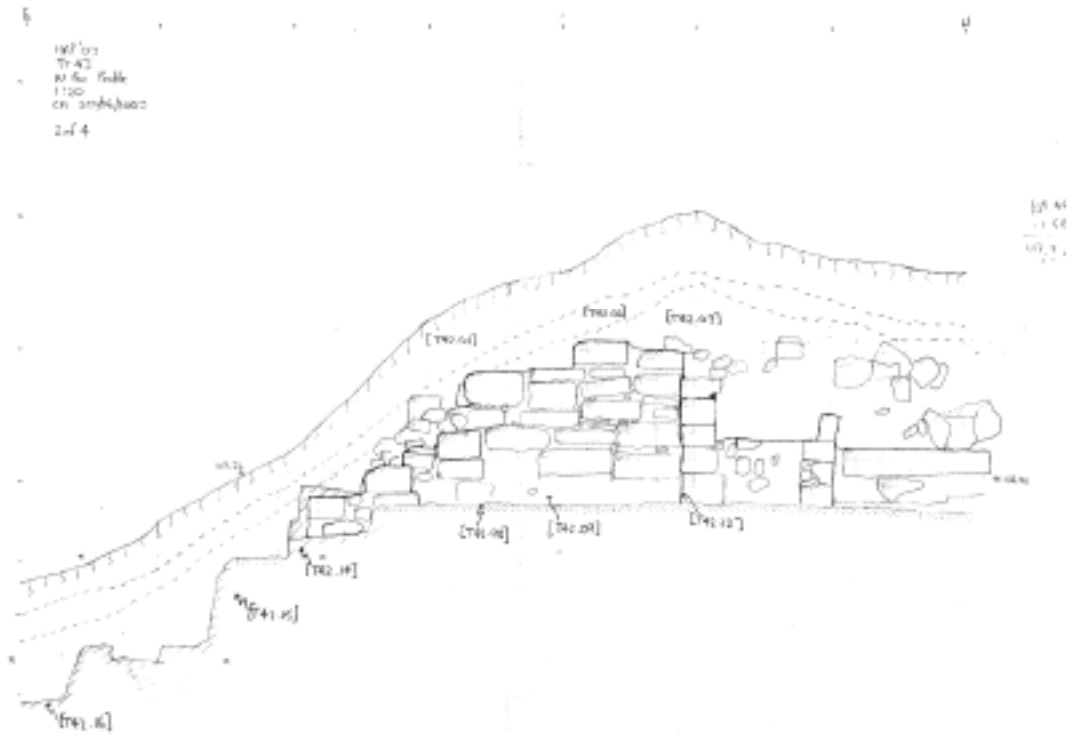
Figure 19. South profile of HT42, upper structure on stairway leading to Court B from Main plaza.
