# A Tour of Aiko

- 1/32 scale
- 6.5 ft. (1.98 m) long - 205 ft. (62.5 m) full scale
- Turnigy SK3 5045 - 450 motor with Yep brand 100 A helicopter ESC. ~1260 W with 6s Li Po, probably 630 W with 3S.
- 12 in. beam - 32 ft. beam full scale.

- Provide a proof of concept for a plywood hull construction.
- Handle ocean waves of up to ~3 ft (100 ft full scale).

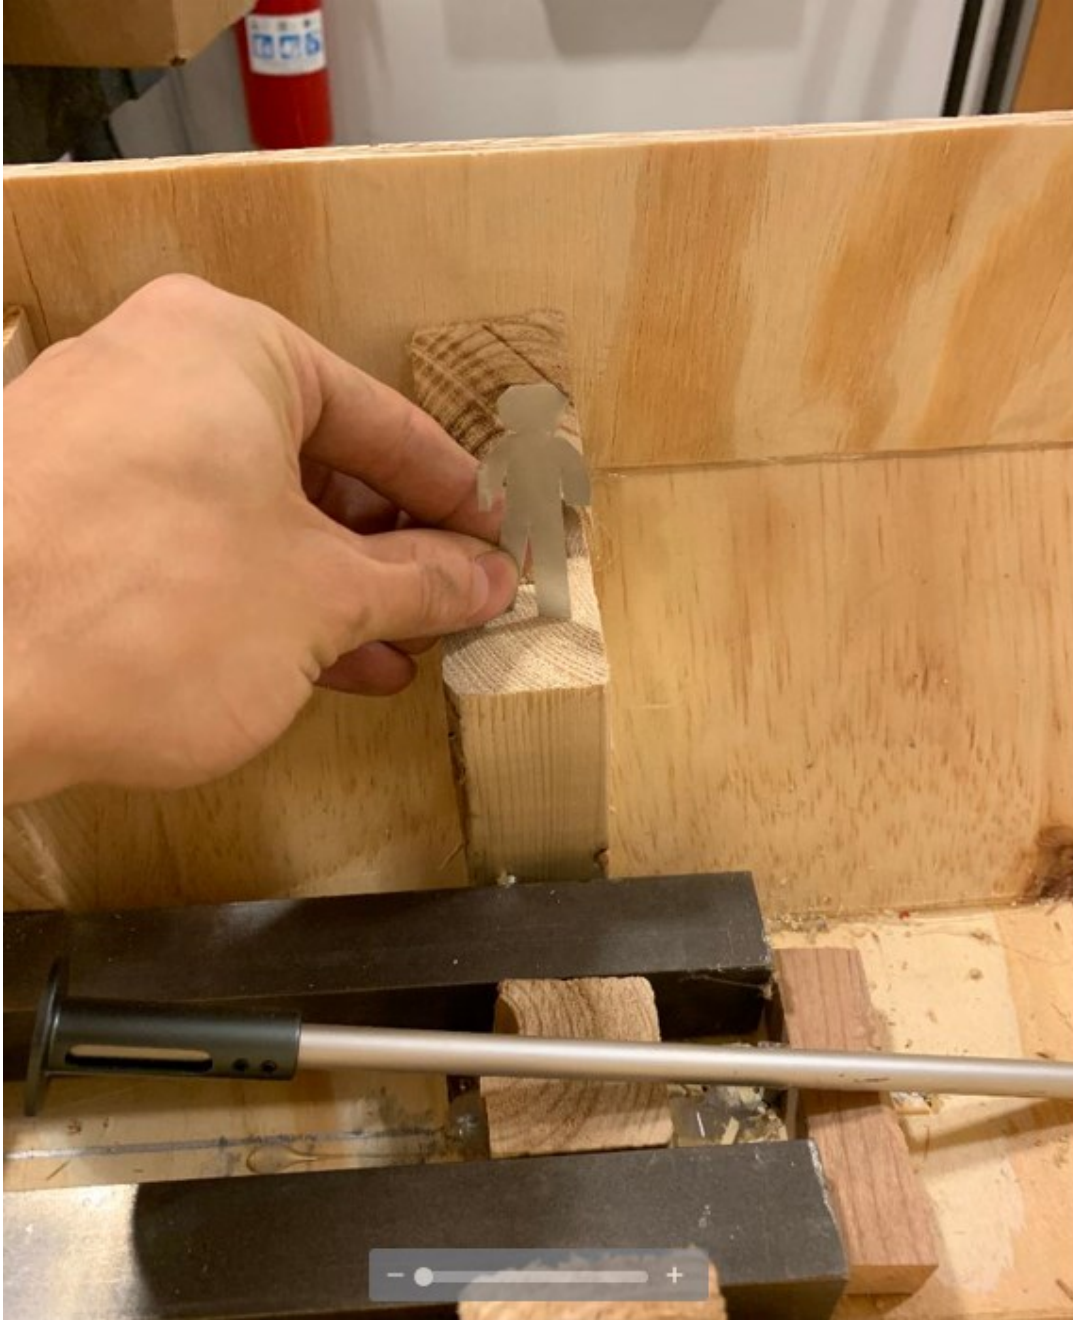
The figure that I am holding in the picture is equivalent to a 6 ft. tall person. Instead of scaling an actual boat down and building a model, these ships are of my own design. Therefore, I use the scale figures to build features that a 1/32 scale crew could use. Also visible are two of the steel bars used to ballast the ship. There are probably 40-50 pounds of ballast in the bilge of the ship.

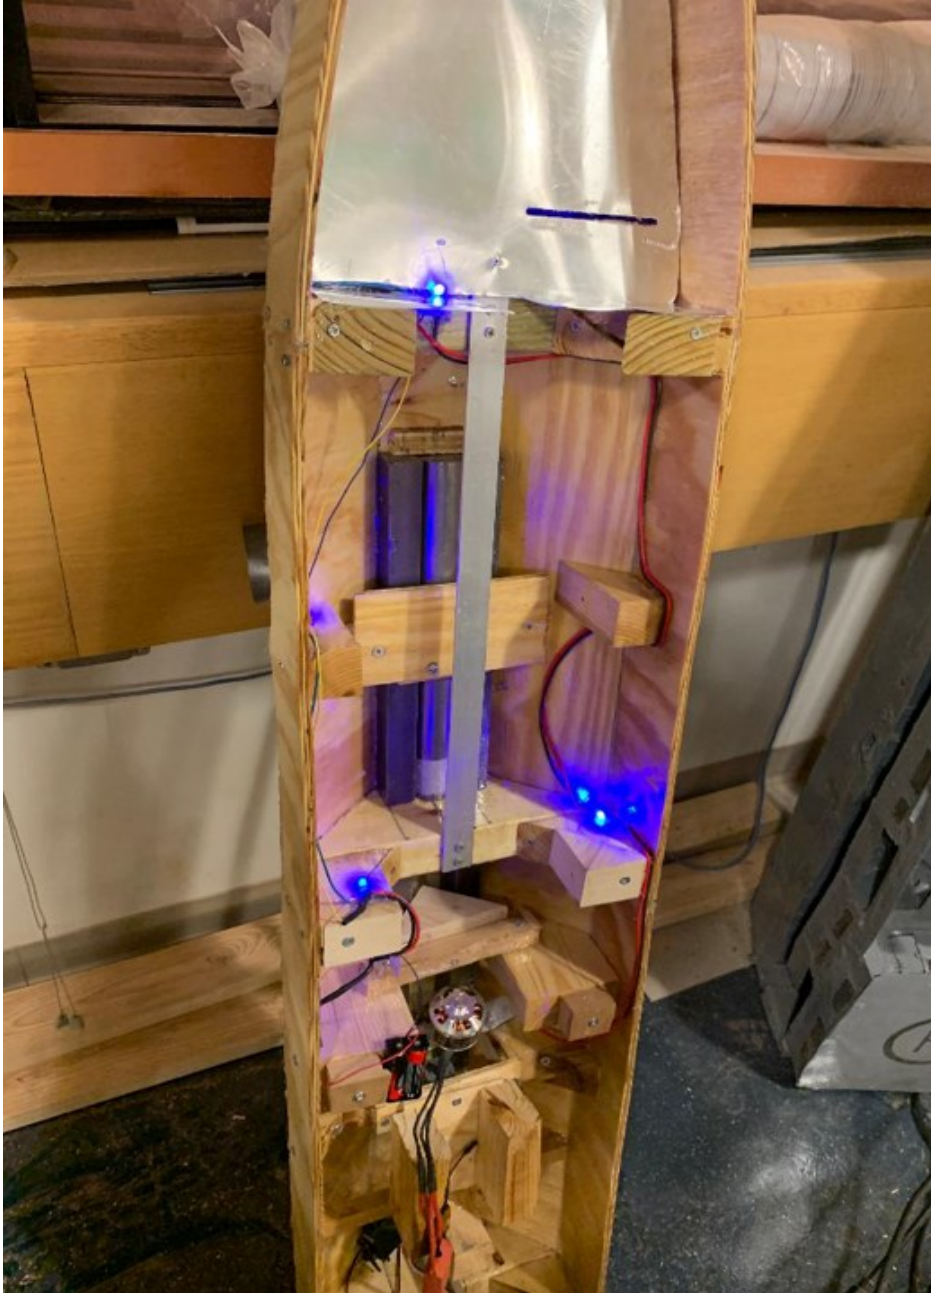
I began adding the deck for the first belowdeck level (second belowdeck level is the bilge where the ballast and sewage tanks are). I also began adding lighting. These are blue LEDs soldered in parallel and connected to two AAA batteries and a switch with a resistor.

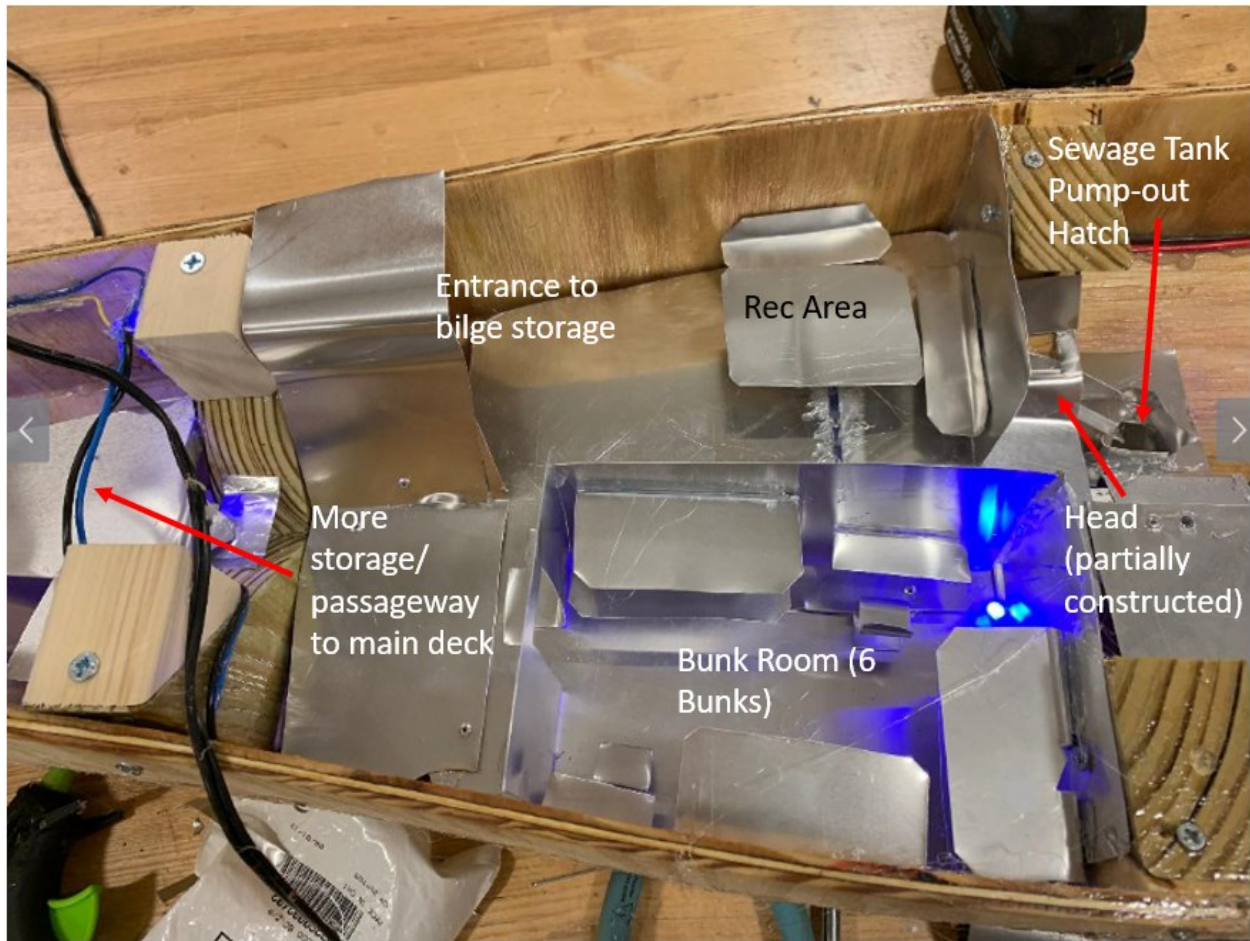
This shows the crew quarters. This level of the ship was left as mostly bare metal and epoxy-coated wood. The crew would consist of 6 members, plus the captain (the captain has separate quarters at the stern of the ship). This is in the first belowdeck level; there is storage in the bilge below. The sewage tank for the head is directly under the pump-out hatch in the bilge. When the head was finished, a wall was installed between the head and the pump-out area, and walls were also constructed around the pump-out room. A pipe also extends into the tank from the galley sink and the second deck head. No sleeping pads, etc. were installed in the bunk room; these would be installed by the crew members on a full scale ship.

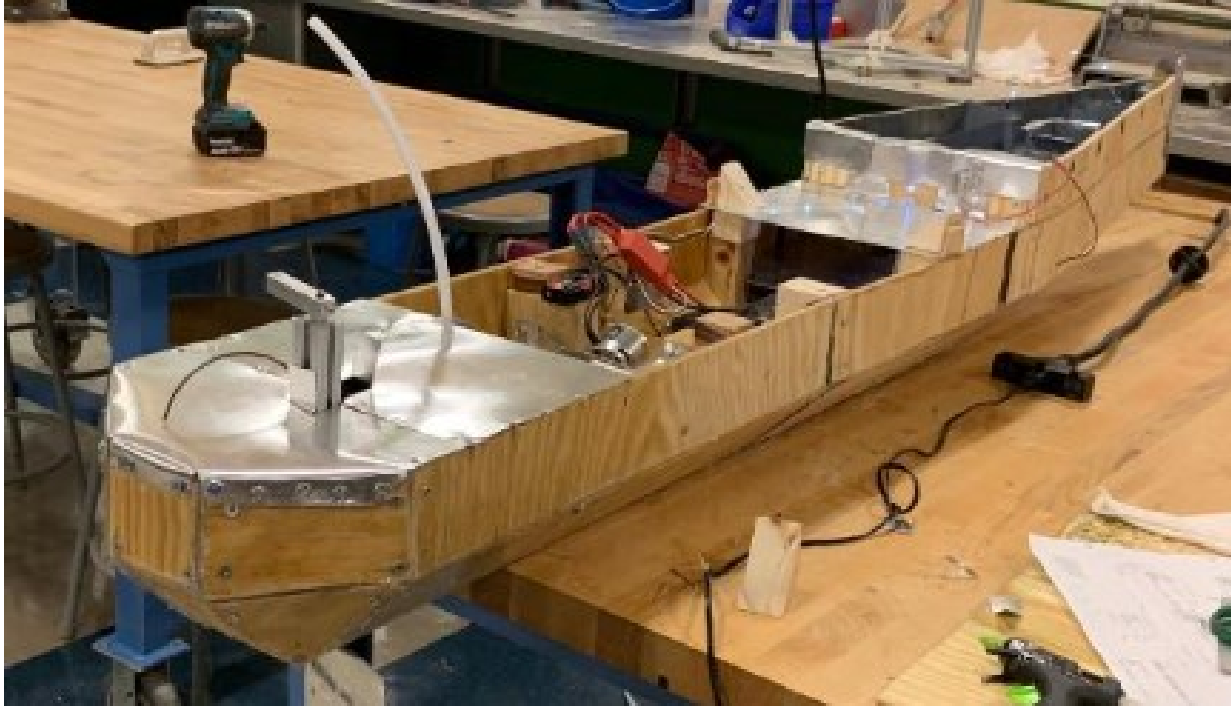
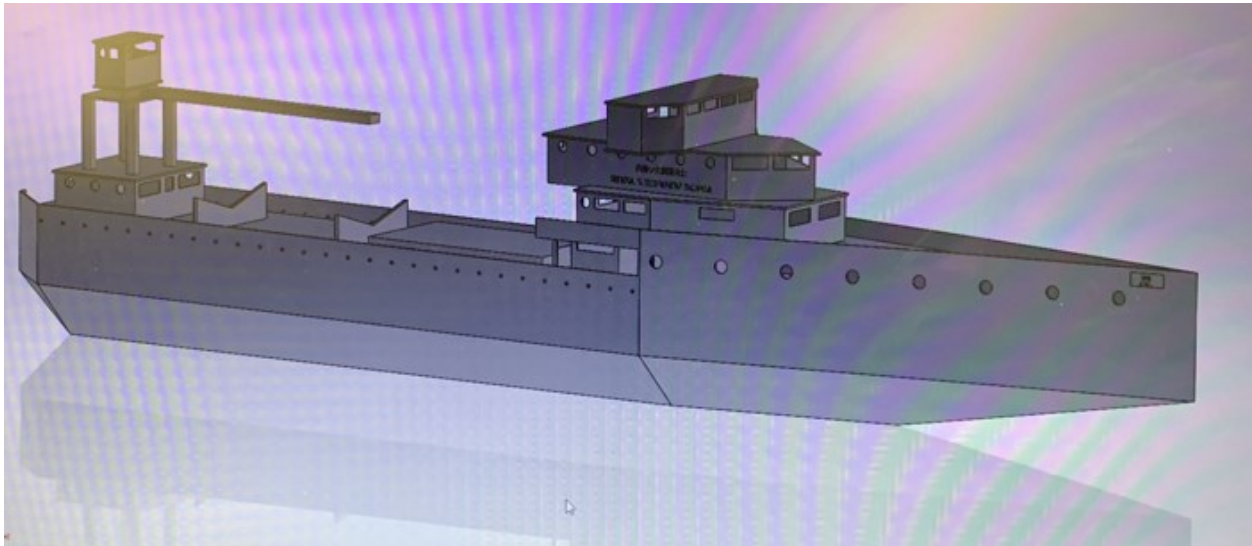
At this point, I measured what I had built so far and created a Solidworks model of it. I also added a preliminary superstructure design.

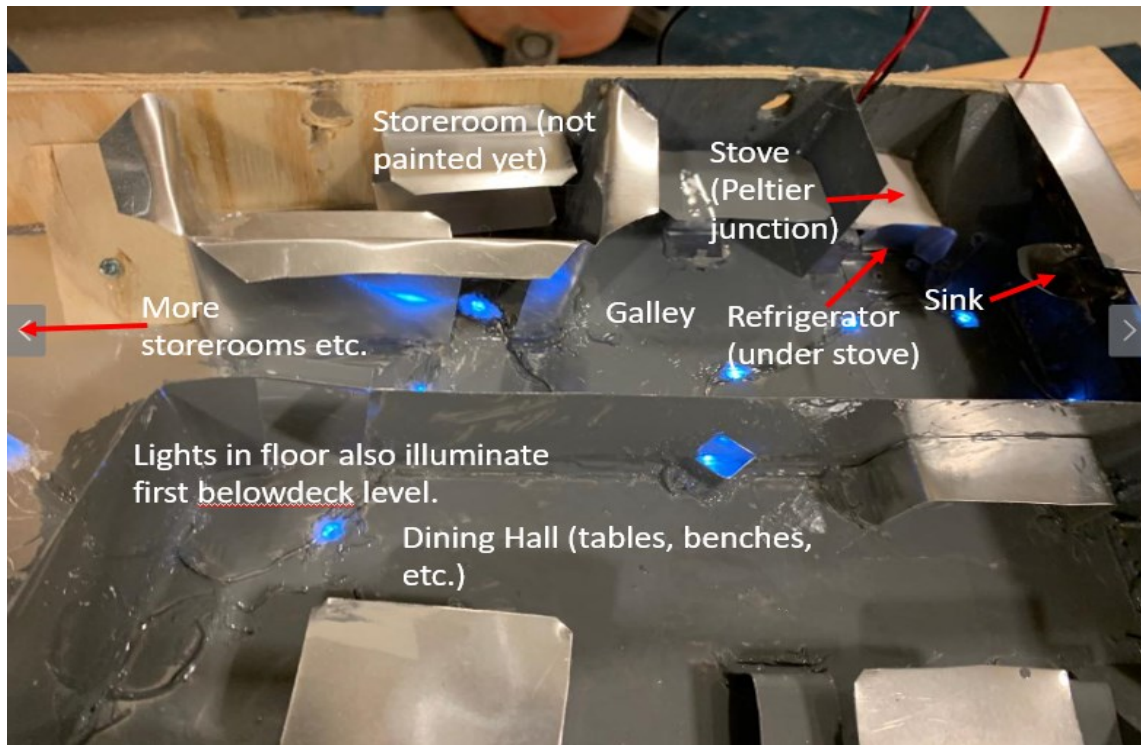
The ship has provisions for a crew living on board for extended periods. There are multiple storerooms, where non-perishable rations would be stored, a small solid state refrigerator for storing perishables (cold side of Peltier junction), a warming plate/stove for heating rations (hot side of Peltier junction), as well as a sink, which is tied to the forward sewage system. The dining hall can easily accommodate the seven crew members, plus extras if necessary. An elevator between the main deck and the first level belowdeck was also constructed.

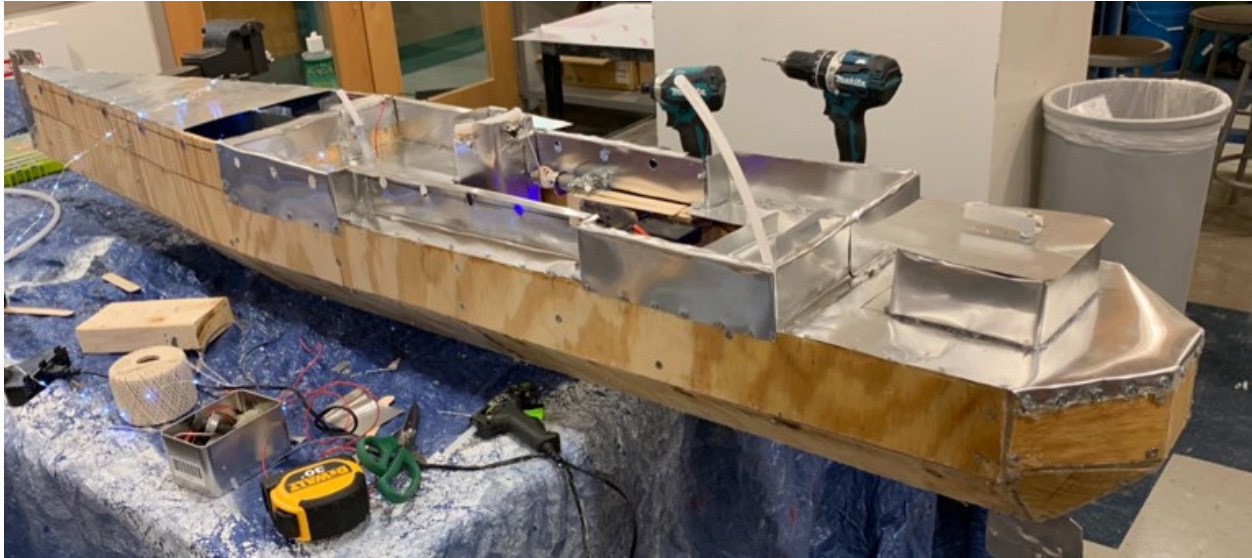
I began building the first deck of the ship. As this ship is designed for very large seas, in rough water much of the first deck may be under water. Therefore, it is designed to be essentially part of the hull. No passageways lead from the first deck to the outside (except for watertight deck hatches at the bow and stern) and the portholes are small and round for increased strength. The forward walls are plywood screwed into the ship's frame. Unfortunately, I forgot to take photos of the captain's quarters or the room at the stern, so a diagram should suffice. Bow is left, stern is right in diagram. The small stern room on the main deck is not particularly interesting; it just has the rudder post (black square in captain's quarters diagram) and a small readout, as well as a couple lights.

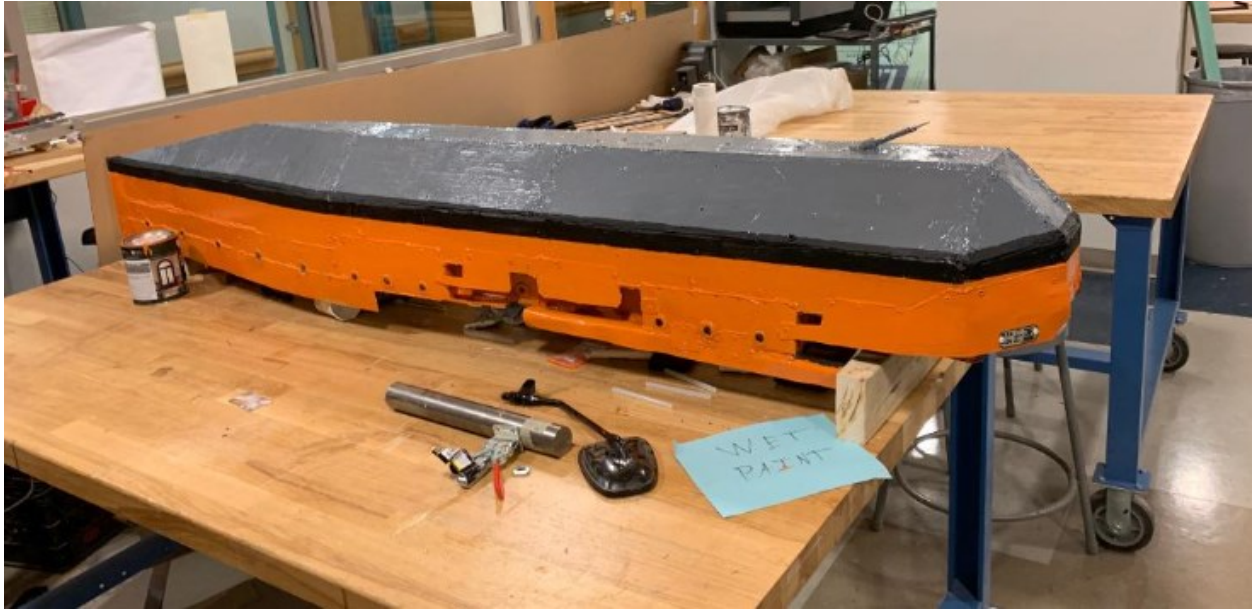
At this point, the ship was turned upside down and the outer hull was coated with epoxy. Once the epoxy cured, the hull was painted, then coated with more epoxy. I also made name plates.

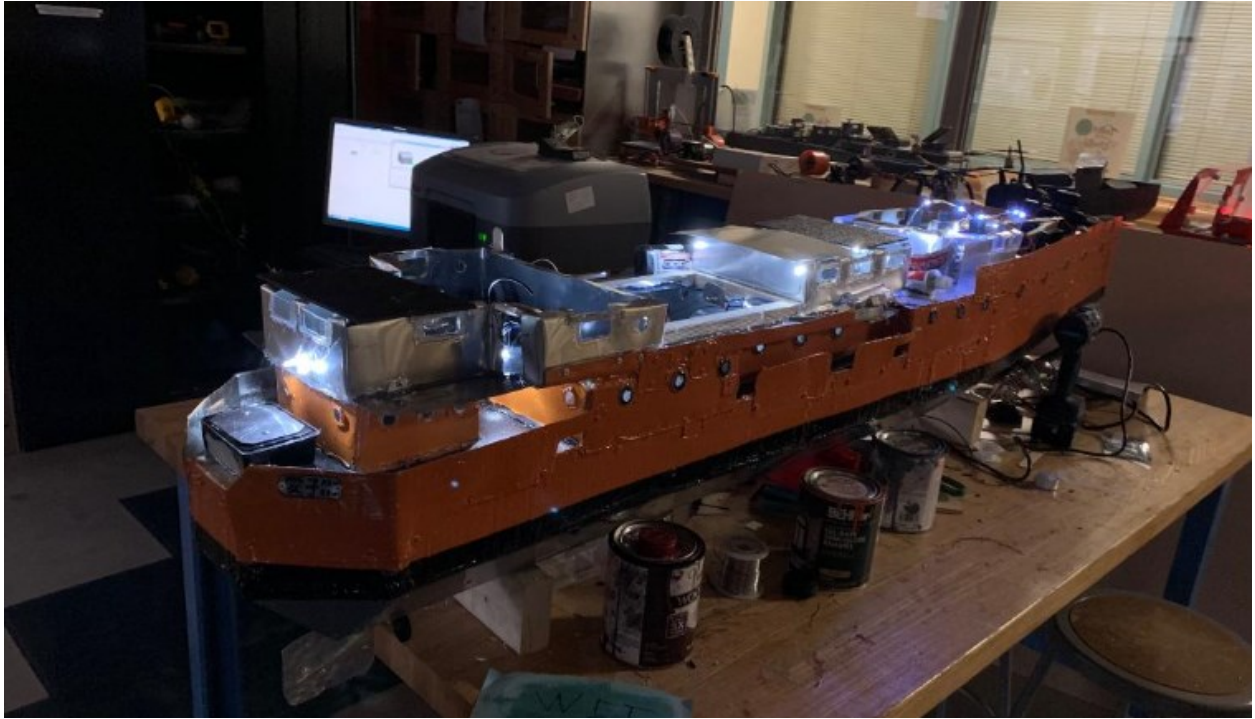
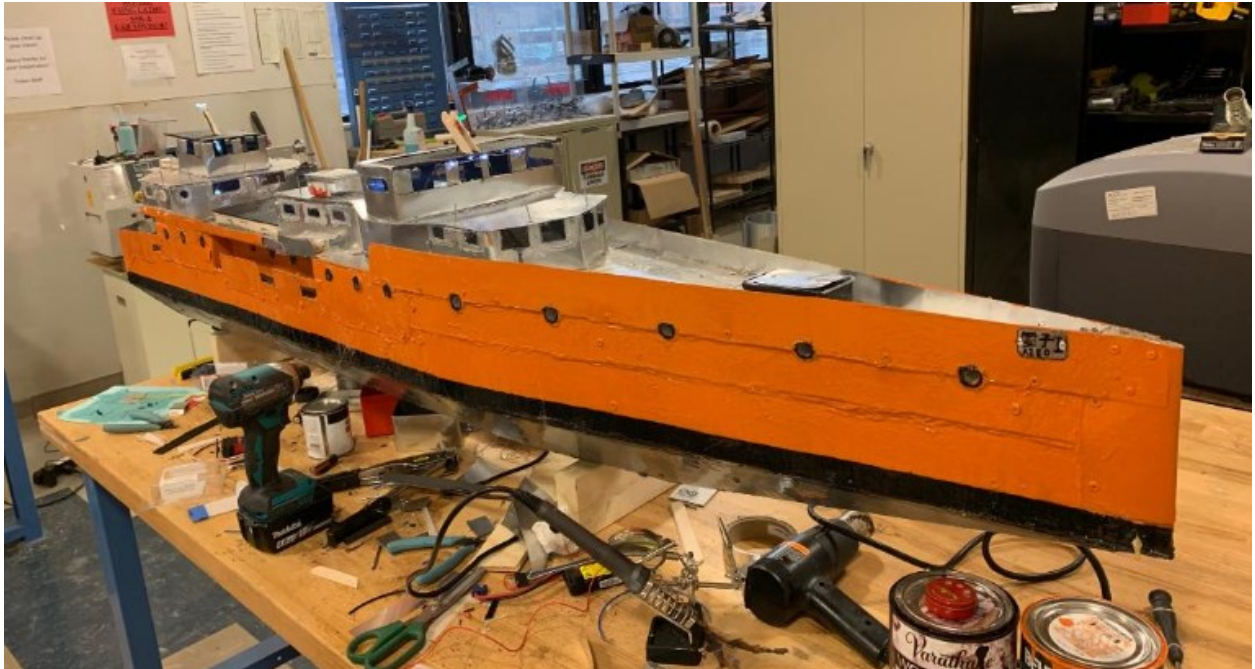
I continued building the superstructure and installing lights. There are two new lighting circuits. One powers most of the main deck lights as well as some of the crew quarters and the upper forward decks. The other illuminates the rest of the upper decks and powers the navigation lights. Note that the nav lights are backwards in this picture due to distracted gluing. This was subsequently fixed.

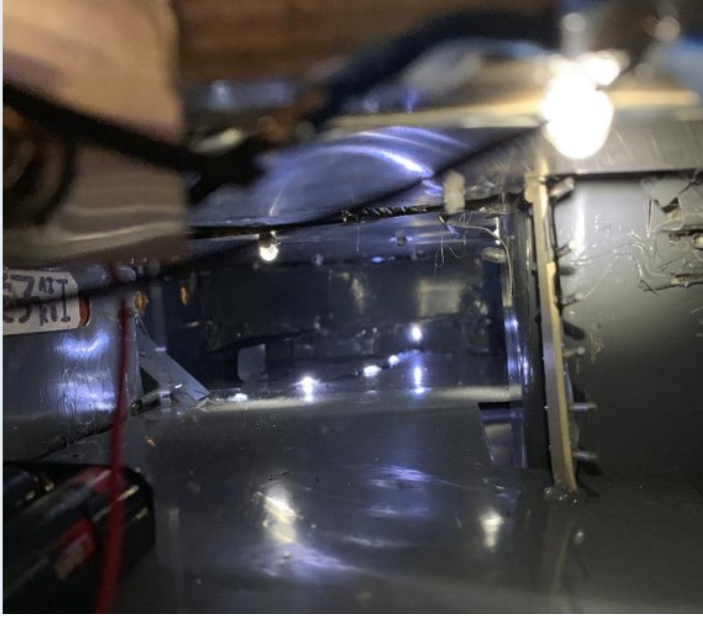
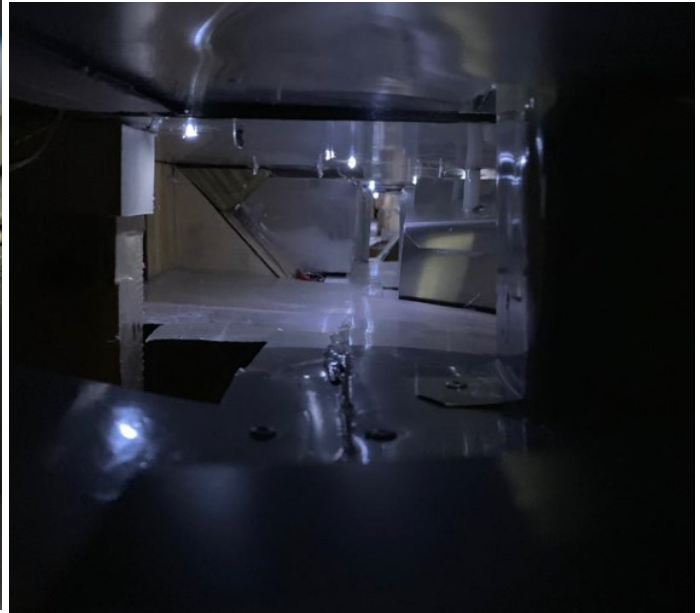
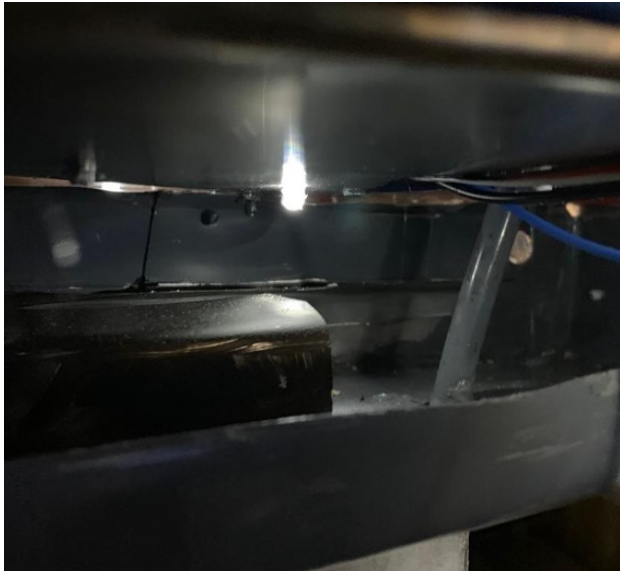
These are some views of the inside of the ship. Upper left: main deck with elevator shaft on right. Ladder in front of elevator shaft leads to second deck mid-ship compartment (multi-use room). Upper right: Looking down the first level belowdeck hallway. Sewage pump-out room is the box at the right before the narrow hallway. Directly left: View of main deck workshop aft of engine room.

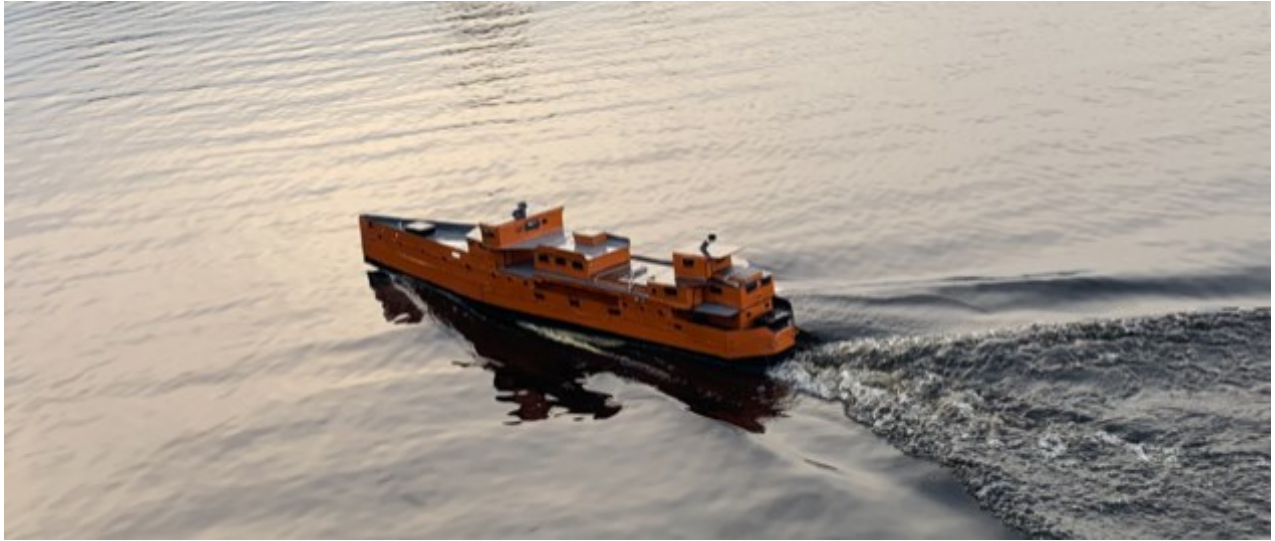
In initial trials, Aiko exhibited very underdamped roll characteristics. This was tested by exciting the hull at its resonant roll frequency using the rudder (the rudder produces roll as well as yaw torque) and observing the response. At approximately 15 degree rudder amplitude, the ship would roll onto its side with each cycle. The phenomenon that this model is encountering is cross seas at the ship's natural roll frequency. Roll dampers were added to eliminate this, and in subsequent tests the roll amplitude at resonance is not much more than the steady state roll created by steady rudder input.

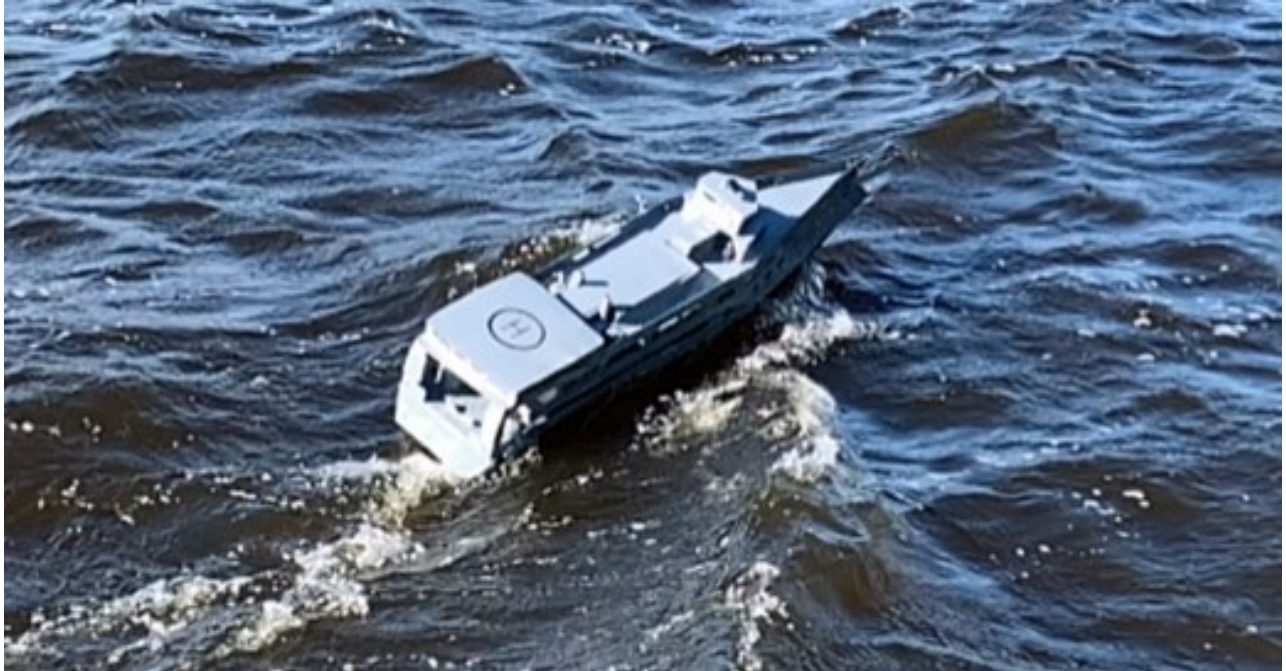
During the same testing session, I tested a coastal ferry model (ローリングール II / Rolling Girl II, above) of the same scale. This demonstrated the advantages of this hull design - the ballast and deeper draft on Aiko improved stability and the lower profile superstructure reduced the roll created by wind loading compared to the ferry. The ferry was nearly impossible to steer, and any steering done was mainly in an effort to keep the ship from capsizing. In contrast, Aiko was very easy to steer and was never close to capsizing. In term of efficiency in calm water, the two ships are similar. Aiko's sharp bow and rounded hull help efficiency, as does the ferry's semi-planing flat bottom (see next page).
