## Pilot Boat Zureteiku

### Stats:

1/32 scale

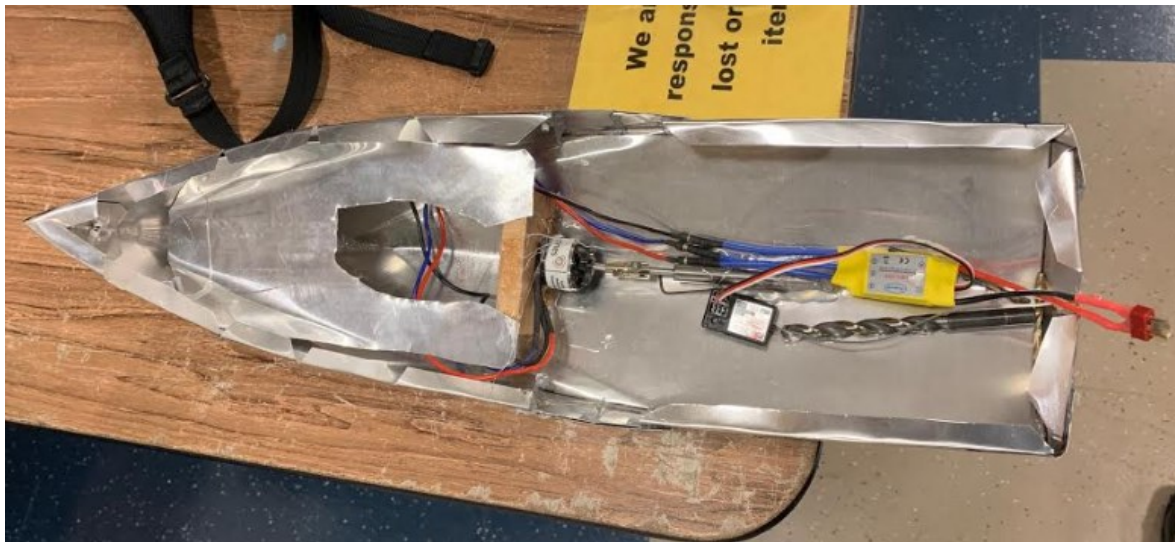
The hull is built with aluminum flashing. This is a thin metal, usually bought in large rolls, which is manipulable by hand, but thick enough to be used structurally if designed appropriately. After temporarily duct-taping the seams, hot glue (for sealing) is added, and then the seams are blind-riveted together. In this photo, it can be seen that the motor is directly attached to the wooden bulkhead; this caused problems that are described in more detail below.

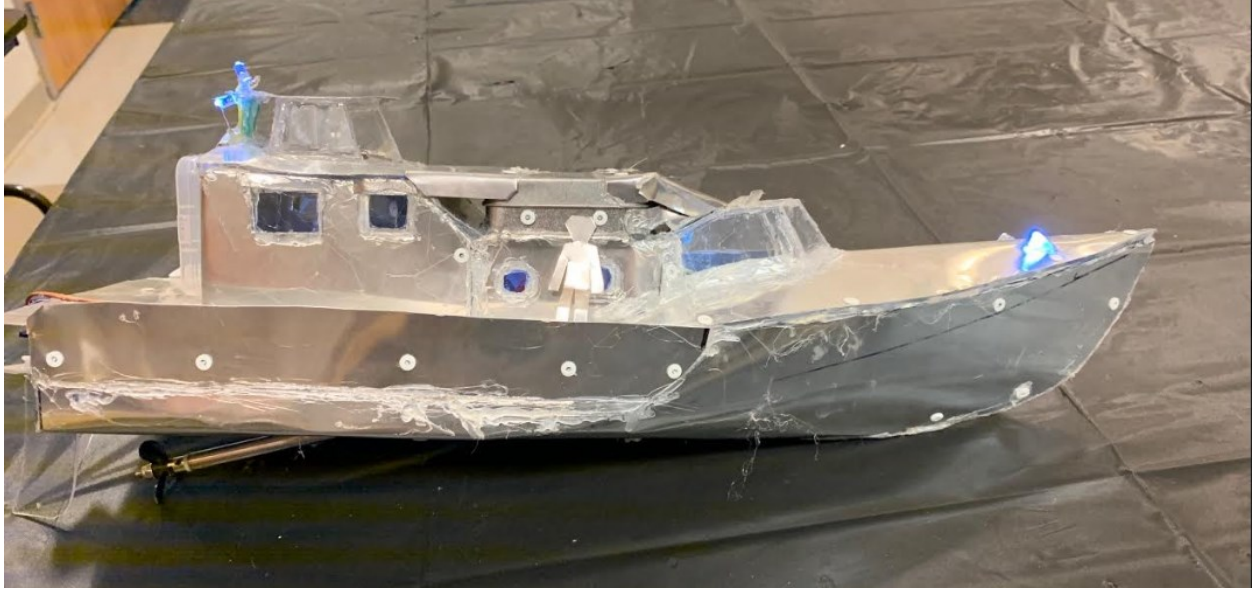
As seen above, the rest of the hull was built from the same aluminum flashing. LED lights are connected to the radio receiver, which regulates the voltage that they receive. Usually, this is sufficient, but in this case, the lights shown here burned out in approximately a week, and needed to be replaced with new lights, this time with a resistor in series. The cut-out figure is used to determine appropriate feature scaling; this figure represents a 6' tall person in 1/32 scale.

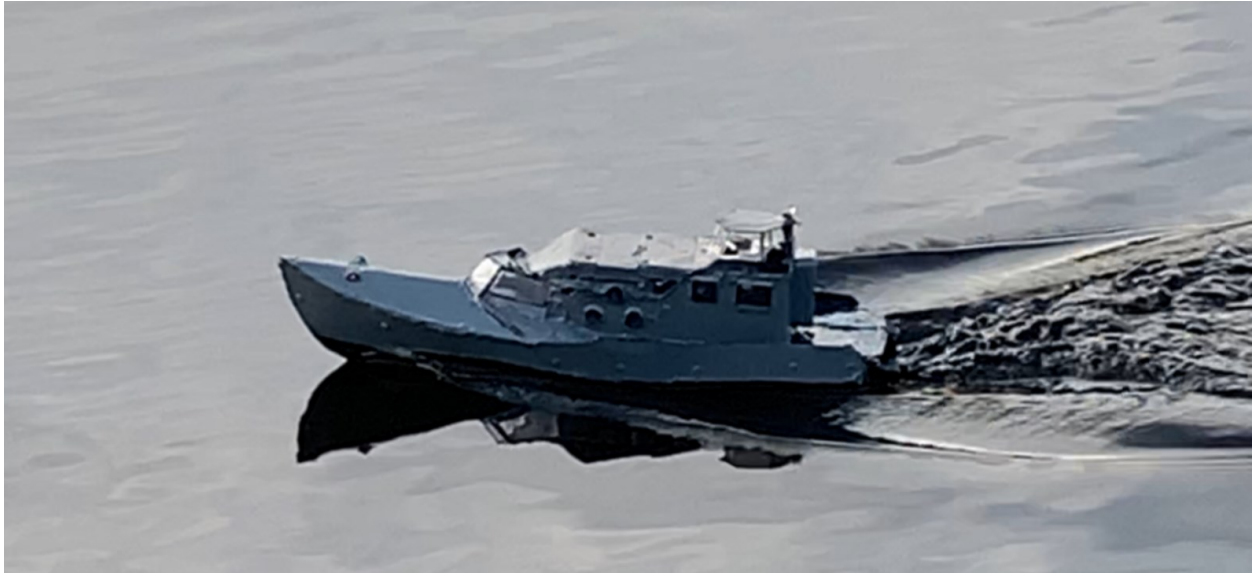
### Initial Sea Trials:

Initial sea trials revealed that the hull was responsive to rudder input during maneuverability tests, as well as relatively efficient, judging from the relatively small bow wave, and also by the lack of churning foam at the bow. This testing was conducted with a 7.4 V (2S) LiPo battery.

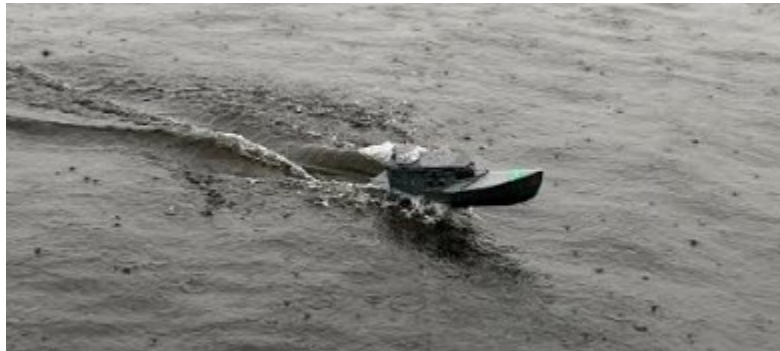
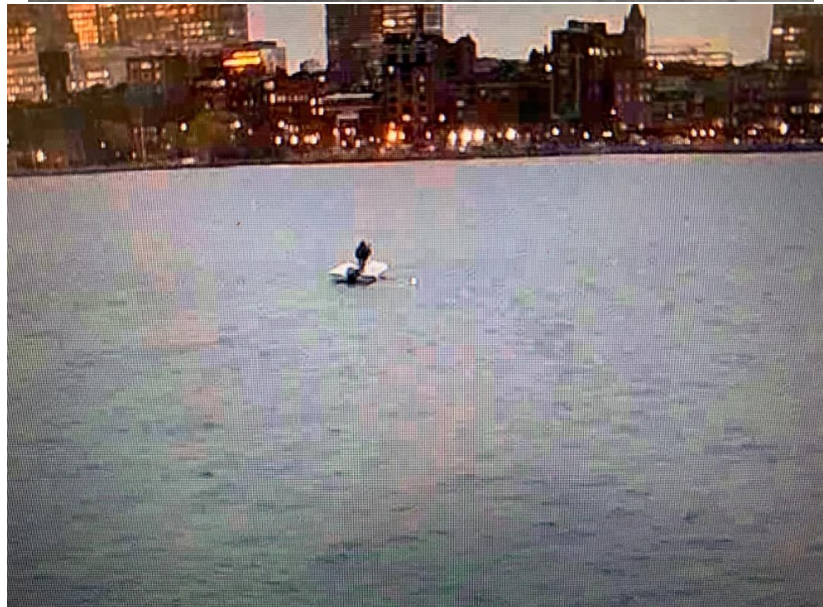
### 11.1 V Test, Motor Mount Failure:

During testing, *Zureteiku* tended to ride a bit bow-high, but otherwise maneuvered well at speed. Unfortunately, the added stress and vibration worked the motor mount screws loose from the wooden bulkhead, so the motor came loose at speed and ripped the motor wires out of the speed controller. Doubly unfortunately, the wind switched at that moment and pushed the vessel out toward the middle of the river. I had to go and teach a laboratory session, so I left and returned a few hours later (after dark) to see if I could spot its running lights along the shore. I figured that it would probably be under the highway overpass, since it was a WSW wind. Having no luck with that, I then went rowing the next day in a snowstorm, but again had no luck. Later, I reviewed footage from the MIT boathouse webcam and discovered that the boat had been recovered by a motorboat from MIT. I later learned that a marine engineer from MIT saw *Zureteiku's* running lights and figured that the boat was in trouble, since it was drifting unattended at dusk. The figure above is a capture from the webcam video that shows the motorboat with *Zureteiku's* masthead light at its right (small white light in the water).

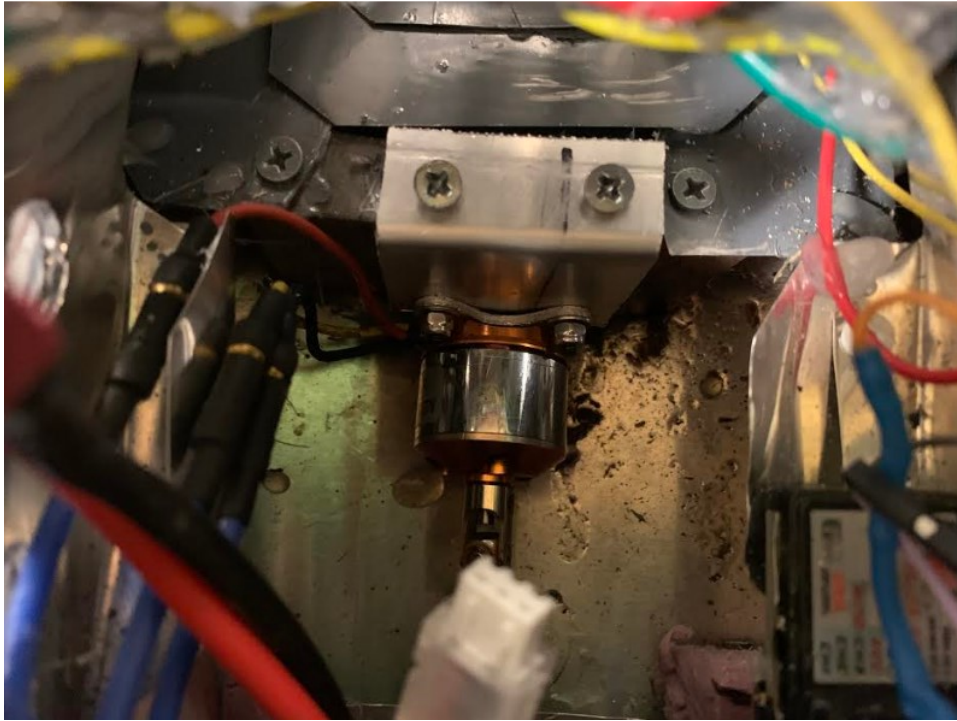
## Motor Mount Redesign

After recovering *Zureteiku*, I assessed the motor mount design and decided to reconfigure it. As the motor had been installed before the superstructure, the screws holding the motor mount to the bulkhead were now nearly impossible to reach. Therefore, I designed the L-shaped aluminum bracket in the above figure to hold the motor. To replace or maintain the motor, the bracket (with motor attached) can be removed by unscrewing the two easily-accessible top screws.

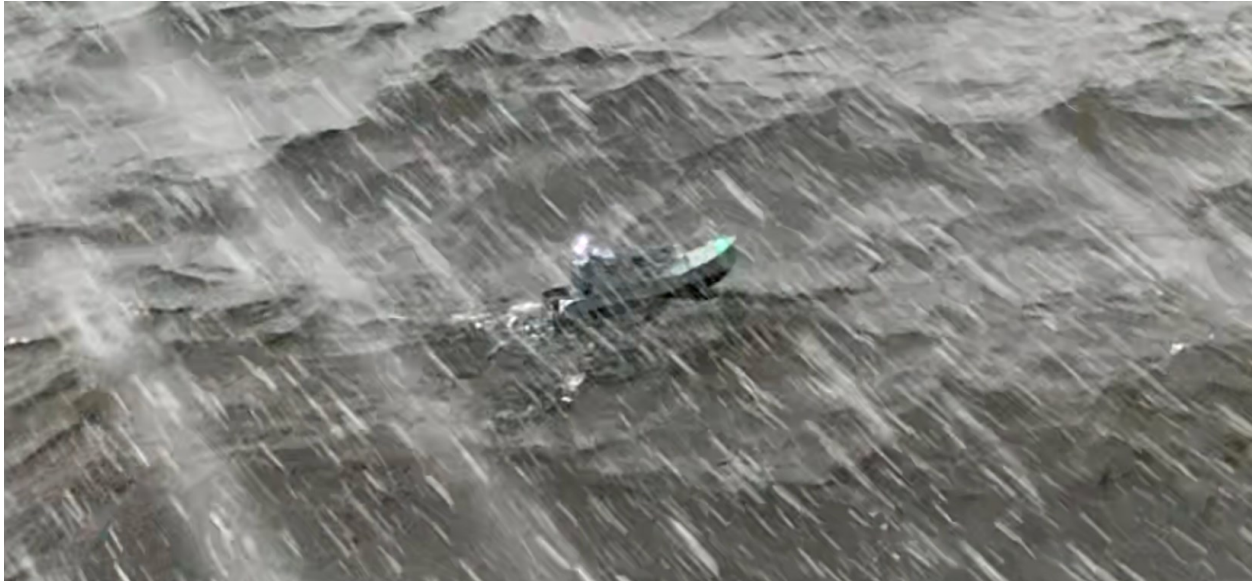
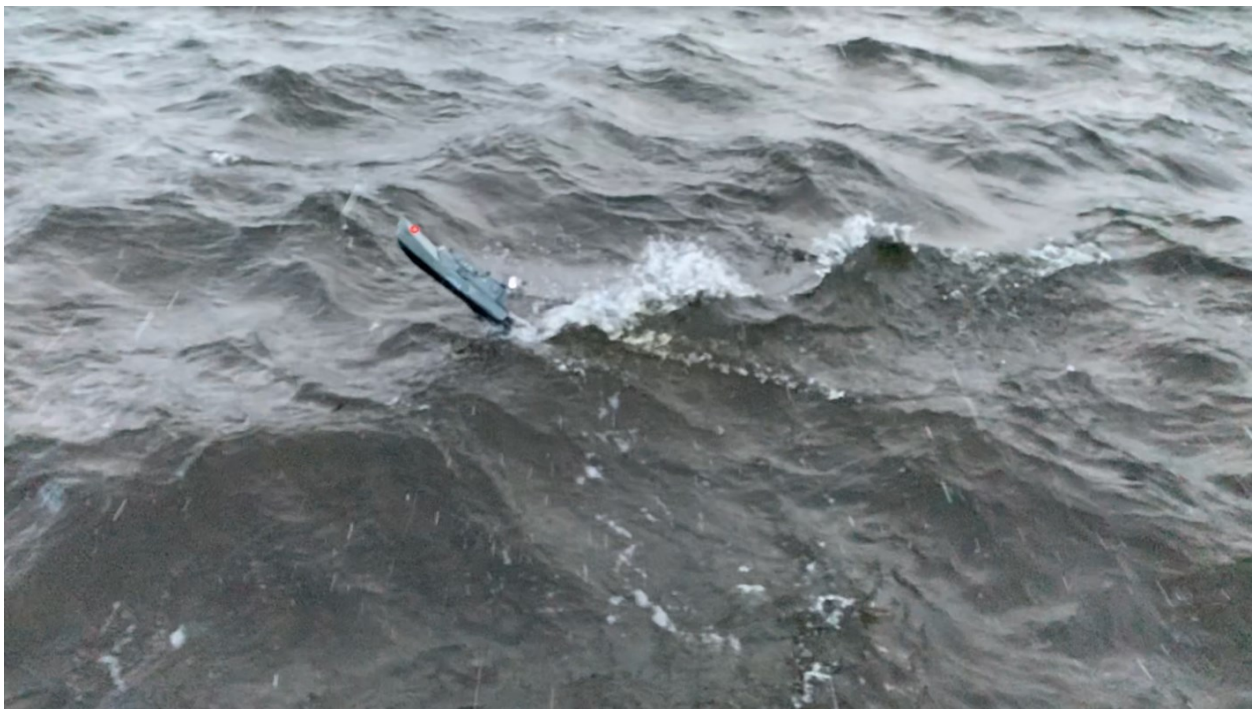
### Adverse Weather Sea Trials, 2.2 Mile Trial

After the motor mount repairs, as well as replacement of a stripped shaft set screw, the vessel was again tested on the Charles River. During its first test, a strong northwest wind was present (blowing onshore, to avoid a repeat of the unintentional MIT trip). The wind was sustained at around 20 mph, which translates to ~110 mph in full scale. Performance was quite good; the bow rose over the wave crests without either slamming or burying. The goal of the test was to complete a 2.2 mile (70.4-mile full scale) trip around an island on the Charles River Esplanade. During this trip, a strong

snow squall developed, with frequent gusts up to 40 mph (220+ mph, Category 5 hurricane force full scale)! The top figure shows the density of the snowfall (and also the utility of the running lights!). The bottom figure shows Zureteiku navigating upwind at full speed, which resulted in considerable air-time as the vessel launched off of one steep wave and landed on the next. Such a vessel in full scale would be equipped with shock absorbing crew seats, as slamming is essentially unavoidable in such extreme conditions. The vessel responded well to rudder and throttle inputs and was very stable both in roll and yaw. It seemed almost impervious to the wind. There were a few waves which were deliberately encountered broadside in an attempt to induce a capsize. One of these succeeded, and the self-righting hull functioned appropriately. These conditions lasted for approximately half of the trip. Battery capacity was at approximately 50% after the 2.2-mile trip, so estimated range would around 4.4 miles (140.8 miles full scale), with potentially more range in calm conditions.
